Durability of Post-Tensioning Grout Systems with Mixed-In Chlorides

A THESIS
SUBMITTED TO THE FACULTY OF
UNIVERSITY OF MINNESOTA
BY

Benjamin L. Thiesse

January 2014

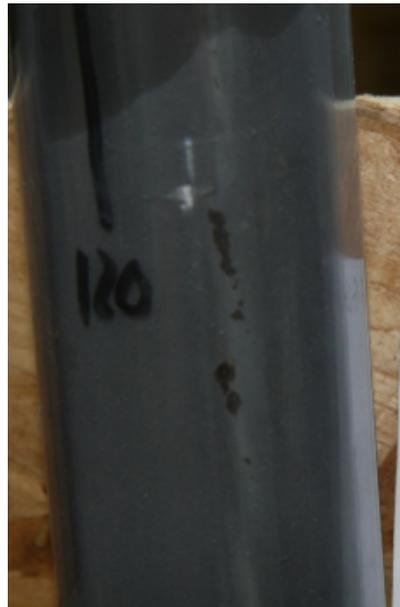
Figure 2: Specimen F-S-.6-11.5-A

Specimen	Description	Figure Number	Changed/Unchanged /New
F-S-.6-11.5-A	Two 1 cm long stains about 1/3 the way down from top	Figure 2	Unchanged
R-S-1.0-11.5-C	Two stains. The first stain is a 3.5 cm long stain by 1/2 cm wide about a third of the way up from the bottom. The second stain was a series of three small blotches that sat on the "Repair Line". Each blotch was about 1cm long by 1cm wide.	Figure 3 Figure 4	Changed
R-H-1.0-11.5-A	1/2 cm circle stain, 2cm below the repair line	Figure 5	New
R-H-1.0-11.5-B	4cm long stain, 1cm wide that is about 1/3 the way down from the top.	Figure 6	Unchanged
F-S-1.0-11.5-A	Two stains right next to each other that each are about 2cm x .5cm that are both about half the way down the tube.	Figure 7	Unchanged
F-H-1.0-11.5-B	A stain that is 2cm x .5cm that is near the top. New stain 1cm x 1cm at very top on the 0° line	Figure 8	Unchanged/New
F-S-1.0-13-A	Two different lines of blotches that are about 2cm x .5cm that is located near the top.	Figure 9	Unchanged

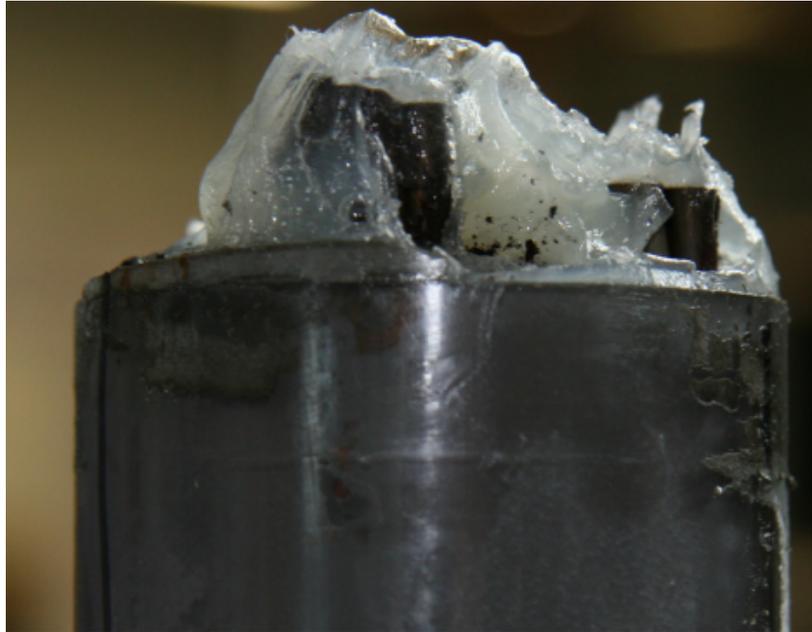
Figure 10: Specimen F-S-1.0-13-B

F-S-1.0-13-B	A stain that is 1cm x 1cm near the top with smaller blotches below.	Figure 10	New
F-H-1.0-14-B	A stain that is 2cm x 2cm at the top of the sample.	Figure 11	New
F-H-1.0-14-C	A stain that is 1/2 cm x 1/2 cm at the top of the sample.	Figure 12	New

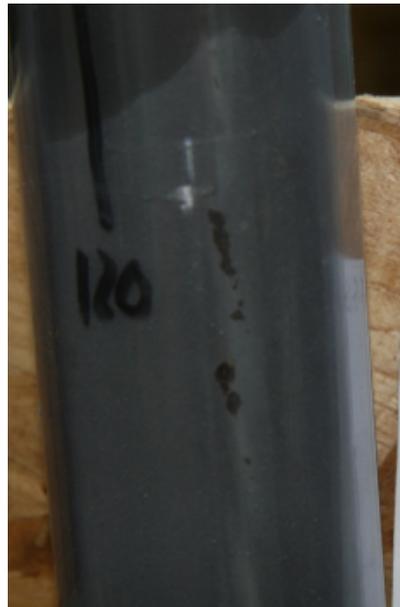
Figure 2: Specimen F-S-.6-11.5-A

Specimen	Description	Figure Number	Changed/Unchanged /New
F-S-.6-11.5-A	Two 1 cm long stains about 1/3 the way down from top	Figure 2	Unchanged & Shipped
R-S-1.0-11.5-C	Two stains. The first stain is a 4.5 cm long stain by 1 cm wide about a third of the way up from the bottom. The second stain was a series of three small blotches that sat on the "Repair Line". Each blotch was about 1cm long by 1cm wide.	Figure 3 Figure 4	Changed
R-H-1.0-11.5-A	½ cm circle stain, 2cm below the repair line	Figure 5	Unchanged
R-H-1.0-11.5-B	4cm long stain, 1cm wide that is about 1/3 the way down from the top.	Figure 6	Unchanged
F-S-1.0-11.5-A	Two stains right next to each other that each are about 2cm x .5cm that are both about half the way down the tube.	Figure 7	Unchanged & Shipped
F-H-1.0-11.5-B	A stain that is 2cm x .5cm that is near the top. New stain 1cm x 1cm at very top on the 0° line	Figure 8	Unchanged
F-S-1.0-13-A	Two different lines of blotches that are about 2cm x .5cm that is located near the top.	Figure 9	Unchanged

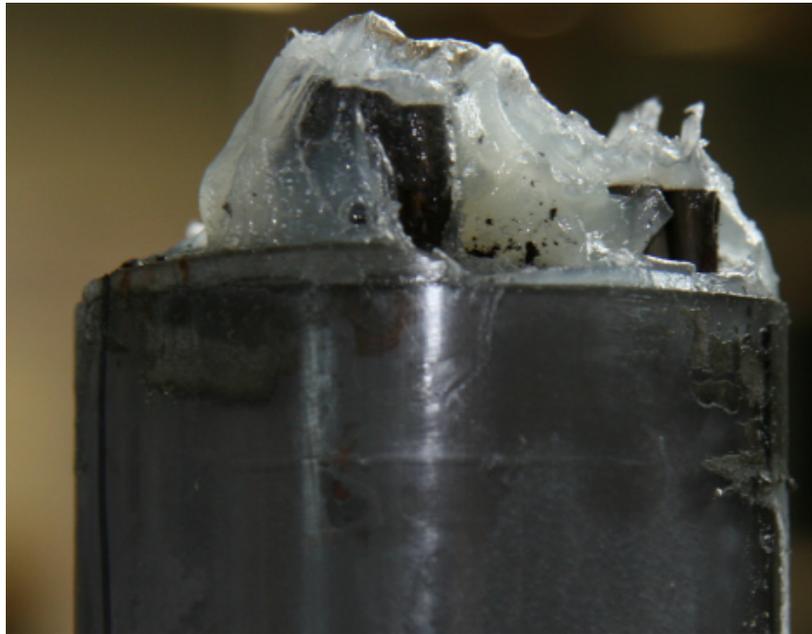
Figure 10: Specimen F-S-1.0-13-B

F-S-1.0-13-B	A stain that is 1cm x 1cm near the top with smaller	Figure 10	Unchanged

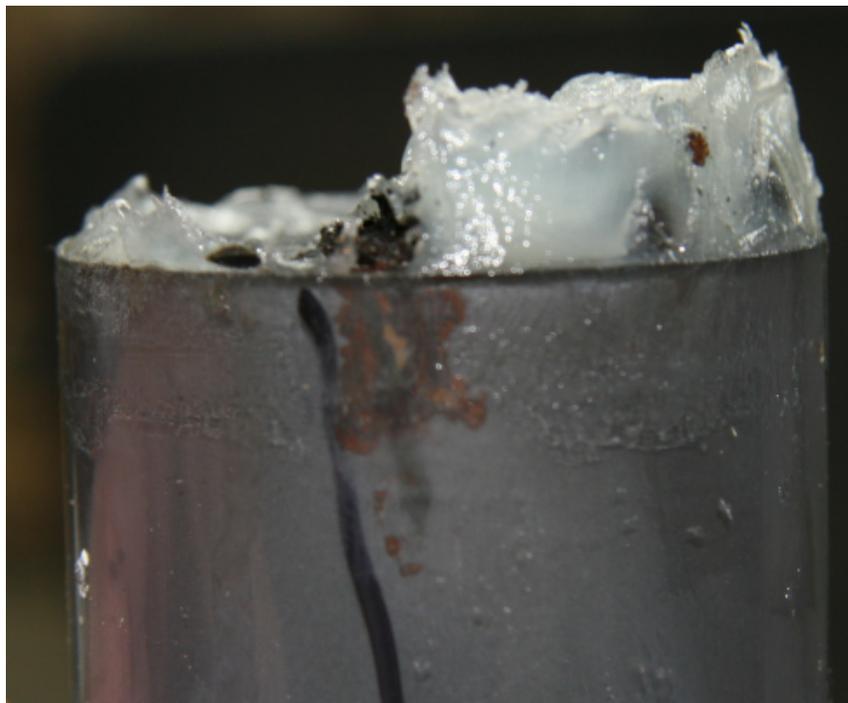
Figure 11: Specimen F-H-1.0-14-B

blotches below.		
F-H-1.0-14-B	A stain that is 2cm x 2cm at the top of the sample.	Figure 11	Unchanged
F-H-1.0-14-C	A stain that is ½ cm x 2 ½ cm at the top of the sample.	Figure 12	Changed
F-S-.6-13-B	Three stains. The first is 5cm x 5cm mid way down surrounding the electrode pad. The second stain is 1cm x ½ cm, 3cm from the top. The third stain is ½ cm x 4cm, ½ way to the top near 360° line.	Figure 13 Figure 14 Figure 15	New/Changed
F-S-1.0-11.5-C	"Dot like" stains from top to 2cm down	Figure 16	New
F-S-1.0-14-C	2cm x ½ cm near top	Figure 17	New
F-S-.4-11.5-C	Three stains. First, ½ cm x ½ cm stain, 2 cm from top. Second, ½ cm x ½ cm stain, 4 cm from top. Third, ¼ cm x ½ cm, 2 cm down from top.	Figure 18	New
F-S-.4-13-C	½ cm x ½ cm, 2 cm down from top	Figure 19	New
F-S-.4-14-C	½ cm x ½ cm, 2 cm down from top	Figure 20	New

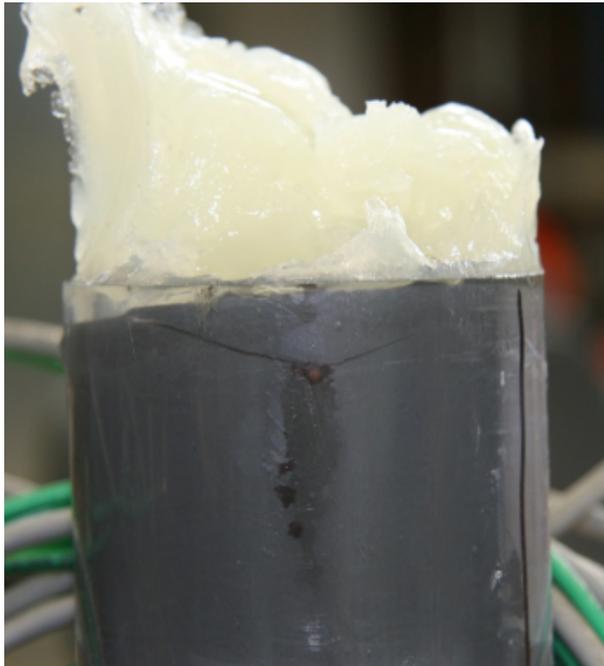
Figure 16: F-S-1.0-11.5-C

One of the new stains that were observed during this inspection was a little more interesting than the others. Specimen F-S-1.0-11.5-C (solid, sealed, 1.0% chloride and 11.5 pints/bag of water) had developed a stain that was near the strand location and was near the top. But, the notable characteristic of this stain was the crack that had developed with the stain. When corrosion occurs, the resulting material has a larger volume than the material consumed. This expansion creates tensile stresses in the concrete and causes cracks. This stain and crack were noted so that it could be determined if changes occur during the upcoming inspections, a picture of this specimen can be seen in Figure 19.

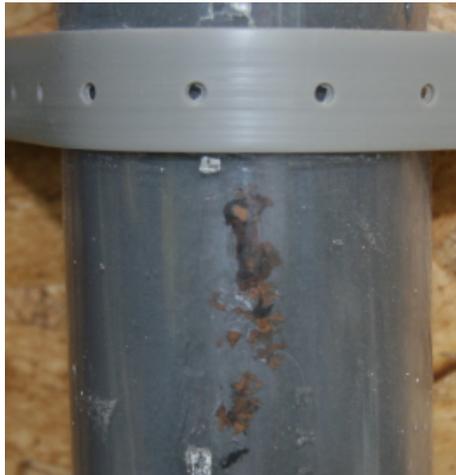
Figure 2: Specimen R-S-1.0-11.5-C – First Stain

Specimen	Description	Figure Number	Changed/Unchanged /New	Rack Letter
R-S-1.0-11.5-C	Two stains. The first stain is a 4.5 cm long stain by 1 cm wide about a third of the way up from the bottom. The second stain was a series of three small blotches that sat on the "Repair Line". Each blotch was about 1cm long by 1cm wide.	Figure 2 Figure 3	Unchanged	L
R-H-1.0-11.5-A	½ cm circle stain, 2cm below the repair line	Figure 4	Unchanged	M
R-H-1.0-11.5-B	4cm long stain, 1cm wide that is about 1/3 the way down from the top.	Figure 5	Unchanged	M
F-H-1.0-11.5-B	A stain that is 2cm x .5cm that is near the top. New stain 1cm x 1cm at very top on the 0° line	Figure 6	Unchanged	M
F-S-1.0-13-A	Two different lines of blotches that are about 2cm x .5cm that is located near the top.	Figure 7	Unchanged	M
F-S-1.0-13-B	A stain that is 1cm x 1cm near the top with smaller blotches below.	Figure 8	Unchanged	M
F-H-1.0-14-B	A stain that is 2cm x 2cm at the top of the sample.	Figure 9	Unchanged	N

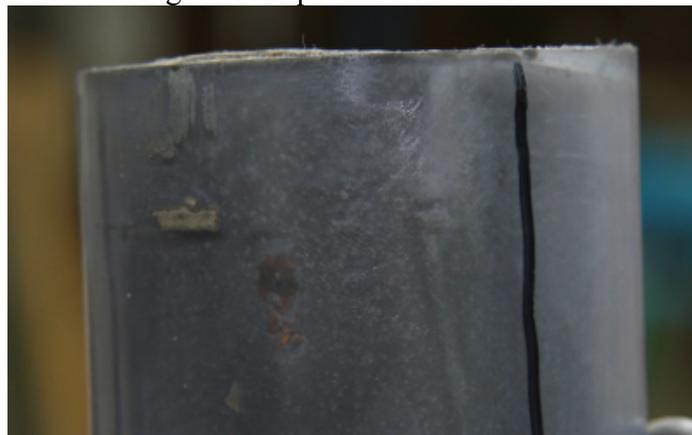
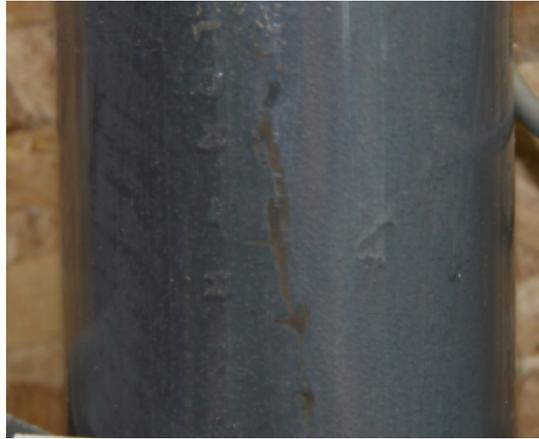
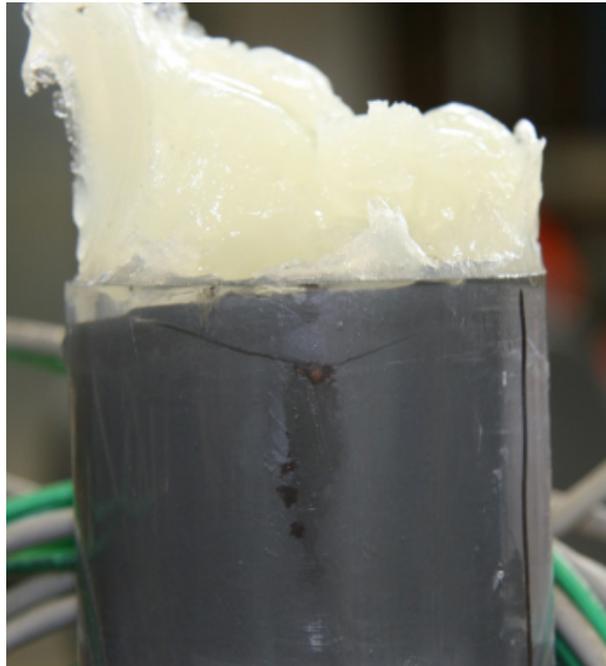
Figure 11: Specimen F-S-.6-13-B

Figure 12: Specimen F-S-.6-13-B

Figure 13: Specimen F-S-.6-13-B

F-H-1.0-14-C	A stain that is ½ cm x 2 ½ cm at the top of the sample.	Figure 10	Unchanged	N
F-S-.6-13-B	Three stains. The first is 5cm x 5cm mid way down surrounding the electrode pad. The second stain is 1cm x ½ cm, 3cm from the top. The third stain is ½ cm x 4cm, ½ way to the top near 360° line.	Figure 11 Figure 12 Figure 13	Unchanged	T
F-S-1.0-11.5-C	"Dot like" stains from top to 2cm down	Figure 14	Unchanged	T
F-S-1.0-14-C	2cm x ½ cm near top	Figure 15	Unchanged	T
F-S-.4-11.5-C	Three stains. First, ½ cm x ½ cm stain, 2 cm from top. Second, ½ cm x ½ cm stain, 4 cm from top. Third, ¼ cm x ½ cm, 2 cm down from top.	Figure 16	Unchanged	T

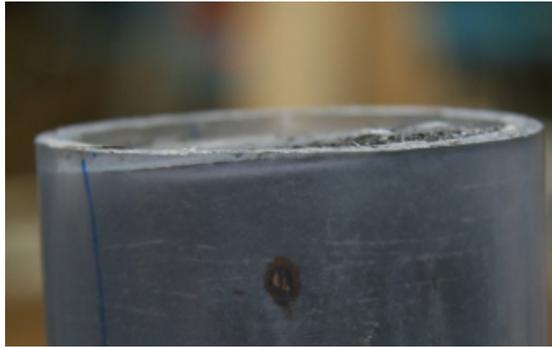
Figure 17: F-S-.4-13-C

F-S-.4-13-C	½ cm x ½ cm, 2 cm down from top	Figure 17	Unchanged	T
F-S-.4-14-C	½ cm x ½ cm, 2 cm down from top	Figure 18	Unchanged	T
F-S-.75-11.5-A-2	1cm x 1cm, 2cm from top	Figure 19	Changed	A
F-S-.75-11.5B-2	2.5cm x 1cm, 3cm from top	Figure 20	Changed	A
V-S-.75-11.5-A-2	Two Stains: First is unchanged, 2cm x ½ cm, half way down, Second is new 2cm x ¼ cm, 2cm below other stain.	Figure 21	Changed	A
V-S-.75-11.5-B-2	Spots 2cm down, cracks running through	Figure 22	Unchanged	A
V-S-.75-11.5-C-2	2cm x ½ cm, 1 cm down from top	Figure 23	Unchanged	A
F-S-.85-13-A-2	Three Stains; First Two are unchanged: First is 1 ½ cm x ½ cm, second is 2 ½ cm x 1 cm. Both 1 ½ cm from top. Third stain is new, ¼ cm x 1 cm, 2cm right of first two stains.	Figure 24	Changed	B
F-S-.4-11.5-B-2	1cm x ½ cm, 2cm from top	Figure 25	Unchanged	
F-S-.4-11.5-C-2	½ cm circle, 1 cm from top	Figure 26	Unchanged	B
F-H-.4-13-C-2	½ cm x 1cm, 1 ½ cm down from top	Figure 27	Unchanged	C

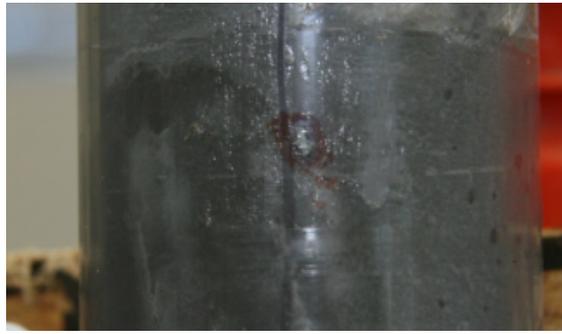
Figure 28: V-S-.65-11.5-C

V-S-.65-11.5-C	1cm x ½ cm, 4cm down from top	Figure 28	New Specimen	C
F-H-.75-13-A	½ cm circle, 1 cm from top	Figure 29	New Specimen	D
F-H-.75-13-B	½ cm circle, 1 cm from top	Figure 30	New Specimen	D
F-H-.75-13-C	1cm x ½ cm, 3 cm from top	Figure 31	New Specimen	D
V-S-.4-13-B	1 ½ cm x ½ cm, 4 cm from top	Figure 32	New Specimen	D
F-S-.65-11.5-A	¼ cm x ¼ cm, ½ cm from top	Figure 33	New Specimen	E
F-S-.65-11.5-B	2 ½ cm x 1 cm, 3 cm from top	Figure 34	New Specimen	E
V-S-1.0-11.5-A	2 ½ cm x 1 cm, 3 cm from top	Figure 35	New Specimen	F

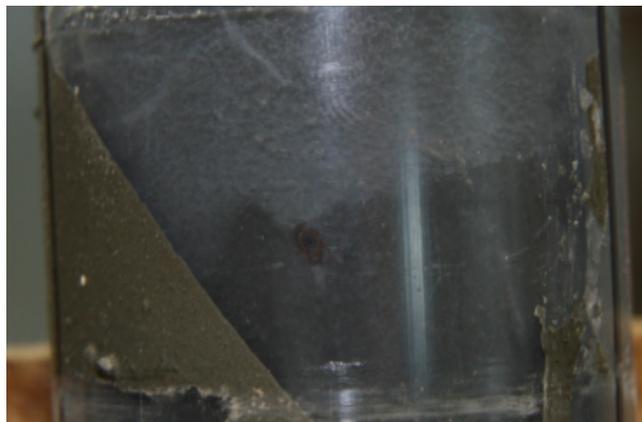
Figure 36: V-S-1.0-11.5-B

V-S-1.0-11.5-B	1 ½ cm x ½ cm, ½ cm from top	Figure 36	New Specimen	F
F-S-.4-13-F	¼ cm x ¼ cm, 2 ½ cm from top	Figure 37	New Specimen	H
F-H-.65-13-A	1 ½ cm x ½ cm, 1 ½ cm from top	Figure 38	New Specimen	H
F-H-.65-13-B	½ cm x ½ cm, 2 cm from top	Figure 39	New Specimen	H
V-S-.85-13-B	Three Stains: 1) 1cm x ½ cm 2) 1 ½ cm x 1 cm 3) ¼ cm dots	Figure 40 Figure 41 Figure 42	New Specimen	J
V-S-.85-13-C	2cm x 1cm, 1cm from top	Figure 43	New Specimen	J
F-S-1.0-11.5-B	Two Stains: 1) ½ cm x ½ cm 2) 1 ¼ cm x ½ cm	Figure 44	New Specimen	K
V-S-1.0-11.5-A	Two Stains: 1) 1cm x ½ cm, 2 cm from top 2) 2 ¼ cm x 1 cm, 4 cm from top	Figure 45	New Specimen	L
F-S-1.0-11.5-C	1 cm x ½ cm, 2 cm from top	Figure 46	New Specimen	L
F-S-1.0-14-B	1 ½ cm x ½ cm on top	Figure 47	New	N
F-S-.65-13-B	2cm x 1 cm, 1 ½ cm from top	Figure 48	New Specimen	N
F-S-.65-13-C	2cm x ½ cm, 2cm from top	Figure 49	New Specimen	N
F-S-.75-13-B	1 ½ cm x ½ cm, 1 ½ cm from top	Figure 50	New Specimen	O

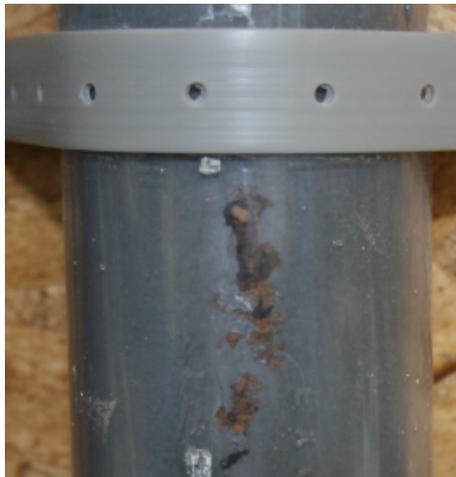
Figure 1: Typical horizontal crack 0.25 cm below surface

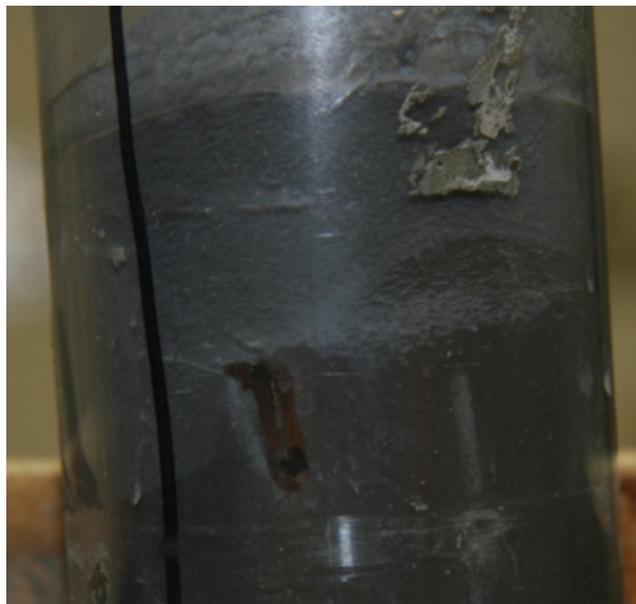
Figure 69: F-S-1.5-13-B-2

F-S-1.5-13-B-2	1 ½ cm x ½ cm, 2 ½ cm from top	Figure 69	Unchanged	P
V-S-1.5-13-C-2	2 ½ cm x 1 ½ cm, 3cm from top	Figure 70	Changed	P
F-S-1.0-13-A-2	1) 2 ½ cm x ½ cm, 3cm from top (Changed) 2) 1cm x 1cm, 3cm from top (Unchanged)	Figure 71	Changed	P
V-S-1.5-11.5-B-2	1cm x ½ cm, 3 cm from top	Figure 72	New	P
