Hati Flight 01 Analysis

Synopsis

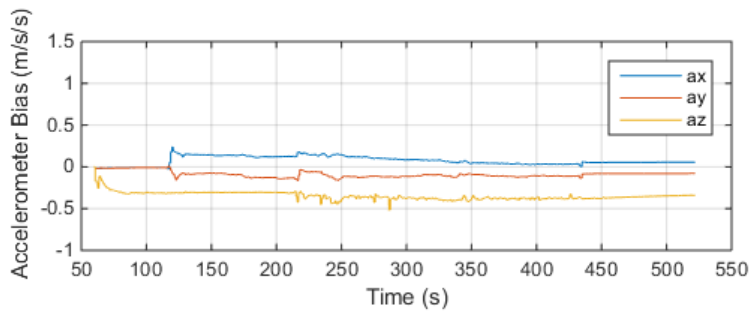
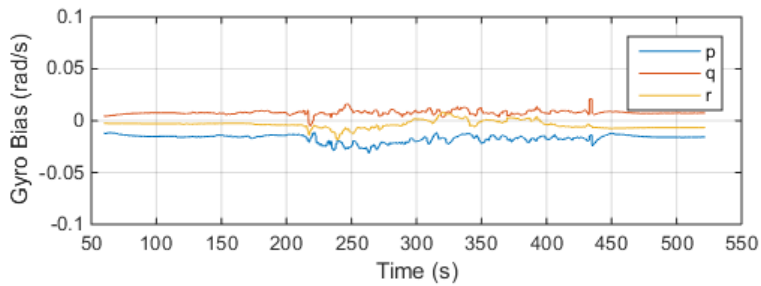
For comparison, Skoll flight 12 biases are below with the y-axis scaling applied.

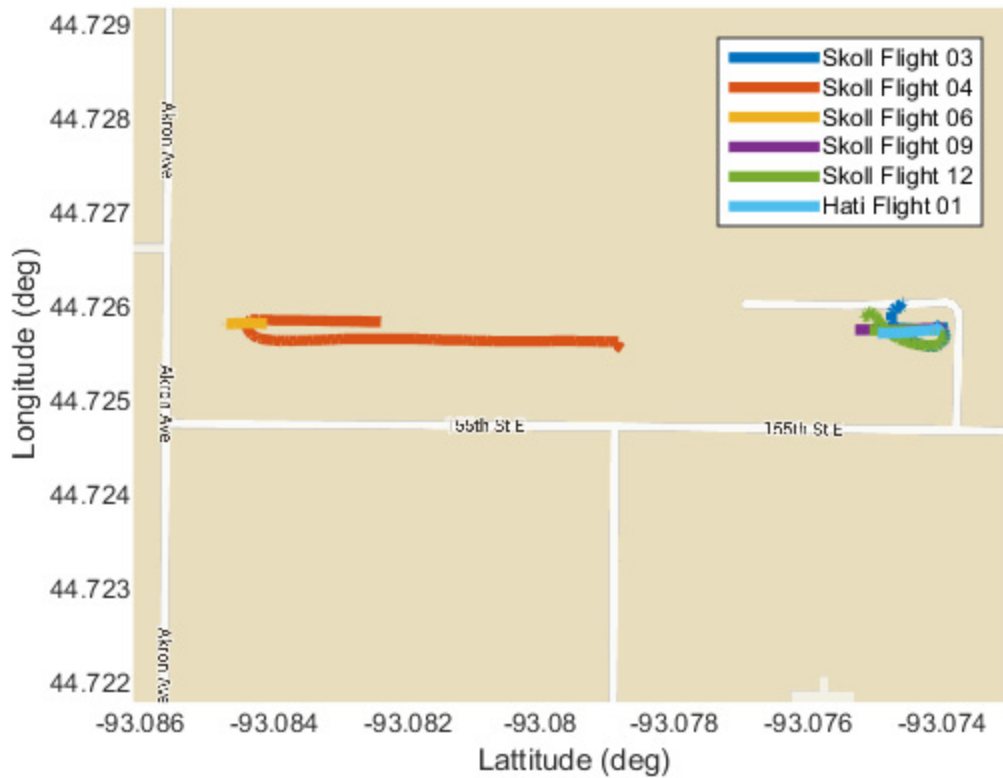
For Hati Flight 01, a West launch heading was used, but the software was reset on the truck because of the new higher sampling rate. This flight was the first using a 150 Hz sampling rate, which limits the flight data recording time to just over 8 minutes. With flight times of about 6 minutes, the decision was made to reset software on the truck just prior to launch. The hypothesis is that without significant heading motion or time prior to launch, and the initialization of a value 180 degrees from the true value, the EKF did not converge prior to launch.

Examining other mAEWing1 flights, all of the previous flights, except one, were either initialized and then driven to the launch location with the software running or, when a software reset was performed on the truck, the launch direction happened to be East.
