Conditions Assessment for the Andrew Peterson Farmstead

Peggy Anderson, Alejandro Sanchez, Mohamed Alqari, Fred Counts, Anne Drolet, Holly Engle, Joel Holstad, Elizabeth Kinney, Jenna Rempfert, Sarah Ward, Alexandr Young, and Lisa Zeeb

Students in ARCH 5672: Historic Building Conservation
Instructor: Todd Grover, AIA

ANDREW PETERSON FARMSTEAD Carver County, Minnesota

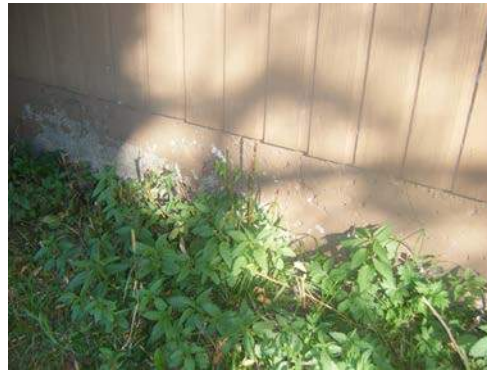
The farmhouse is a two-story building with a three season porch running almost the full width of the house. The porch is visible in a photograph of the house from 1885, see Figure 1. At that time it seems to have been just a covered porch, and was enclosed at some later date. The foundation wall of the porch is concrete and is generally in good condition with minor cracking. The concrete is painted brown to match the siding, and the

paint is peeling in places, see Figure 2. The siding of the porch runs vertically, similar to the rest of the house and the barns. It appears to be in good condition with little to no rot visible and is painted brown.

Figure 2. Concrete foundation wall of porch.

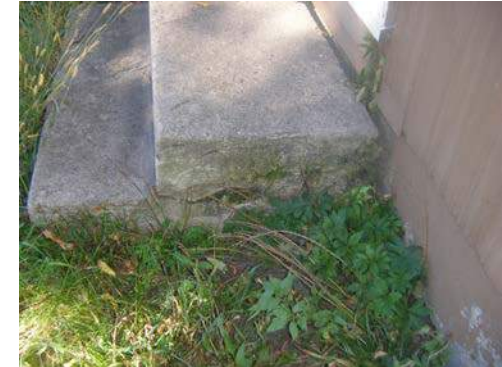
The front steps leading up to the porch door are concrete and have two risers. The concrete has a coarse aggregate, and seems to be in good condition except on the side faces where there is some spalling. The steps are not attached to the porch, and there has been some movement of the steps relative to the porch. This has resulted in a 1"-2" gap between the steps and the porch and an overall downward slope, See Figure 3.

Figure 3: Steps at front porch.

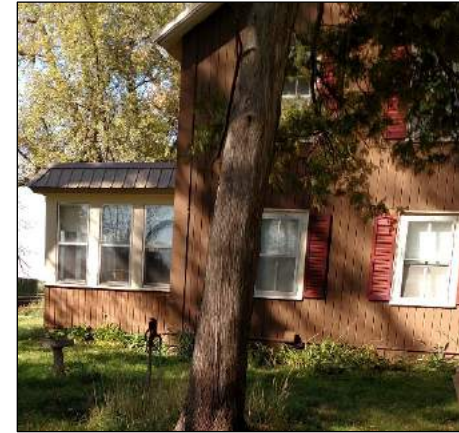
The siding has no visible signs of imminent structural failure. The paint on the north façade is intact. The paint on the central and south façades, though, does show failure with flaking, peeling and weather-damage. The central main house section's

Fig. 3) Southern enclosed porch. Photo taken facing west.

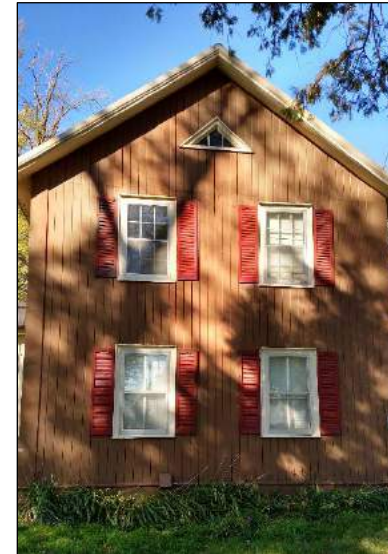
Fig. 4) Central main house section. Photo taken facing west.

For the central main house's siding, the peeling and cracking of the brown paint requires removal, particularly in anticipation of restoration to the earlier 1885 blue.

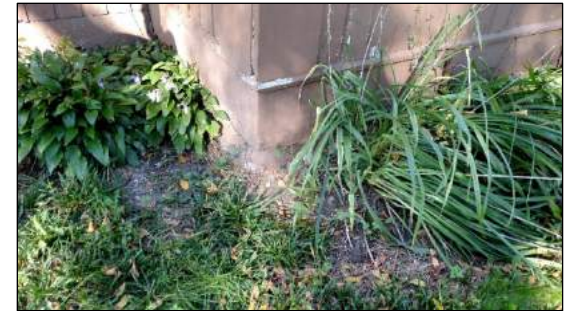
The foundation of the central wing is rough fieldstone and appears to be original. A brown-painted 12-inch-wide base board covers the top portion of the fieldstone. (fig. 6) The foundation for the north wing and south porch is not visible due to the enclosures.

Fig. 6) Detail of foundation and siding baseboard. Photo taken facing northwest.

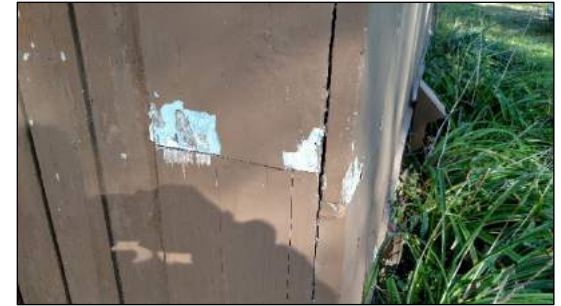
brown paint has chipped off in a number of places, exposing layers of light blue and white paint as well as bare wood. (fig. 7) Notes about the 1885 photograph indicate the house was painted blue at that point in time, and the 2015 Master Plan indicates the house paint will be restored to this blue during the second stage of the farm's development.²

Fig. 7) Flaked off paint revealing white and then blue paint beneath. Photo taken facing north.

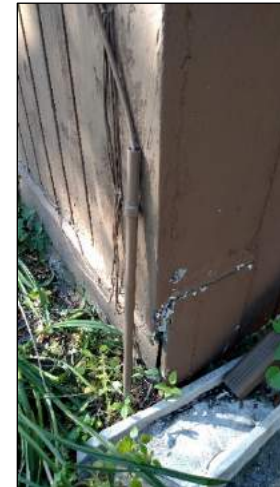
At the base of the northeast corner of the central section, a short board is plastered in with a mortar-like substance that crumbles when pulled away from the structure. Beneath the mortar patch, trapped water has degraded the wood, which is damp to the touch. Due to the placement of the downspout extension and splash-block, it is likely that defective ground and surface drainage has caused the degrading of the wood. (fig. 8)

Fig. 8) Replaced wood piece plastered in with mortar-like substance. Note splash block. Photo taken facing southwest.

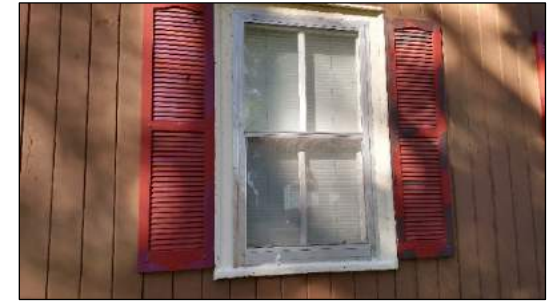
The windows do not show any structural decay. The paint is in similar condition as the siding paint with the overpainting peeling and in need of removal. (fig. 9) The glazing is

Fig. 9) Detail of window frame and shutters. Note condition and inappropriate addition of the aluminum storm windows. Photo taken facing west.

The wooden window framing restoration should follow the same process of stripping and wood examination. Extensive cracking and peeling was not obvious during this evaluation, but some areas do show paint failure and closer examination is needed. The Preservation Brief 9 describes the method of restoration for windows which should be followed.⁶

- Due to the condition and material of the shutters, and the fact that no shutters were on the house in 1885, the shutters should be removed.

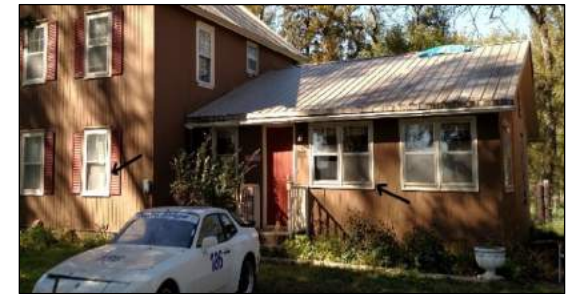
The aluminum storm and screen insets have signs of wear. The screen on the center section's lower northeast window and the screen on the north wing's window are both in need of repair. (fig. 10)

Fig. 10) Identification of windows with broken screens and storm windows. Photo taken facing south west.

Replacement storm windows should be wooden if possible and compatible with the original window profile.

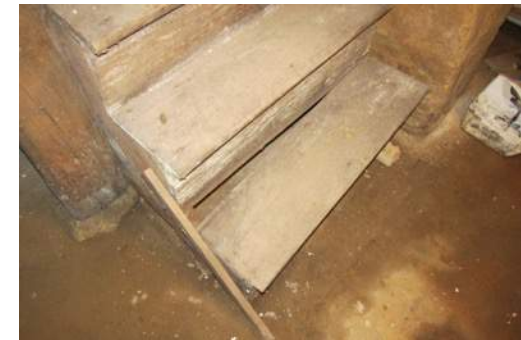
Basement Main Stairway- Broken Bottom Step

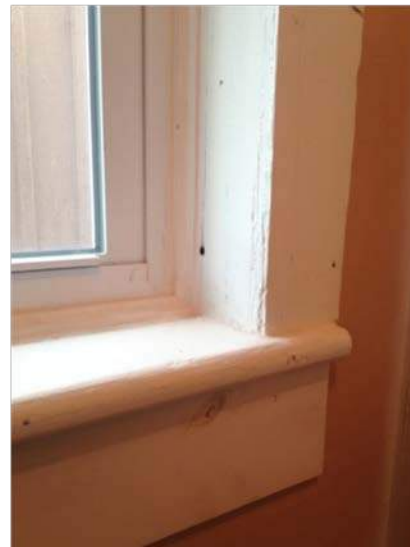
The framing style of Window 1a is architrave, where the head rests on the two casings. In addition, there is a modern wooden apron that sits beneath the sill and stool. The casings, sill, and stool have a considerable amount of damage. There are many scratches, cracks, and dents on the casing which were simply painted over. There is a noticeable dent in the stool as well. These characteristics give the Window 1a a very rough texture. Window 3a and Window 3b both have a post and lintel style frame, where the header rests on top of the two casings. Unlike Window 1a, both of these windows do not have aprons. The frames on Window 3a and Window 3b are in good condition. While there are minor scratches on the wood, the texture of the wood is not as rough as in Window 1a.

Window 1a- Frame Detail

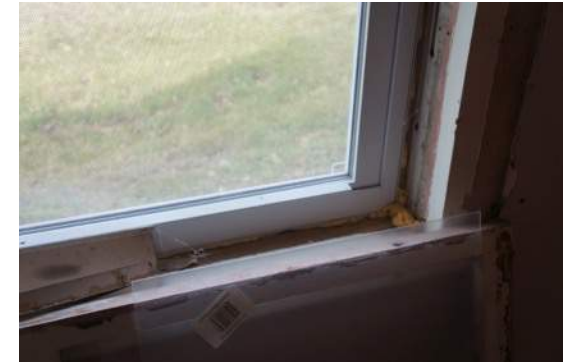
For Window 5a, there is a non-historic screen on the exterior. The installation is poor, and spray filler is visible around the window edges. The new vinyl window is not tall enough to fill the original frame. A wood infill panel has been added to close the opening. On the interior of the historic wood frame, there is a strip of missing paint. Examination of other original wood frames of the farmhouse suggests that the unpainted strip was once concealed by a wood guide. The top right interior of the frame shows water damage. Investigation into the source of this damage must be made and the issue should be addressed as soon as possible in order to prevent further damage. There are also insect holes in the top of the window frame. These are most likely caused by powderpost beetles. The presence of these insects is an indicator of moisture problems within the wood. Before repairing the window, overall moisture problems should also be addressed.

Window 5a- Close-up of Improper Spray Fill

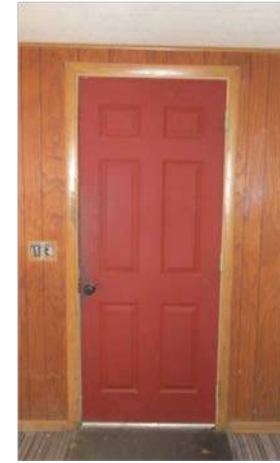
Door 4-1 is a modern four panel stile and rail door. It is painted red and in good condition.

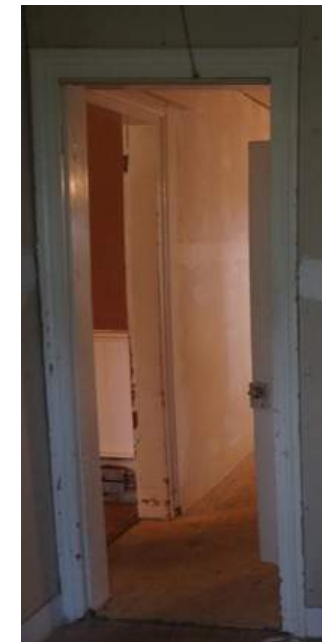
The wood doorframe is historic. The overall opening clearance is 79 inches high and 29 inches in width. Although there is currently no door, there is evidence on the frame that one existed. The inside of the northern frame section has holes and an outline of where the hinges once were. The southern side of the frame has holes and an outline of

a lockset. The door head has a non-historic metal track attached.

The metal track of Door 5-1 should be removed and a new door be installed. According to the interpretation and function of the room, a historically appropriate door should be used. Existing doors in the house should be examined when selecting door for compatibility.

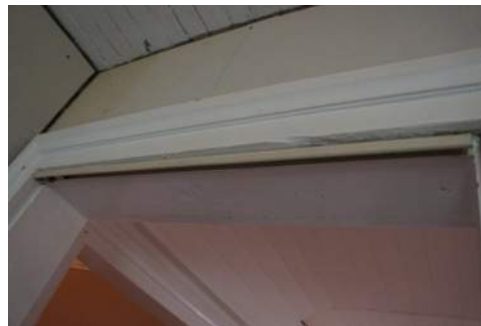
Door 5-1 Metal Track

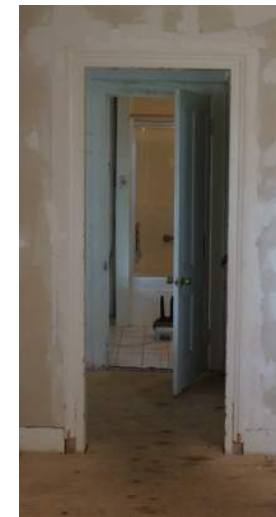
Door 6-1

Door frame 6-1 is original and in poor condition. The bottom of the east side of the frame is severely damaged. Some of the wood edges are nicked and portions of the frame are completely missing.

On Door 6-1, it is recommended that wood be added to the bottom of the frame and patched to appear continuous. It should then be repainted in the original white color. Depending on the interpretation of the house, it may be necessary to find historically compatible wood for subsequent repairs.

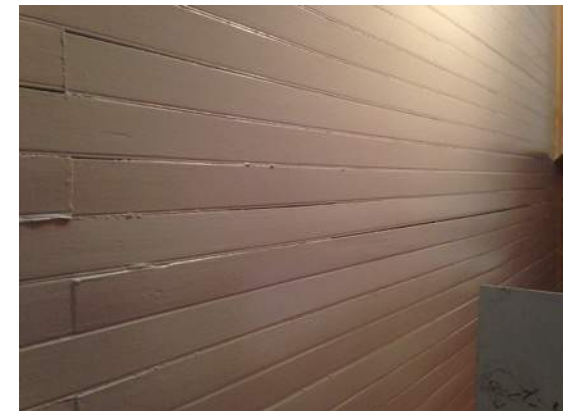
In general, the ceiling is in poor condition. Firstly, the ceiling is sagging at the northeast corner of Room 3. In this area, there are gaps and small pools of paint within the grooves. The light fixture is in working condition. Just north of this light fixture, there is a small circular depression where another light fixture may have been attached. The ceiling is also covered with some small scratches and dents.

Room 3 Sagging Ceiling

It is a high priority to locate and eliminate the cause of the water damage in Rooms 1, 2, 3, and 4. A possible source of damage could be leaking pipes. It is recommended that the plumbing on the second floor is inspected.

A structural engineer should examine the ceiling as well. According to Preservation Brief 39, the roof and plumbing should both be inspected. Since there is water infiltration in the basement, these could perhaps have the same source. Ceiling water damage often occurs because of condensation on pipes, mildew growth, and drainage channel blockage in the interior. The pools of paint drops and small gaps within the grooves are also indicative of water damage. While it is visible in the ceiling, it could likely affect structural members in the interior as well. This stabilization should also occur in the breezeway. Although it is not original as evidenced by the materials used, it should mothballed and stabilized by installing a proper drainage system to stop runoff that could be causing damage to the roof and eventually the interior.

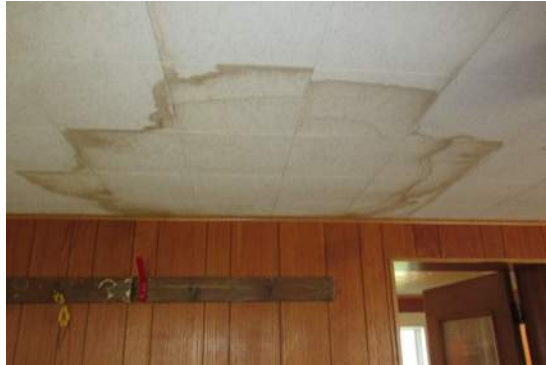
The ceiling in room 4 is acoustical ceiling tile. There is considerable water damage to the tiles in the northeast corner of the room, southeast corner of the room, and on the

Room 4 Water Damage on Ceiling

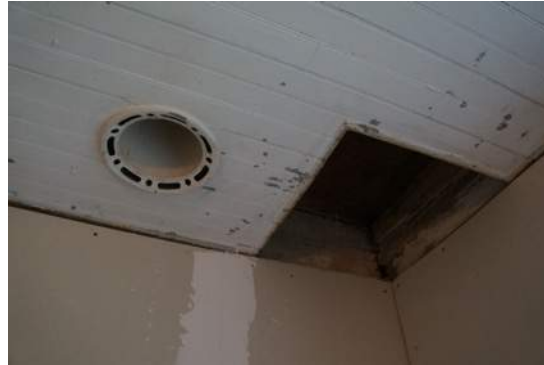
Room 5- Holes in Ceiling at Southwest Corner

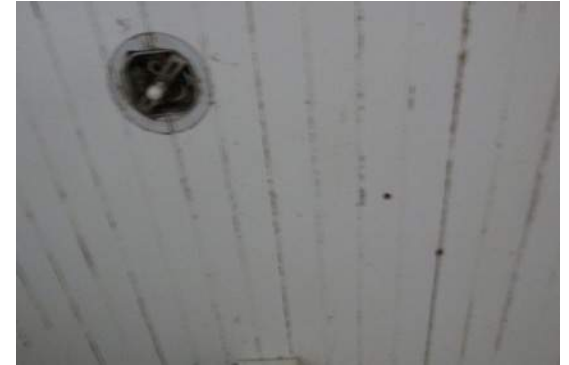
The ceiling in the bathroom is similar to the white tongue and groove wood boards in other rooms on the first floor. However, it is in poor condition. The white paint is peeling, and there are some holes. The damage is most likely due to improper ventilation of the room and moisture from the shower. There is a light without a cover in the ceiling and a small square exhaust fan.

Room 7- Bathroom Ceiling Light

In Room 7, it is recommended that the ventilation be improved. Once moisture problems are remediated, the ceiling should be repainted white. Paint removal should be done in the gentlest means possible. New paint should be selected based on the color and texture of existing paint samples.

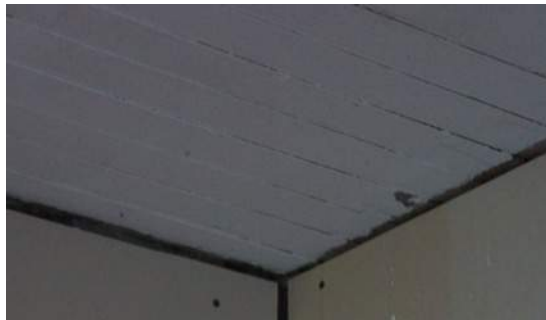
Room 5- Gaps Between Wall and Ceiling

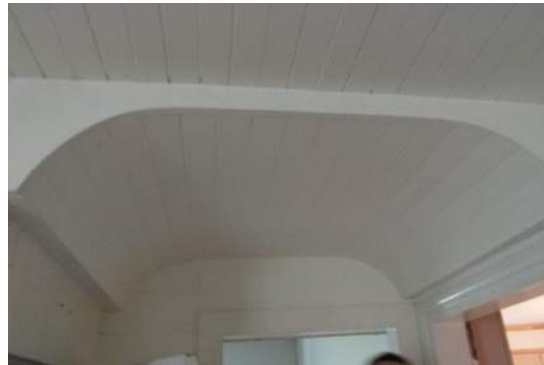
Room 6- Character-Defining Ceiling Feature

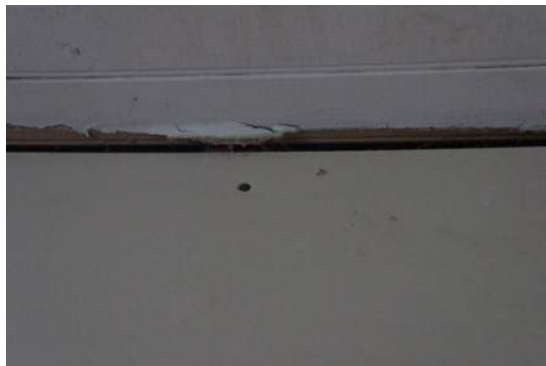
Room 5- Flaking Paint at Ceiling/Wall Edges

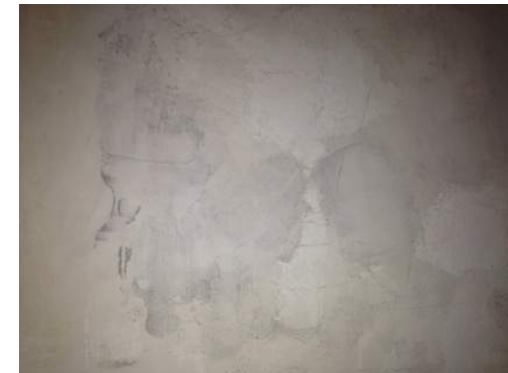
In Rooms 1, 2, and 3 the original plaster was removed from the walls and modern gypsum board was put up in its place. The walls appear to be in structurally good condition, however their texture is still very rough on most walls. There is evidence of modern spackle repairs that were poorly executed.

Room 2 Wall Damage

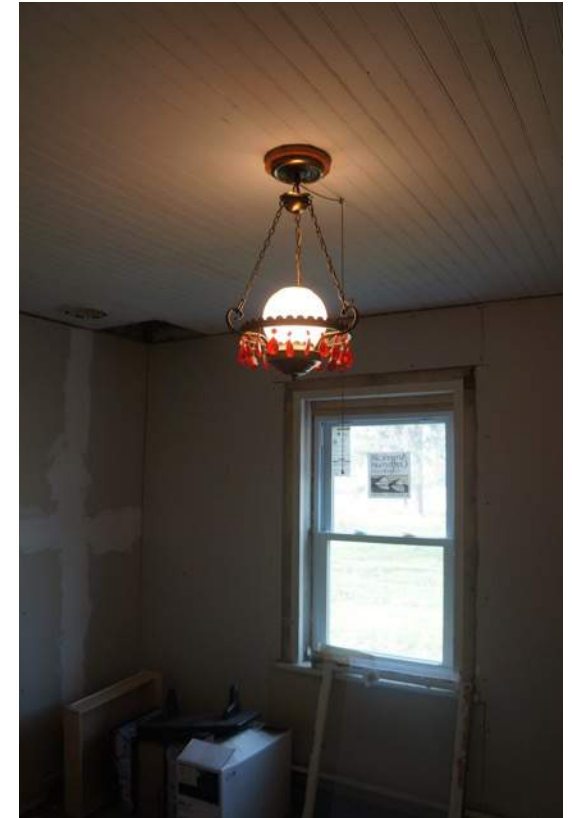
Room 5- Non-historic Hanging Ceiling Light

In Rooms 4 and 5, an electrician should inspect the wiring and stabilize as necessary. In Room 4 specifically, a new faceplate should be added to hide visible wires. In Room 5, depending on the function and interpretation decided for this room, the wires may need to be concealed. If they are determined to be desired as part of the new function, they should be properly secured. In addition, the style and date of the fixture in Room 5 may not be desirable for certain interpretations of the house. If determined undesirable, the light fixture should be taken down and the residual ceiling hole should be repaired. New faceplates should be added prior to use of electrical outlets. Rooms 1, 2, and 3 have no exposed wiring.

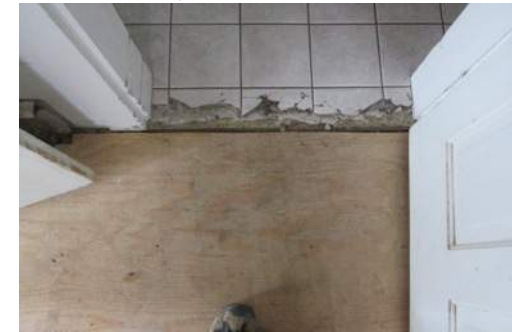
Room 7- Damaged Bathroom Tile

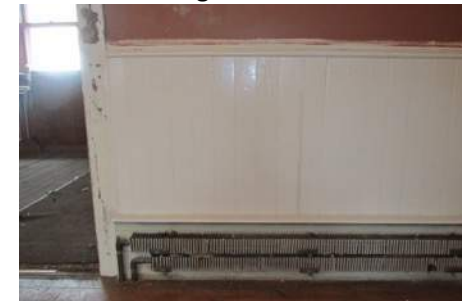
Room 3- Radiant Baseboard Heater

As of right now, the exposed pipes in Room 1 and the plumbing in Room 3 will not cause adverse effects. However, if the house is adaptively reused and the overall program changes, these pipes should be inspected by a professional plumber to make sure they are in good working order.

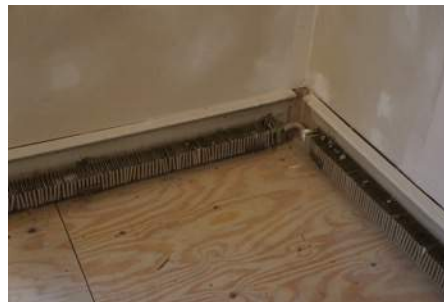
Room 6- Uncovered Radiant Baseboard Heaters on Southeast Corner

The high priority item in this room is to identify the source of water damage and decrease moisture levels of the wood window frame. Electrical outlets should be assessed and secured by an electrician for safety. The radiant baseboard heater should also be assessed by a professional. A cover

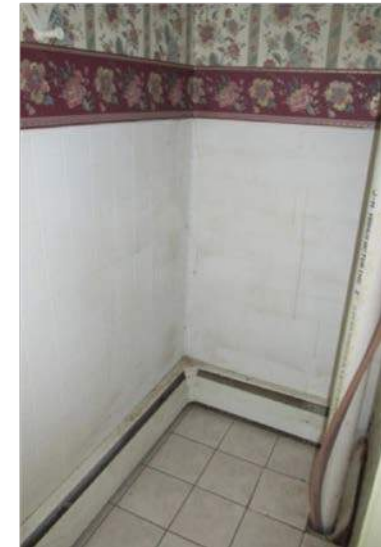
Room 7- Southwest Corner, Wall and Heater

In Room 7, it may be desired to enclose the pipes and repair the floor surrounding the pipes. The improvements to the bathroom may only be superficial to accomplish the desired appearance of the room. However, the plumbing should be professionally inspected to ensure there are no larger issues to be addressed.

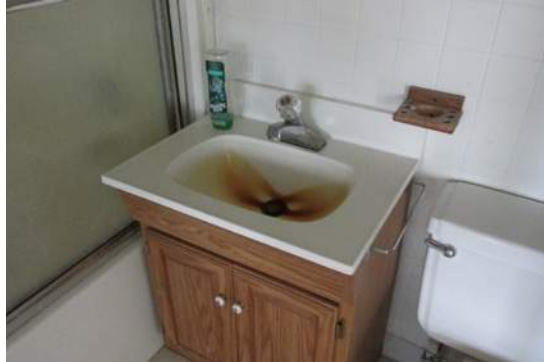
Room 7- Stained Bathroom Sink

necessary for function. The only high priority items in this room are inspection of the sewage pipes and removal of the chipped tile at the threshold.

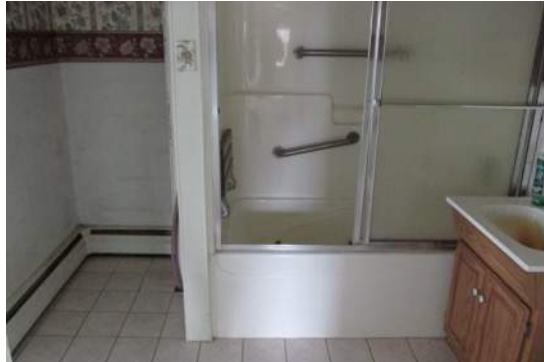
Deposits. The shower appears to be in good condition. There is an exposed sewage pipe on the southwest side of the bathroom near the shower

Room 7- View West, Shower

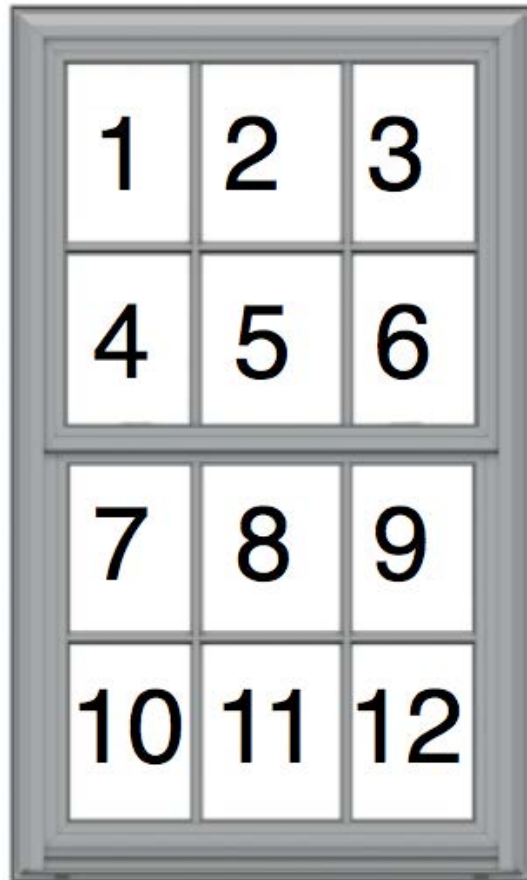
with the wooden components is peeling paint. The floor plan (Figure 1) shows the layout of the second story and is a key to the locations of the windows pictured in this section. The glazing is in acceptable condition with the exception of a few panes which

might need to be replaced. These are identified using the diagram in Figure 2.

Figure 2. This diagram is a key to identify which panes in each window need replacing due to cracking or breaking.

Recommendations: As has been stated in the Peterson Master Plan, repairing the original windows is preferred over replacing them. Restoring the original windows would do much to enhance the historical appearance of the property, therefore it is recommended that a professional contractor experienced in restoring old windows be brought in to do the work. Using *Preservation Brief 9: The Repair of Historic Wooden Windows* by John H. Myers as a guide, it has been determined that the windows of the second story fall under Repair Class 1, meaning there is minimum repair needed to bring the windows into “like new” condition. As the windows are in fairly good condition the cost to repair them should be minimal.

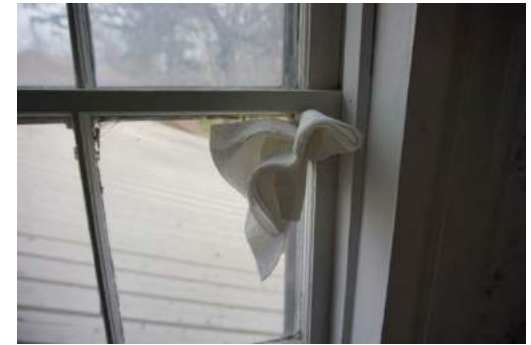
Figure 3. Window #2, lites (3), (9) and (12) are damaged.

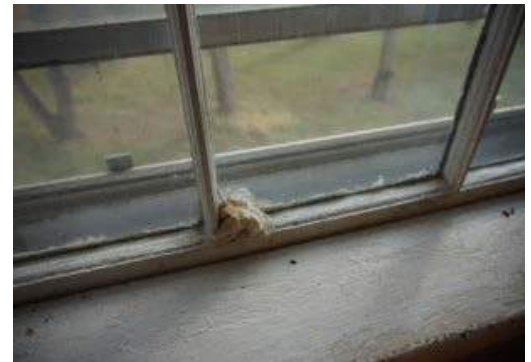
Figure 4. Window #3, lite (11) is damaged.

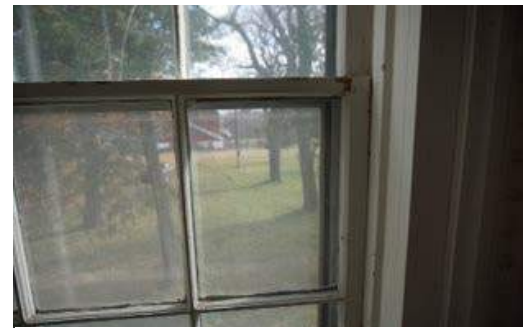
Figure 5. Window #4, lite (9) is cracked.

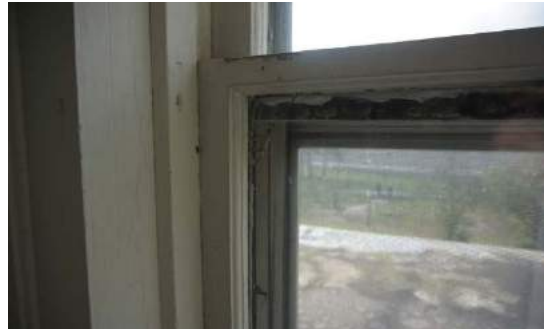
Figure 6. Window #5, lites (7) and (9) are damaged.

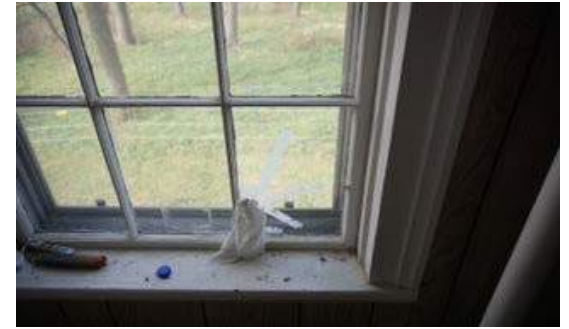
Figure 9. Window #8, lite (12) is damaged.

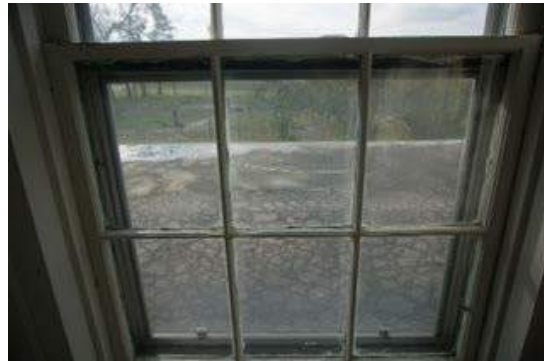
Figure 7. Window #6, lite (7) is damaged.

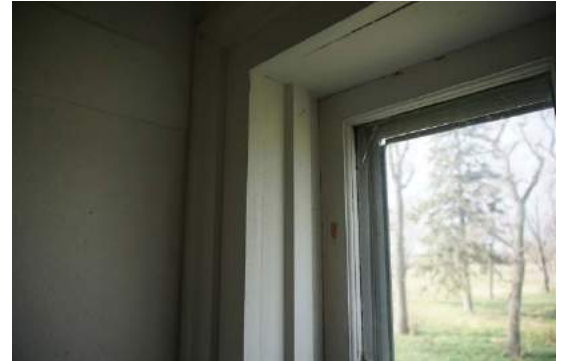
Figure 10. Window #9, lite (1) is cracked.

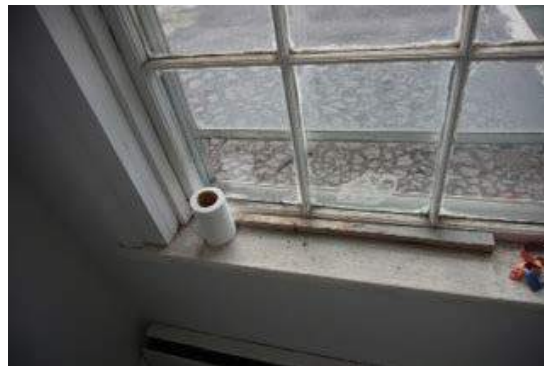
Figure 8. Window #7, lite (10) is damaged.

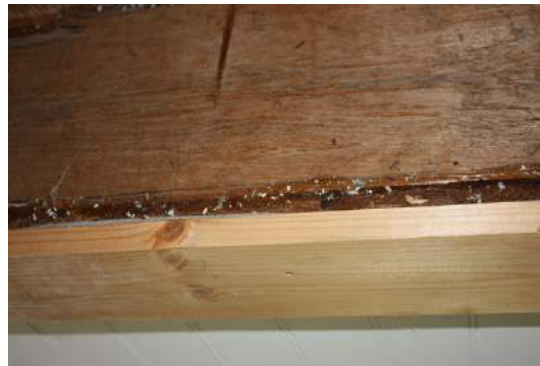
Figure 14. The ceiling structure is revealed at the opening to the attic. The plain board around the opening is not original to the building.

Recommendations: Determine a period of significance and see what color or finish dates to that time period; check the Peterson Diary for a reference. The paint on the ceiling is not chipping or peeling and can remain. If paint removal is required, a heat gun would facilitate removal from the recesses in the beadboard and minimize lead-containing dust.

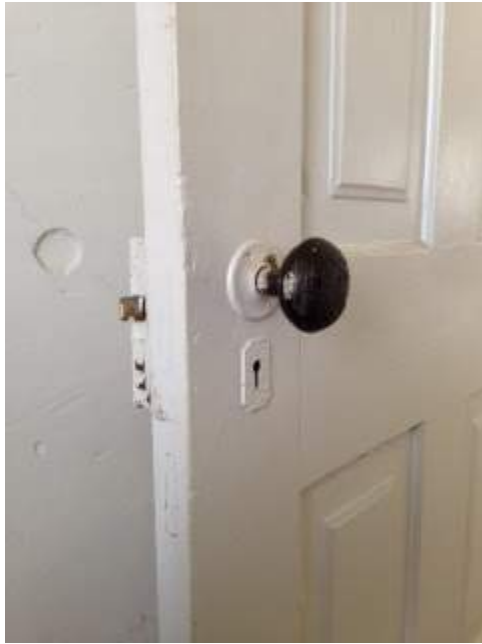
Several doors appear to be original to the construction of the house. These are solid wood doors with inserted panels. Hardware has a dark patina and the height of the knobs from the floor is lower than standard height. These doors have at least two layers of paint. The door to the bathroom is a more recent wood paneled door with a modern looking, off the shelf door brass doorknob. The older doors all have locking hardware, much of this hardware has been painted over (Figure 15).

Recommendations: The paint on the doors is not chipping or peeling, but has been thickly and unevenly applied. Areas of thick paint should be sanded down and repainted. Hardware should be removed and cleaned.

The new door and other new elements of the bathroom should be clearly distinguishable from the restored parts.

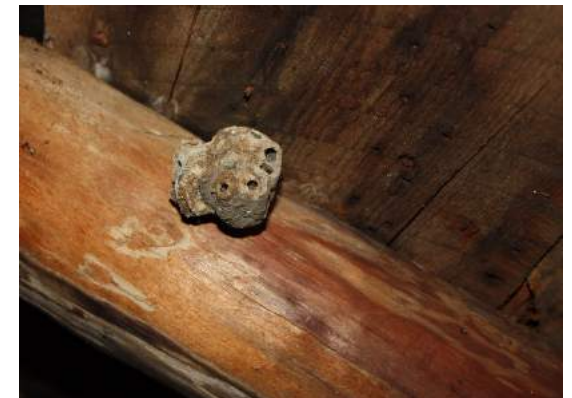
Figure 17. The chimney parging is cracked and discolored. Although water infiltration appears to have been halted, discoloration and insect nests remain.

discolored.

Recommendations: The leaks have been fixed, and the temporary metal roof seems to be a good solution for the moment, though research should be conducted to determine how to best represent the historical roof should the house be restored.

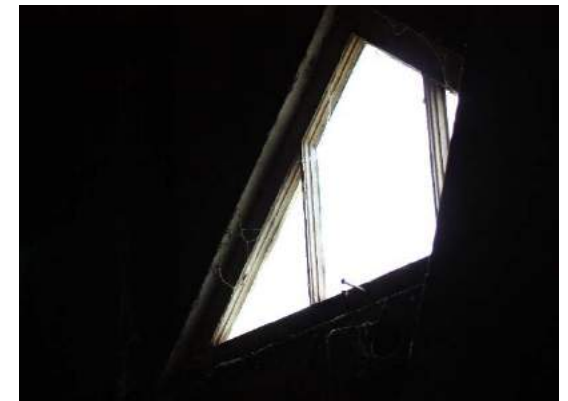
Condition: The windows of the attic appear to be in good condition with no warping, cracking, or damaged glazing; however, they are dirty and much of the paint, both interior and exterior has peeled off.

Figure 19. Attic windows are structurally sound but require cleaning and repainting.

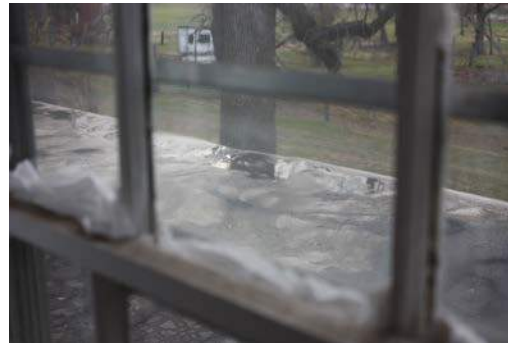
Conditions: The roof of the porch seems to have good integrity, although water does pool on the flat surface. This should be more closely analyzed. The hollow metal exterior door of the porch is not original but is in good condition. Although the porch ceiling does not drain water very well, it does not appear to be leaking (Figures 22 and 23).

Figure 22. The beadboard ceilings of the porch are in good condition.

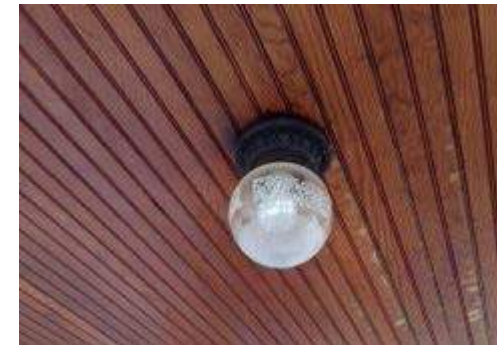
Figure 23. The beadboard ceiling is in good condition.

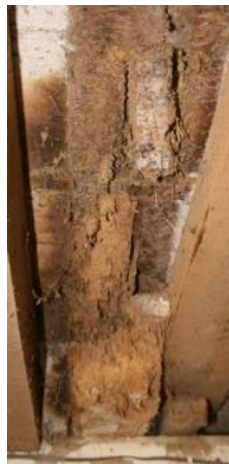
1.4 Joist failure from PPB. Interior damage of joist is visible.

PPB infested structural components should be individually assessed using core drillings to determine structural integrity. Components that have been compromised should be replaced to match existing structure. Finally, all wood components should be treated or painted to reduce further PPB damage from occurring.

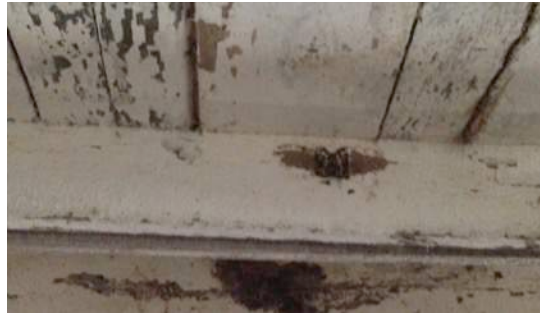
1.4 View of center of joists with metal connection

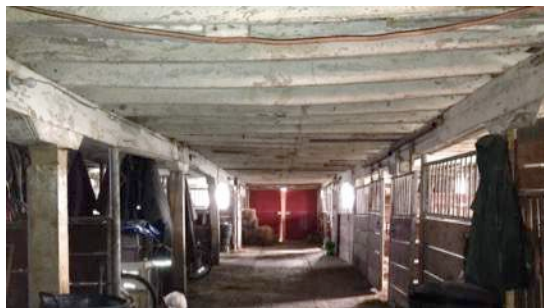
As well as the bending failure of the joists, there is obvious sagging of all the joists especially in the central bay of the barn basement and the deflection was estimated to be about 1-½".

1.6 Joist deflection

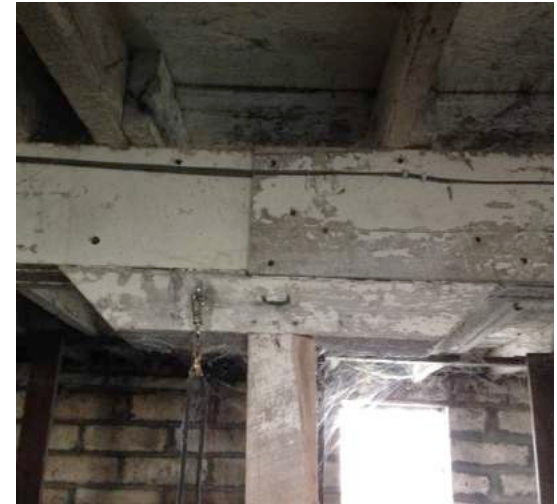
1.14 Beams supported on haunches that bear on a column

The concrete footings supporting the timber columns need to be investigated. Both the size and type the footings are should be determined. This could be achieved by digging some exploratory excavations at the footings. It will also be necessary to calculate the past and future loadings are that the columns and footings are supporting. This will show why the footings have failed in the past, and whether it is likely that they will continue to be overloaded. Furthermore, if possible the type soils in the area should be determined, so that an estimate of the soils bearing capacity can be made. It is possible that some earlier and higher loads caused the failure of the footing and that current or future loadings would not cause future damage. As with most of the timber in the barn, the extent of PPB damage needs to be determined, and the timber

should be fumigated to prevent further damage.

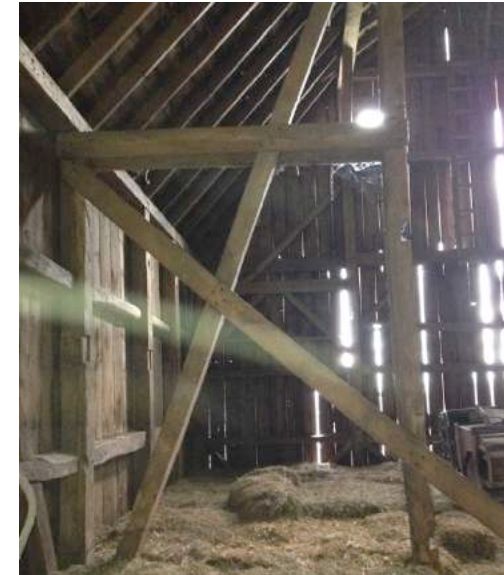
1.22 Loft Bracing Timbers

In general the condition of the braces was good. There was some PPB damage seen one brace in the upper section. The connection of the bracing to the joists was compromised in places, and it seemed that the lateral forces would not transfer well. In one location the joist had been completely destroyed by PPB and had been removed, See Fig 1.4. The two smaller replacement joists were not attached in the same manner, and it is probable that the effect of the bracing has been reduced.

As the inspection was done without ladders, the upper parts of the braces must be checked for damage, as it was not possible to see their condition from the ground. Like most of the timber in the building, the bracing should be fumigated to get rid of any PPB. The missing joist that connects to the bracing must be replaced and reconnected to the bracing. Lastly, all the connections of the bracing to the joists must be examined for structural integrity. Depending on the level of damage seen, it could be possible to splice

in replacement sections, or if necessary entire members might need to be replaced.

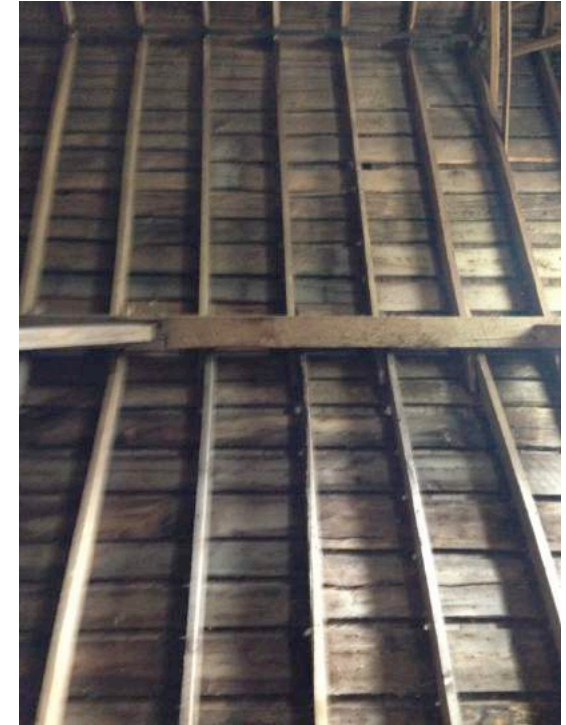
1.26 Roof Interior

It was hard to tell without a ladder what the condition of the planks is. The newer planks look like they are in fairly good condition. The older rougher planks have some longitudinal splitting (along their length), which is probably not affecting their strength. Due to the irregularity of the planks there are some gaps between the edges of the planks, and also gaps along their length due to splitting. It was impossible to tell whether there was any damage due to beetles.

It would be good to survey the roofing planks from up close if possible. Close inspection of primary structural members should be done using a ladder and lift to access and confirm integrity of fastener systems, and absence of PPB and moisture damage.

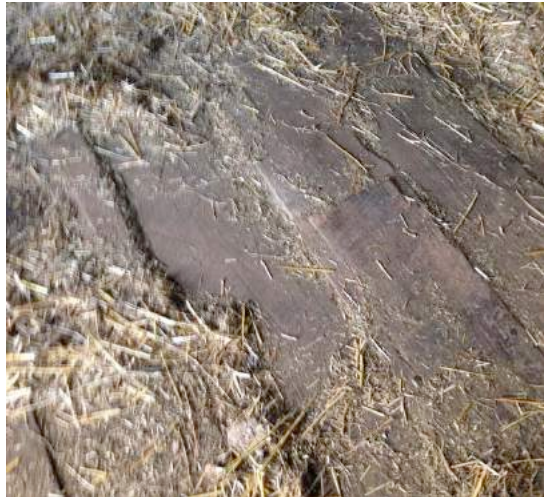
1.27 Loft Floor

The floor was difficult to assess because of the hay in the barn. Damage to the floorboards was seen below in the lower level. Water damage and PPB infestation would be likely causes for this damage but undetermined based on the inability to closely analyze members.

The hay should be removed to allow for a full assessment. A complete structural analysis of the floor will ensure that preservation work can begin safely for contractors. As with most of the wood in the barn, the extent of PPB damage has greatly reduced the strength and quality of each floorboard in the barn.

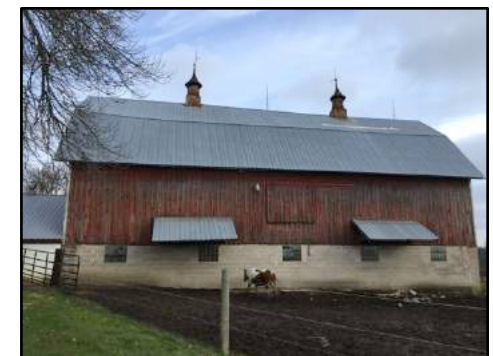
Figure 3: South elevation.

The wood siding's paint is faded away in the central parts more than the edges. (Figure 3.) Some parts of the wood battens are missing, especially in the lower left corner of the façade. (Figure 10.)

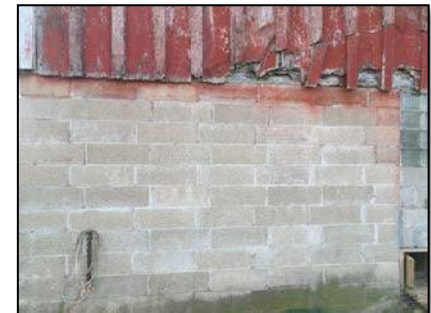
The major issue in the north elevation is the deterioration of wood, especially along the bottom edges due to weathering. (Figure 5.) The sliding door, which is the main entrance to the upper level, is severely decayed. It is slightly inclined at an angle. The paint is peeling off in some parts and fading away in others. Some of the wood siding has holes and scratches, too. Also, some parts of the metal hardware on top of the door are missing.

Figure 5: Efflorescence in the concrete block foundation, and deterioration of the wood.

blocks are of two types, the patterned glass blocks, and the plain ones. This combination is probably due to problems that some patterned blocks suffered from, and therefore were replaced with plain blocks. The top part of the concrete block foundation suffers from discoloration due to the running of the paint of the wood sidings above it. (Figure 5,6.)

The sandstone and field stone foundation is in a good condition. However, the concrete blocks foundation suffers from efflorescence, which means there is a moisture issue perhaps caused by weather or rising damp. (Figure 5.) The bottom part of the fieldstone also suffers from moisture, which is possibly caused by lack of foundation's insulation, which caused crumbling.

Generally, the wood batten and board siding need repair especially along the bottom edges as a result of weather-related moisture, or possibly from the walls underneath it. It is recommended first to test how much the wood is affected by the moisture, if it is the only outer surface, then it can be cleaned and painted. If it is soft that means it is severely affected and needs to be cut and patched. This repair can be done by a

method called the Dutchman Repair.⁶ In this method, the first step is to remove the paint from the damaged area as a preparation for the mechanical removal. Then, a similar wood material should be cut in a slightly larger size than the original wood. Once the new wooden piece is prepared, it should be placed to create an outline on the existing wood. After that, a chisel is used to create an opening in the existing wood, following the outline created earlier. Finally, the new piece is glued with waterproof adhesive. After this step is done, the new piece is trimmed to flush with the old surface. Once the Dutchman Repair is done, the new patched part should be painted with a top-quality exterior paint.

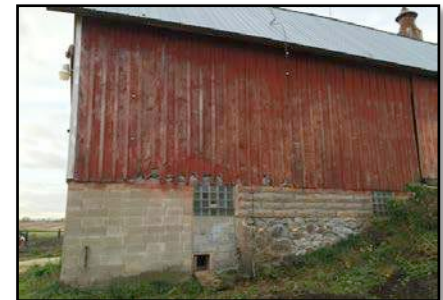
On the west side of the elevation, the wood sidings are cut and patched forming a triangular line right on top of the glass blocks window. The patched part is severely deteriorated and missing parts along the bottom edge. (Figure 6.)

Figure 6: The triangular cut in the wood siding, and the discoloration of the concrete blocks.

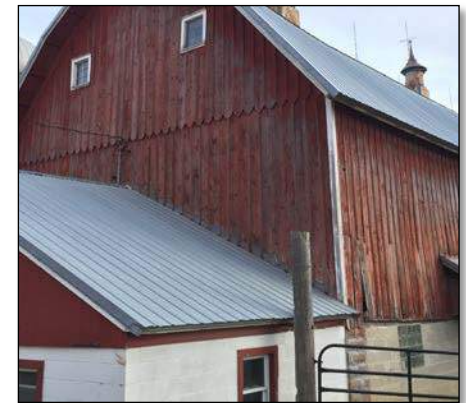
The connection between the new addition and the big barn is clear near the roofline above the new addition's roof. Particularly, there is a line with the width of a board siding with no paint. (Figure 8.)

Figure 8: Connection between the new and the old parts.

For the meeting line between the new addition and the west elevation of the barn, a sealant must be installed before painting along with the rest of the wood sidings.

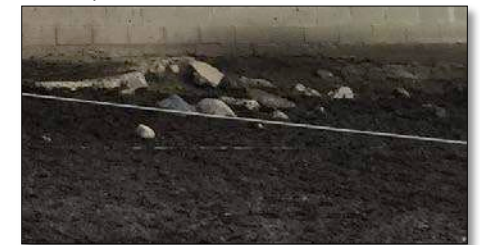
The concrete block foundation suffers from severe efflorescence, mainly in the top parts closer to the wood sidings. Also, it has some vertical cracks in various locations of the concrete blocks more than the mortar. Similarly, the stone foundation suffers from moisture that caused crumbling of the bottom part of the stone. (Figure 9.)

Figure 9: Stone foundation crumbling.

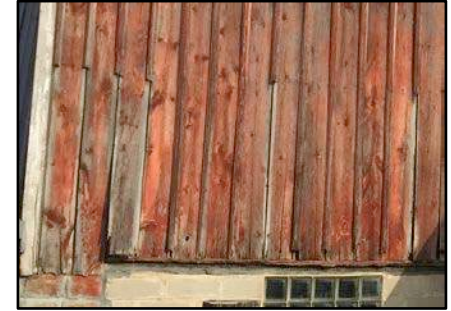
Figure 10: Missing parts of the wood battens.

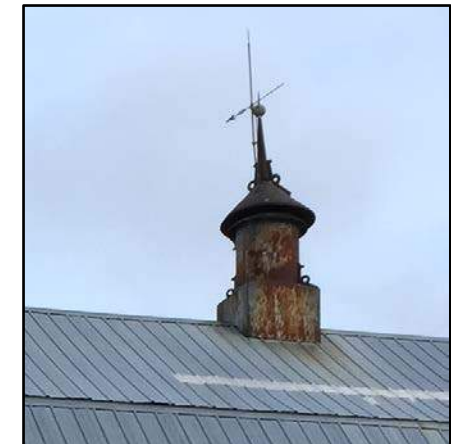
Also, the metal lightning rods suffer from severe corrosion that extends to the metal tin roof. (Figure 11.)

Figure 11: Thunder rod rusting.

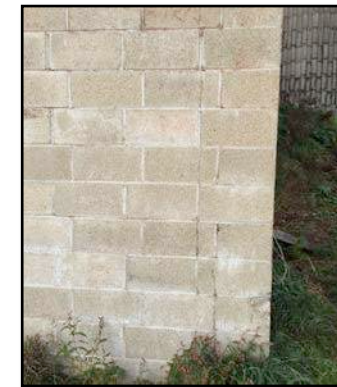
The concrete blocks foundation suffers from some chipping at the corners, but overall is in a good condition, except for some vertical cracks mainly in the corners. (Figure 12.) The mortar is in a good condition. However, it presumably absorbs water, which resulted in efflorescence in the concrete blocks foundation.

Figure 12: Concrete chipping at the corners.

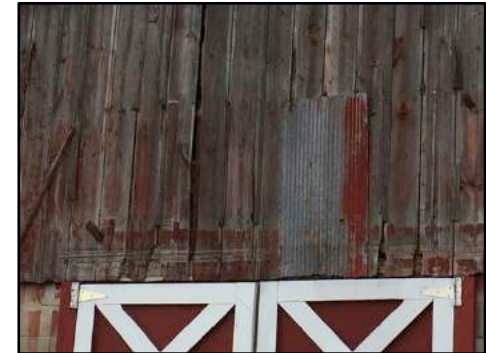
The wood sidings have a lot of holes and deteriorations, especially along the bottom edge due to weathering. The paint of the wood sidings is fairly faded away, and running over the concrete blocks underneath it. A part of the wood sidings is missing and replaced with metal sheets, in the center of the elevation above the door. (Figure 13.) The existing 2 pipes serve no function. Their color is peeling off, too. (Figure 4.) In addition, the window wooden casings have some deterioration in the corners, and the white paint is peeling off, too. The glass and the wooden muntins are in a good condition. The glass blocks windows are in a good condition with only one small crack. The blocks are of two types, the patterned blocks, and the plain ones. This combination is probably due to problems that some patterned blocks suffered from, and therefore were replaced with plain blocks.

Figure 13: Metal sheet covering a missing part of the wood siding.

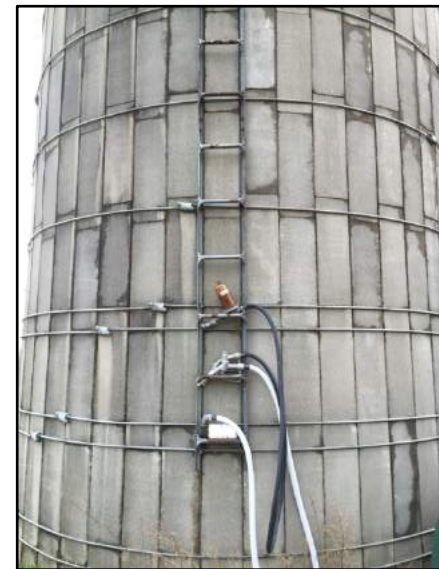
The silo is a new addition, and in a fairly good condition. However, the concrete suffers from moisture, presumably weather related, which resulted in efflorescence, especially at the top parts. Also, the steel ladder has some rusts at some parts. (Figure 14.)

Figure 14: The concrete silo.

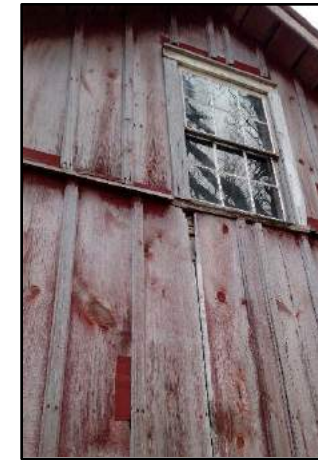
The exterior sheathing has significant decay and splitting along the bottom edges on all sides. Various boards and battens on all facades also have deteriorated, split and broken sections. Many battens are missing, allowing water to infiltrate along the edges of the boards which are not connected through any tongue-and-groove construction. (Fig. 5).

Fig. 5: Missing battens and metal patches. Photo taken facing southwest.

Small pieces of metal are nailed on the wood, presumably to repair smaller holes, and painted the same red as the rest of the exterior. Because of the condition of the paint, likely these metal patches were in place before the 2005 restoration (Figs. 5 & 8).

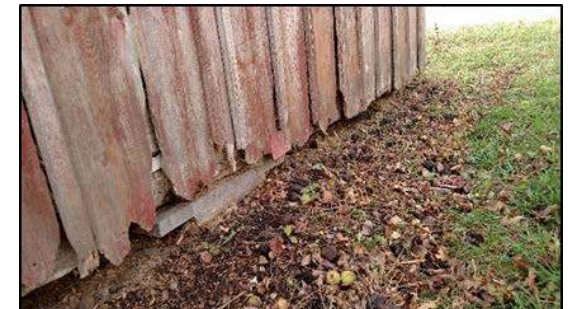
Fig. 6: Example of lower edge board and batten decay and wood-stacked pier. Photo taken facing southwest.

The foundation's piers show varying degrees of failure. Surprisingly, though, the individual rubble stone, bricks, and common sawn wood used to construct each pier are generally without obvious wear. That this foundation provides no protection from the ground water, foliage, or other destabilizing elements suggests that the end decay of the board and batten cladding is due to the wood's water and insect exposure as well as weathering (Fig. 6).

The material used for the southwest and southeast foundational piers perhaps explain the structural settling to the west as stacked wood piers support the southwest corner (Fig. 6) while a large granite field stone supports the southeast corner (Fig. 13).

then to determine which piers still have historically chosen materials and which piers have been rebuilt. The possible responses include: 1) simply resetting the piers; 2) replacing the stacked wood piers, which have the greatest potential for failure, with stone and brick; or 3) completely replacing the pier system with a modern construction method that matches a historically appropriate appearance. The last option would be the last choice from a historical preservation perspective, but the use of the building might require that degree of stabilizing.

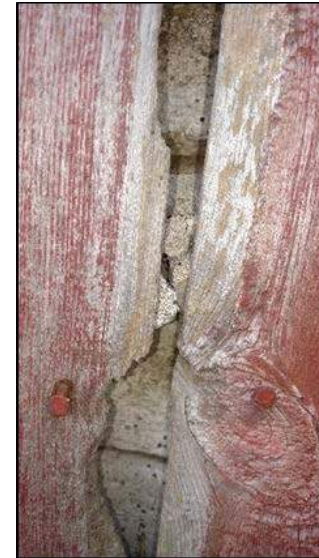
In places where the wood has rotted or decayed, the inner wall of hand-hewn logs is exposed. Though the hewn logs used as internal framing show some signs of beetle infestation, there is no evidence that the infestation is current, and the logs maintain integrity. Since the wood does not show sign of internal decay when tested, then, it is less likely contact between the hewn log beetles and the siding boards caused extensive amount of the external siding degradation (Fig. 7).

Fig. 7: Exposed inner hand-hewn log structure. Photo taken facing south.

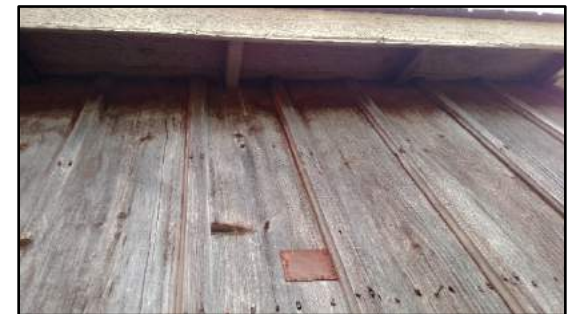
Fig. 8: One of many metal patches. Also shows condition of overhang and fascia. Photo taken facing west.

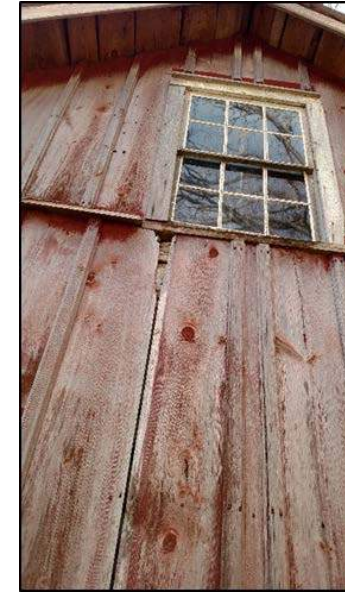
The wood mutins, casing, and drip cap on the window and the fascia boards all have paint loss of the white trim paint that exposes the wood, resulting in expected deterioration (Fig. 9).

Fig. 9: Gable window, frame paint and weather wear, and exposed inner hand-hewn beam wall. Photo taken facing south.

The windows and accompanying frames, sills, and drip caps should be repaired and not replaced. This is the same for the frames and drip caps of the boarded up openings and the door. The wood members need stripping and repainting, and the glazing likely needs new caulking. Using available boards of comparable age always is preferable to replacing the deteriorated wood elements with new material from a preservation perspective. While repainting the siding will make matching the way the wood is cut less important, it could be worth looking for wood boards with similar band saw marks to keep any future weathering patterns consistent.

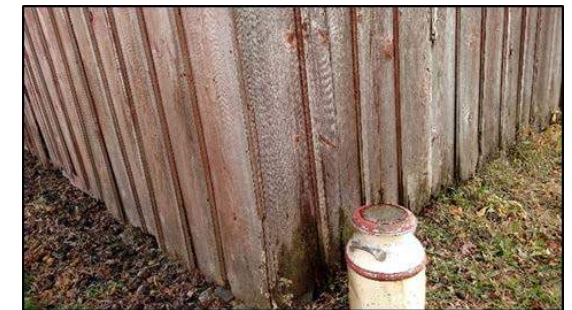
Fig. 10: Rising damp and moss. Photo taken facing

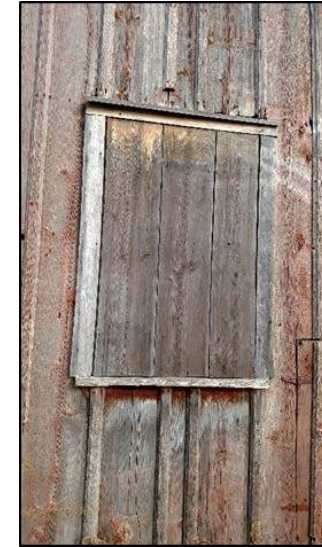
Though some battens are missing, the wood in general does not show extensive breakage or decay apart from the ends. The wood used for the fill of the boarded-up opening centered on the main story does not show the same signs of wear as the surrounding boards and battens. This suggests the wood is either newer than the board and batten or has worn differently due to the framing paint as seen on the upper window frame. The exposed wood does not show any real decay (Fig. 11).

Fig. 11: Boarded over window opening with frame. Note peeling and weather worn frame.
