Conditions Assessment for the Andrew Peterson Farmstead

Peggy Anderson, Alejandro Sanchez, Mohamed Alqari, Fred Counts, Anne Drolet, Holly Engle, Joel Holstad, Elizabeth Kinney, Jenna Rempfert, Sarah Ward, Alexandr Young, and Lisa Zeeb

Students in ARCH 5672: Historic Building Conservation
Instructor: Todd Grover, AIA

ANDREW PETERSON FARMSTEAD Carver County, Minnesota

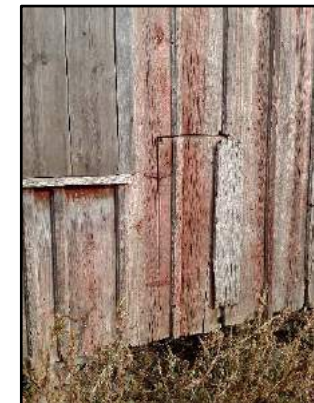
The boards and battens of the small cut-in door to the lower right of the window has the same paint and wear as the surrounding wood. That the double triangular strap hinges are also red suggests that this was cut and then painted at the same time as the rest of the façade. The unfinished and random appearance of the board nailing the door shut raises questions about the opening's use (Fig. 12).

Fig. 12: Small hinged door nailed shut with worn board. Photo taken facing north.

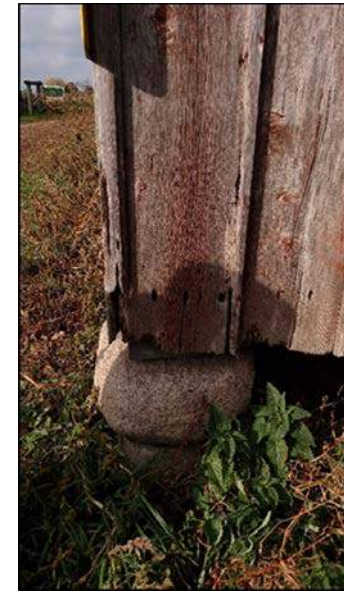
The material used for the southwest and southeast foundational piers perhaps explain the structural settling to the west as stacked wood piers support the southwest corner (Fig. 6) while a large granite field stone supports the southeast corner (Fig. 13).

Fig. 13: Granite field stone pier. Photo taken facing west.

then to determine which piers still have historically chosen materials and which piers have been rebuilt. The possible responses include: 1) simply resetting the piers; 2) replacing the stacked wood piers, which have the greatest potential for failure, with stone and brick; or 3) completely replacing the pier system with a modern construction method that matches a historically appropriate appearance. The last option would be the last choice from a historical preservation perspective, but the use of the building might require that degree of stabilizing.

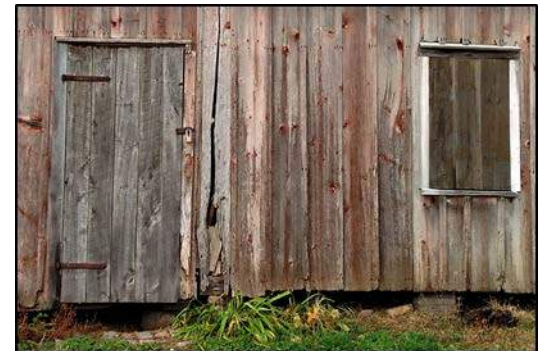
The hardware is in good condition, with the hand-forged iron strap-hinges and latch still firmly attached. The only part of the door that shows signs of decay is the door frame and along the top edge of the wood boards (Fig. 14). The top edge decay is probably due to water leaking behind the drip cap.

Fig. 14: Door hardware, decayed framing, broken wood and second boarded window space. Photo taken facing west.

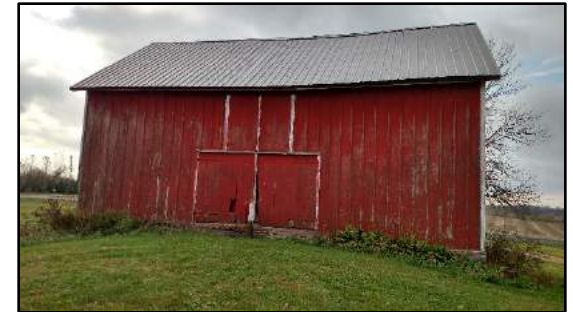
Fig. 1: North façade

- The lower entrance swing door has substantial wood deterioration of boards, although less so along the bottom edges. It isn't clear if these breaks are due in part to trauma from use or completely to water infiltration. (Figs. 1 & 7)
- The threshold beam beneath the main doors has extensive signs of powderpost beetle infestation and deterioration from ground-water seepage from the stone and mortar contact. (Fig. 8)

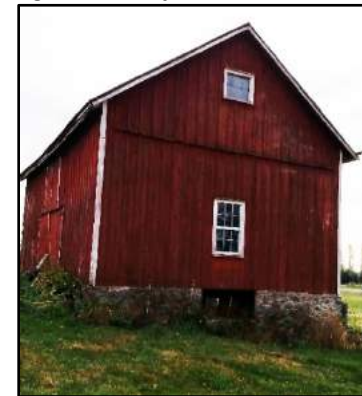
Fig. 3: West façade

- Like the north façade, the west façade's paint has uneven weathering, but it is not as degraded. The white trim paint is also primarily intact except for the window sills. (Fig. 3)
- The board ends of the siding do not show decay. The foundation has been repointed more recently with the assumed cement-rich mortar and primarily is between the wood and the fieldstone. The ground slope directing water away from the foundation and the intact mortar potentially is the reason the wood does not show extensive rising damp or rot. (Fig. 9)
- The casings of the gable and first story windows only show nominal flaking of

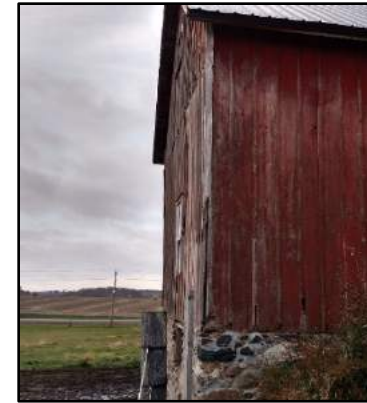
Fig. 4: East façade.

- Areas exposed from missing battens have been painted white, thus suggesting that this barn was once painted white. The type of white paint that was used might be influencing the greater stability of much of the red paint layer. Missing battens also promote the water infiltration from rain and snow and which creates wood decay of the boards. (Figs. 4 & 5)

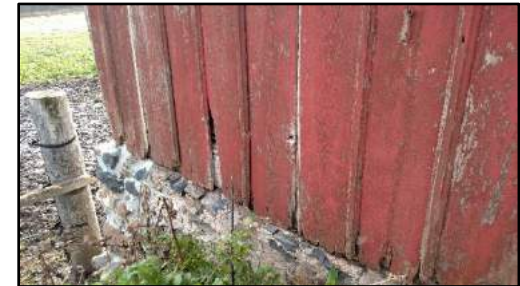
The roof line sags in the middle, suggesting possible structural weakness. The foundation of field stone has signs of being grouted with a few different mortars and at different times. It is difficult to tell from the outside if any of the present mortar is original or if it has all been covered in subsequent repointing and surface grouting. A presumed older tan mortar has been used between the fieldstones and as surface grouting. In part due to its degradation and in part due to being used as a surface grouting, it is most likely the original mortar. A presumed newer gray cement-rich mortar has been used for more recent repair and repointing. (Fig. 5).

- Extensive wood cracking and splitting exists along the bottom of the boards and battens, likely due to water infiltration from ground and stone and mortar contact. The rotted areas of these board ends also expose large hand-hewn sill beams, potentially adding bug infestation to the causes of wood rot. (Fig. 5)

Fig. 5: Detail of foundation and mortar. Photo taken facing southeast.

Even though the foundation's surface appears sound with only some minor cracking in the mortar, it is possible that the foundation will need to be reset or rebuilt to resolve any framing misalignment due to settlement. Attention needs to be given to repointing or surface grouting where mortar has been lost and threatens to compromise the foundation's integrity. Due to there being two types of mortar used, it is suggested that a Type M mortar be used for any repointing, and potentially to replace the older, tan mortar. Whether to color this gray or tan should be determined by appearance. Considering the plan for using this structure for visitor purposes, using a stronger mortar is recommended to help prevent further foundation shifting.

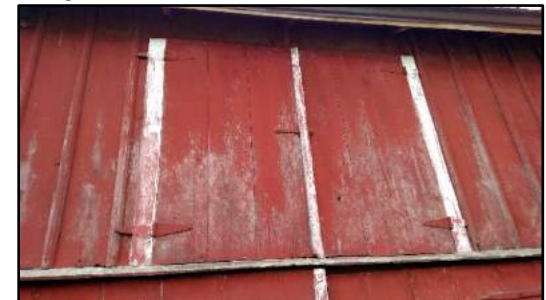
- The white trim paint, different from the older white base paint, is extensively deteriorated, with flaking and peeling likely due to weather exposure, although possibly to the application of latex paint over an oil paint layer. The flaking exposes a red paint layer and the upper door hinges have white paint over red, all evidence of the white trim paint being added after the barn was originally painted red. (Fig. 6)

Fig. 6: Upper swing doors. Photo taken facing south.

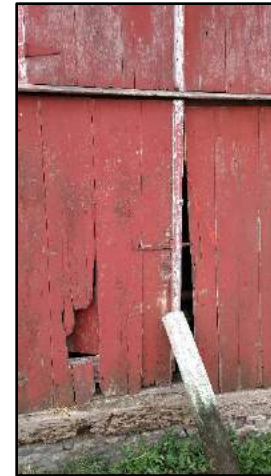
Fig. 7: Lower swing doors with breakage. Photo taken facing south.

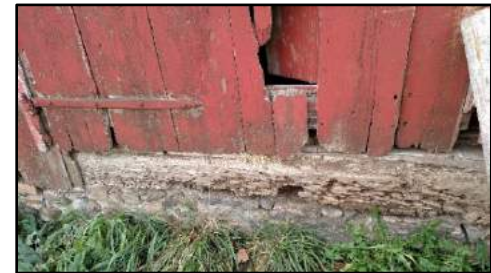
Fig. 8: Hand-hewn beam door sill. Photo taken facing south.

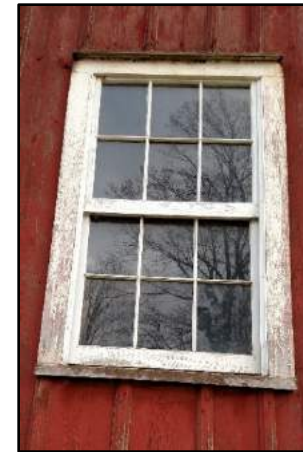
surface paint, with the sill wood exposed but not obviously degraded. (Fig. 10)

Fig. 10: First story window. Photo taken facing east.

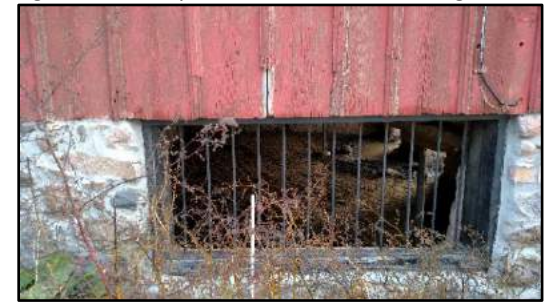
- The wood frame of the foundation window opening has some chalking, but the metal rebar insert is solid and shows no sign of deterioration. (Fig. 11)
- The foundation interior view reveals evidence of extensive powderpost beetle infestation of the exposed upper-level floor boards and hand-hewn load-bearing beam. Adjustable steel poles have been added for reinforcement. The wet earth floor with standing water creates a source for excessive humidity and water damage. (Fig. 12)

Fig. 11: Foundation window opening. Photo taken facing east.

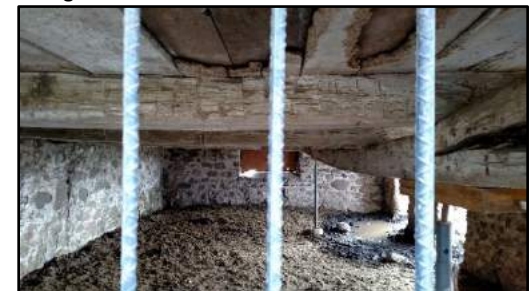
foundation opening has been boarded over. (Fig. 12)

Fig. 12: Interior of lower level. Photo taken facing east.

Since moisture in cement is drawn up into the wood when the one is in contact with the other, and the primary place where wood has degraded is where the siding comes in contact with the foundation, the replaced or repaired board ends should be primed on all surfaces with an oil based primer. The presence of standing water also indicates the need for re-grading around the building. Consistent maintenance should prevent further issues.

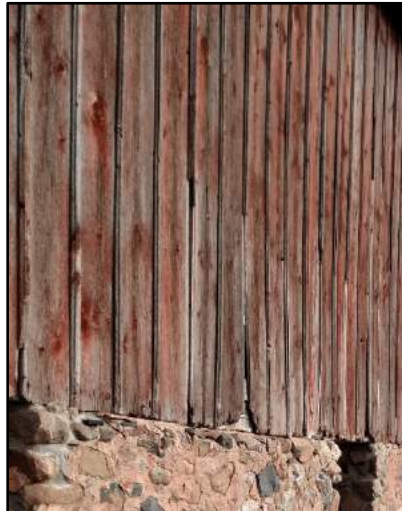
- The board and battens are almost completely exposed, with the red paint showing extensive weathering effects with chalking and peeling. (Fig. 2)
- The lower edges of the boards and battens have deteriorated where they meet the foundation. The foundation on this side appears to have more of the tan older mortar and surface grouting than the gray newer cement-rich mortar, suggesting that the moisture in the older mortar and stones has been able to easily be drawn up into the wood than the newer mortar. The base of the foundation sits in the standing

- groundwater, and the south is exposed more directly to the rain and snow, all which also provides easy conduction of water. (Fig. 13)
- Board breakage and rotting is present, particularly where battens are missing. (Fig. 14)
- Barn quilt square is in good condition, likely due to its age. (Fig. 2)
- There are no apparent structural weaknesses compromising the foundation at the openings. There are some places of minor loss of mortar along the sides of the openings. Surface grouting has a red tint that appears to be staining from the painted board and batten above. (Figs. 2 & 15)

Fig. 13: Degraded boards, missing battens, and contact of boards on stone foundation. Photo taken facing northeast.

All missing battens and wood deterioration and decay should be repaired or replaced but

not with new lumber. The wood species is most likely a pine although this should be confirmed. The boards are not dovetailed, so replaced boards should be flat, milled 12-inch-wide boards. The battens, though, need to be replaced with three-inch wood strips chamfered on both sides. If possible, after the rotted end is removed, replacement wood pieces should be spliced onto the existing board. All wood surfaces should have the older paint stripped. Proper precautions should be taken if the paint, once tested, is lead-based. The cladding should then be primed and repainted in order to protect the siding and structure.
