Deterioration of Mixed Rebar and Fiber-Reinforced Concrete Bridge Decks

February 2019

Research Project
Final Report 2019-09

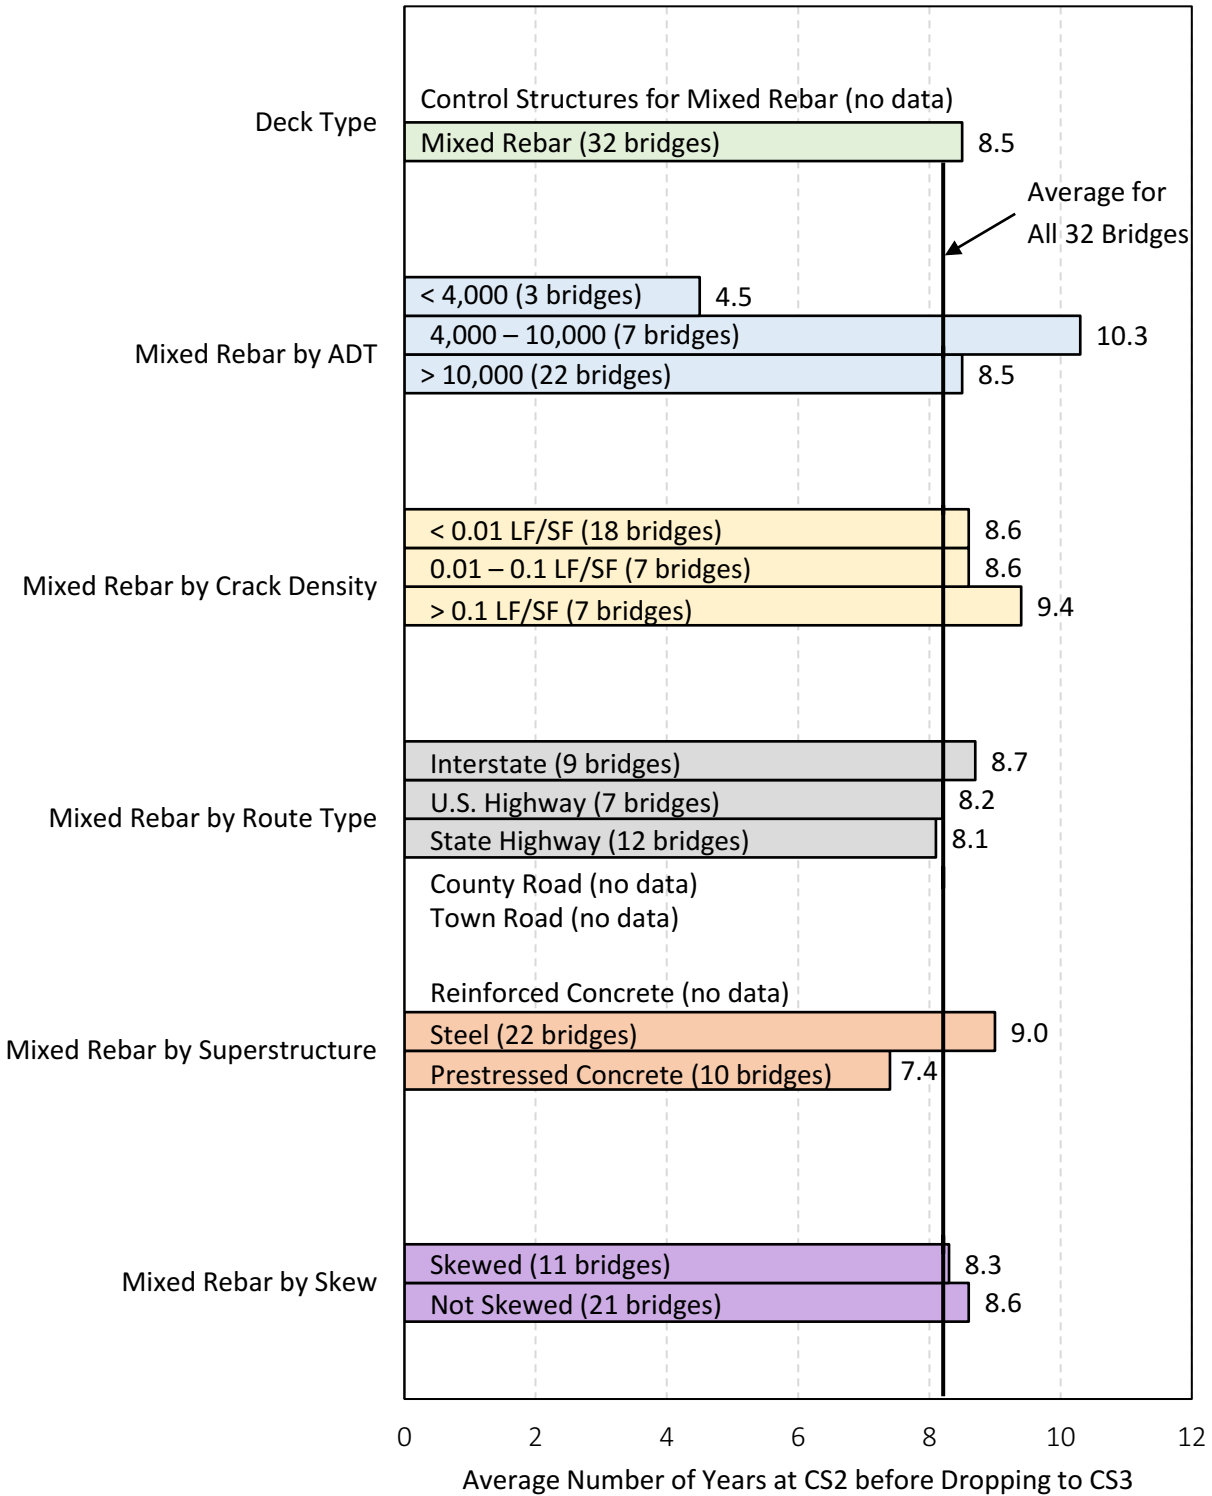
A total of 32 mixed rebar deck bridges had data that could be used to determine the number of years a bridge remained at condition state 2 before dropping to condition state 3 for CoRe Element #359 Cracking on the Underside of the Deck. These 32 structures did not include beginning tails less than 7 years. A beginning tail refers to a set of data that starts at least three years after the bridge was built. If the data had a beginning tail at condition state 2, the first year that the bridge was recorded at condition state 2 was unknown, and the number of years at condition state 2 could not be accurately calculated. All mixed rebar decks spent an average of 8.5 years at condition state 2 before dropping to condition state 3. Mixed rebar decks with all levels of wearing surface crack density, with an Interstate, U.S. Highway, State Highway, steel superstructure, skew, and no skew all remained at condition state 2 for an average of 7.5 to 9.5 years, which is within one year of the average for all mixed rebar decks. This indicated that these factors did not affect the number of years that the decks remained at condition state 2 before dropping to condition state 3. The bar charts for the number of years at condition state 2 for CoRe Element #359 are shown in Figure 3.1 and Figure 3.2.

Figure 3.2 Average number of years each subset remained at condition state 2 (< 2% distressed) before dropping to condition state 3 (> 2% but < 10% distressed) for CoRe Element #359 including beginning tails of at least 7 years (32 bridges)

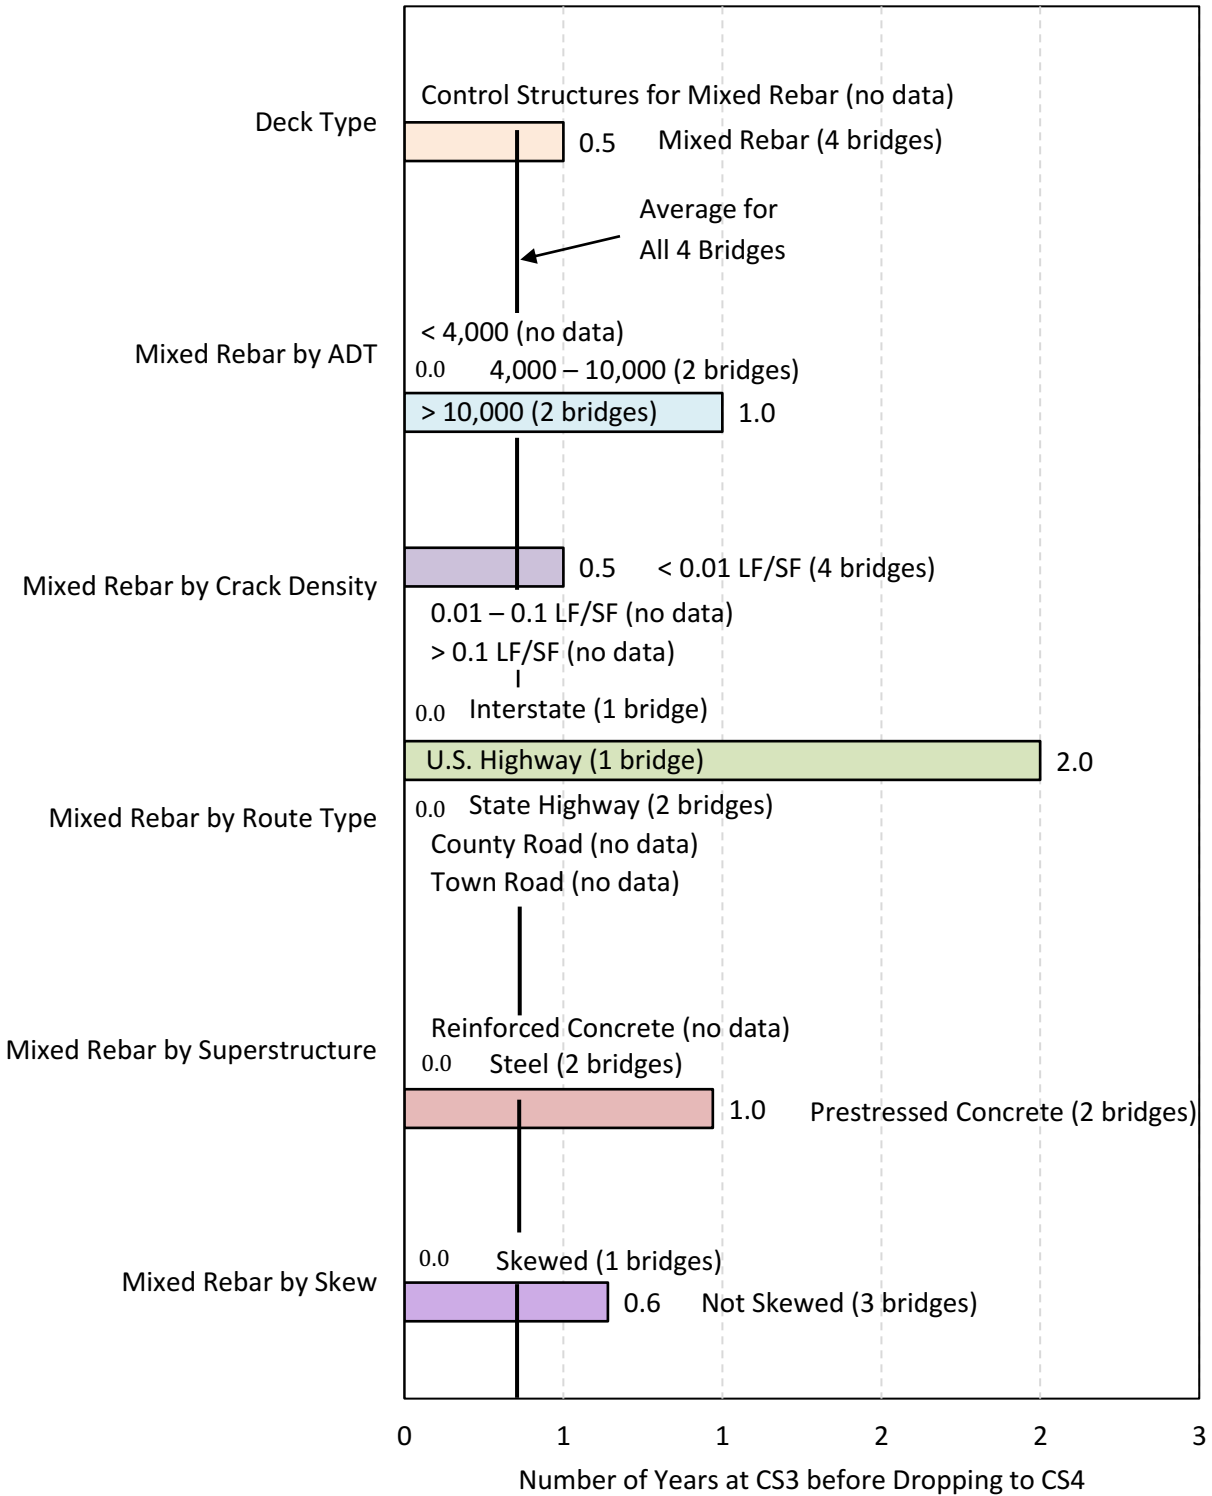
All bridge decks with usable data (no beginning tails less than 7 years) for calculating the number of years a deck remained at condition state 3 before dropping to condition state 4 for CoRe Element #359 had mixed rebar decks. All mixed rebar decks spent an average 0.5 years at condition state 3 before dropping to condition state 4. Bridge decks with an ADT between 4,000 and 10,000, an Interstate, a State Highway, a steel superstructure, and skewed bridges all remained at condition state 3 for zero years. This means that the bridge decks dropped from a condition state 1 or condition state 2 directly to a condition state 4, spending no time at condition state 3. Data from four bridges were used to calculate the average number of years all bridge decks with usable data remained at condition state 3 (0.5 years), which is too small of a sample size to draw any conclusions. The bar chart with the number of years each subset remained at condition state 3 is shown in Figure 3.3.

Figure 3.3 Average number of years each subset remained at condition state 3 (> 2% but < 10% distressed) before dropping to condition state 4 (> 10% but < 25% distressed) for CoRe Element #359 not including beginning tails (4 bridges)

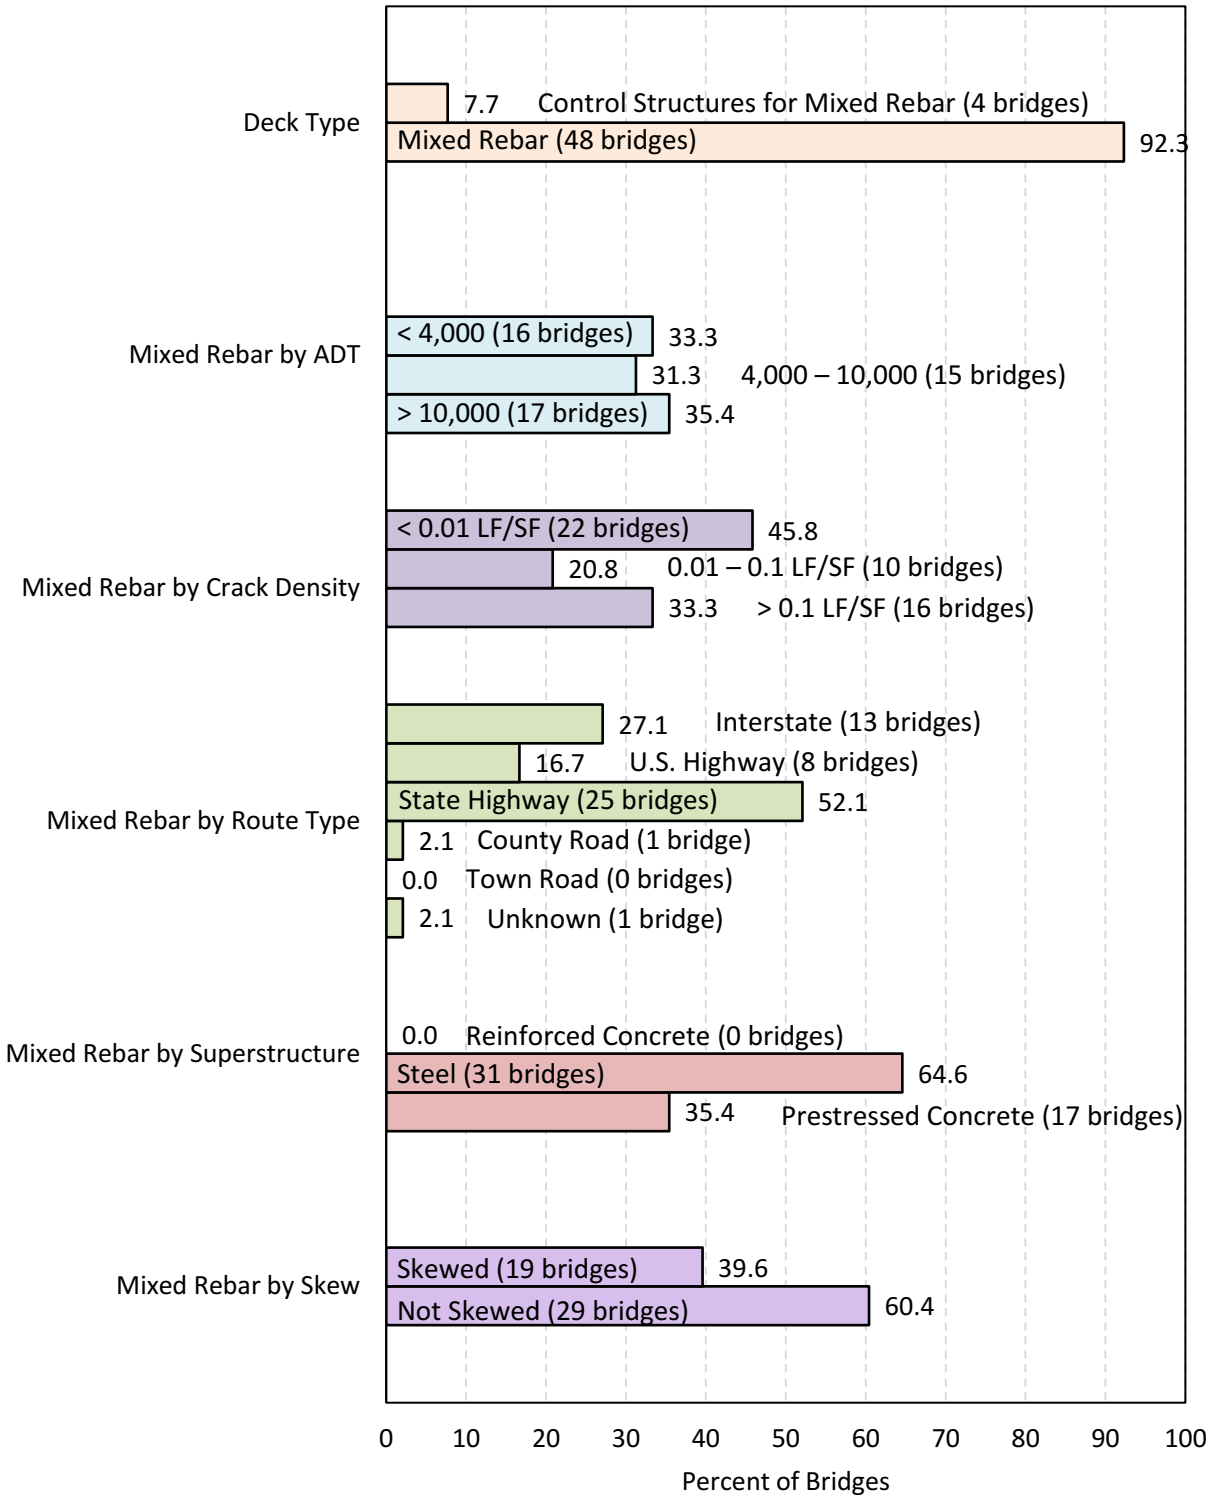
The following observations were drawn from the analysis of bridge decks with at least 2% of the deck in condition states 3 and/or 4 for NBE Element #12 Reinforced Concrete Deck (underside of deck). Of the 52 bridge decks that had at least 2% of the deck in condition states 3 and/or 4, over 90% were mixed rebar decks and less than 10% were the control structures. More than 50% of these mixed rebar decks carried a State Highway, had a steel superstructure, and were not skewed. The mixed rebar decks were split almost equally between each level of ADT. This indicated that ADT did not affect the amount of the deck in condition states 3 and/or 4. The bar chart reporting the percentage of bridges in each subset with at least 2% of the deck in condition states 3 and/or 4 is shown in Figure 3.4.

Figure 3.4 Percent of bridges in each subset that have greater than or equal to 2% of the deck area in condition states 3 and/or 4 for NBE Element #12 (52 bridges)

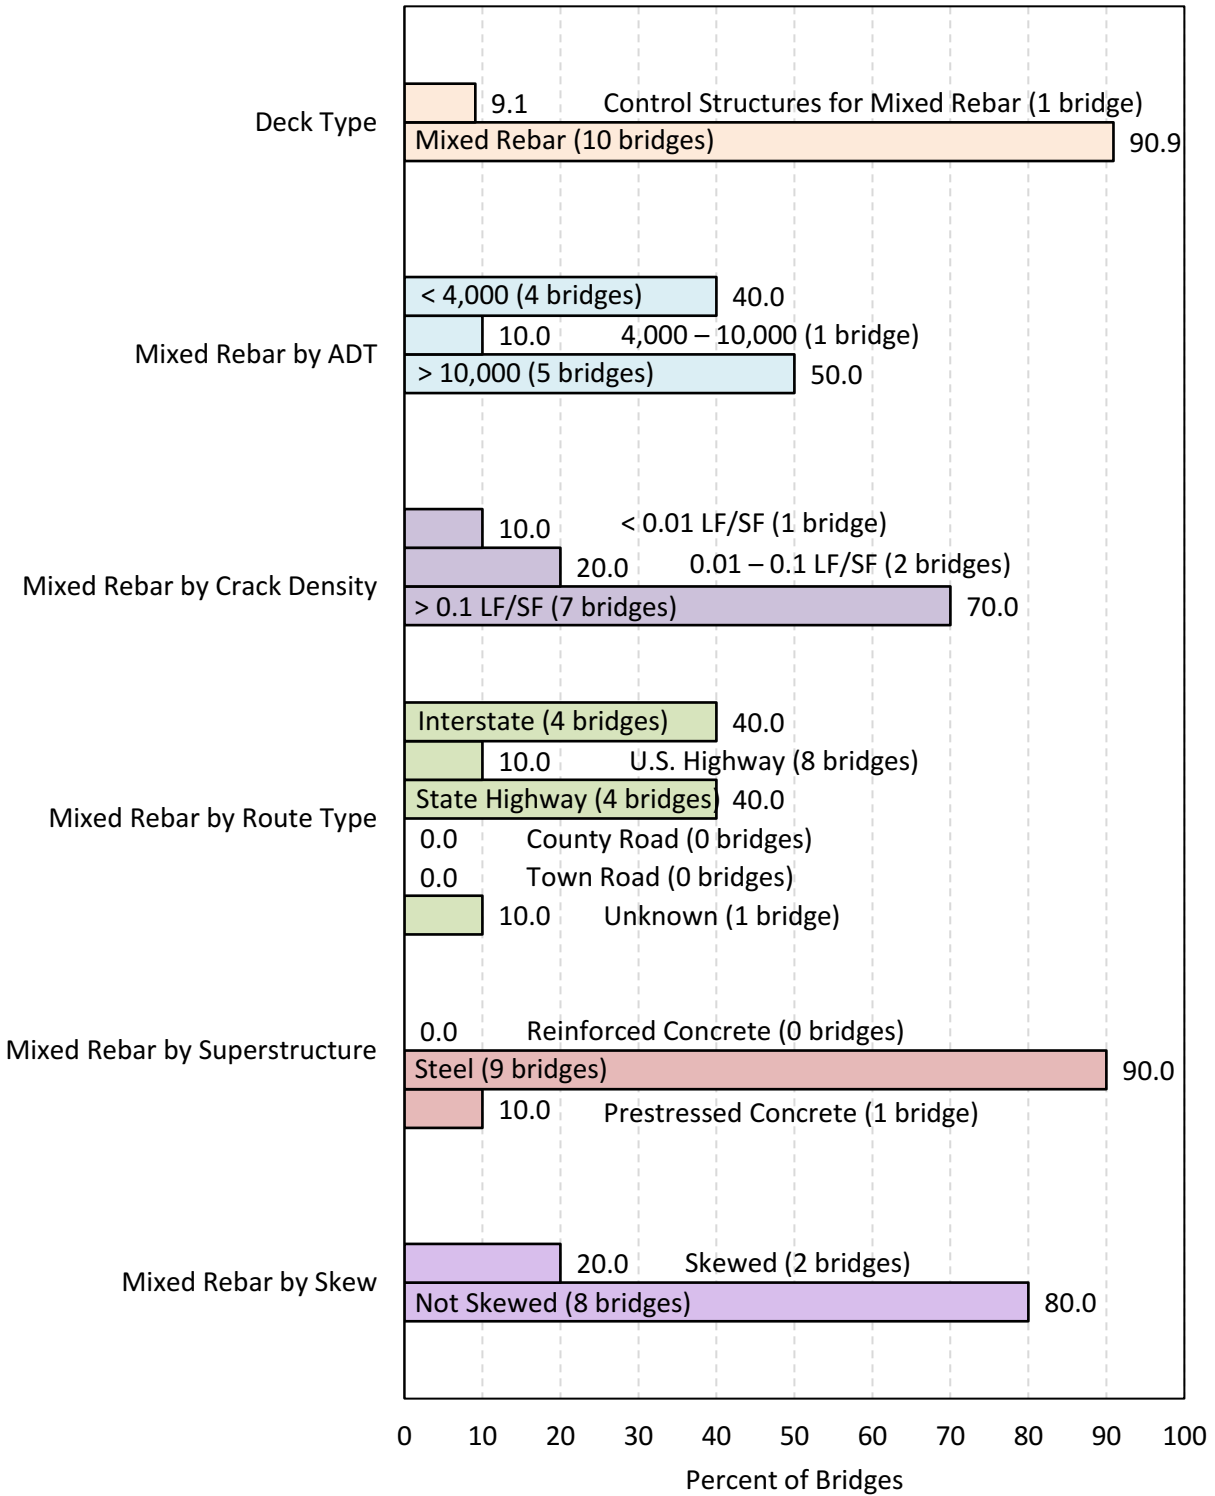
The following observations were drawn from the analysis of bridges with at least 5% of the deck in condition states 3 and/or 4 for NBE Element #12 Reinforced Concrete Deck (underside of deck). Of the 11 bridge decks that had at least 5% of the deck in condition states 3 and/or 4, over 90% were mixed rebar decks and less than 10% were the control structures. Only 11 bridges in the study had at least 5% of the deck in condition states 3 and/or 4, which is too small of a sample size to make any accurate conclusions. The bar chart reporting the percentage of bridges in each subset with at least 5% of the deck in condition states 3 and/or 4 is shown in Figure 3.5.

Figure 3.5 Percent of bridges in each subset that have greater than or equal to 5% of the deck area in condition states 3 and/or 4 for NBE Element 12 (11 bridges)

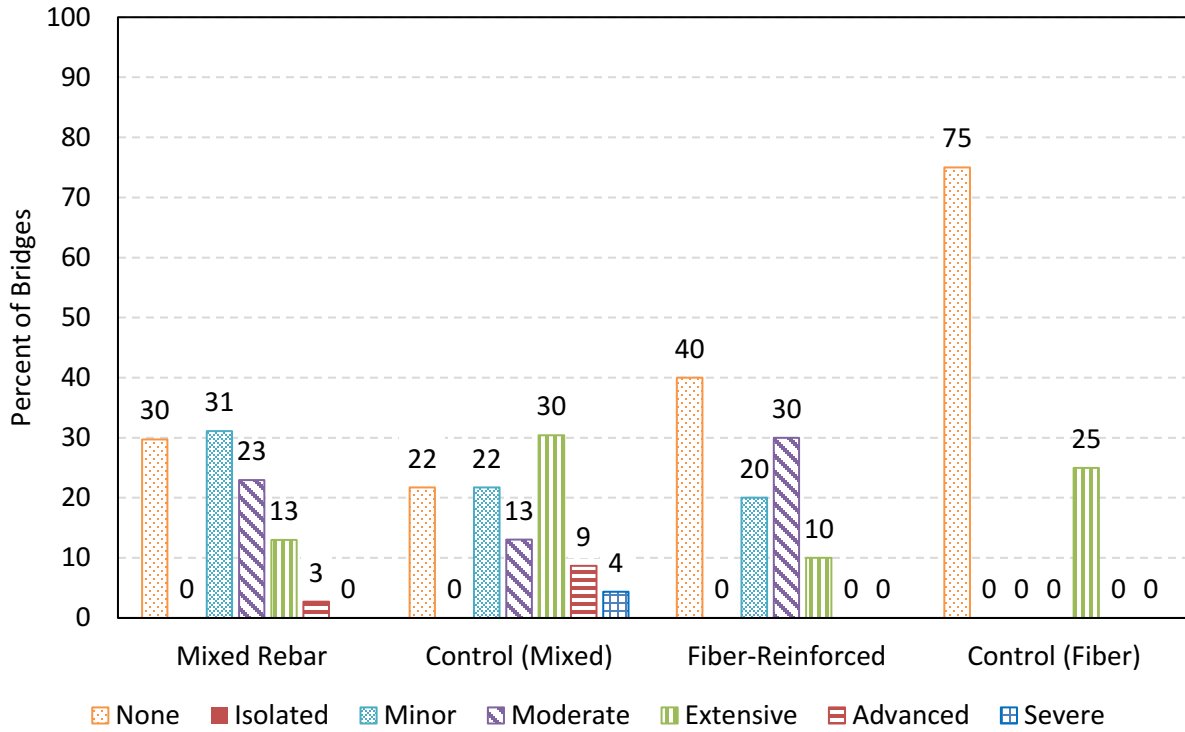
Based on the visual inspection observations, the mixed rebar decks showed more signs of deterioration on the underside of the deck than the control structures. Of the bridges that were visually inspected, 47% of the mixed rebar decks and 26% of the control structures had spalling with exposed rebar. Delamination was present on 54% of the mixed rebar decks and 13% of the control structures. The decks with the most severe spalling and delamination had mixed rebar, but the decks with the most severe cracking with efflorescence were the control structures (epoxy-coating on both layers of rebar). This may indicate that the epoxy-coating on the bottom layer of rebar has been delaying corrosion of the rebar. The efflorescence may not have been as severe in the mixed rebar decks compared to the control structures because the bottom layer of rebar had likely corroded and caused the concrete to spall off the structure. The percentages of each type of deck that had cracking with efflorescence, spalling with exposed rebar, and delamination are shown in Figure 3.6, Figure 3.7, and Figure 3.8, respectively. The completed inspection forms for the mixed rebar decks and their control structures are in Appendix D.

Figure 3.6 Percent of bridges visually inspected at each category for cracking with efflorescence

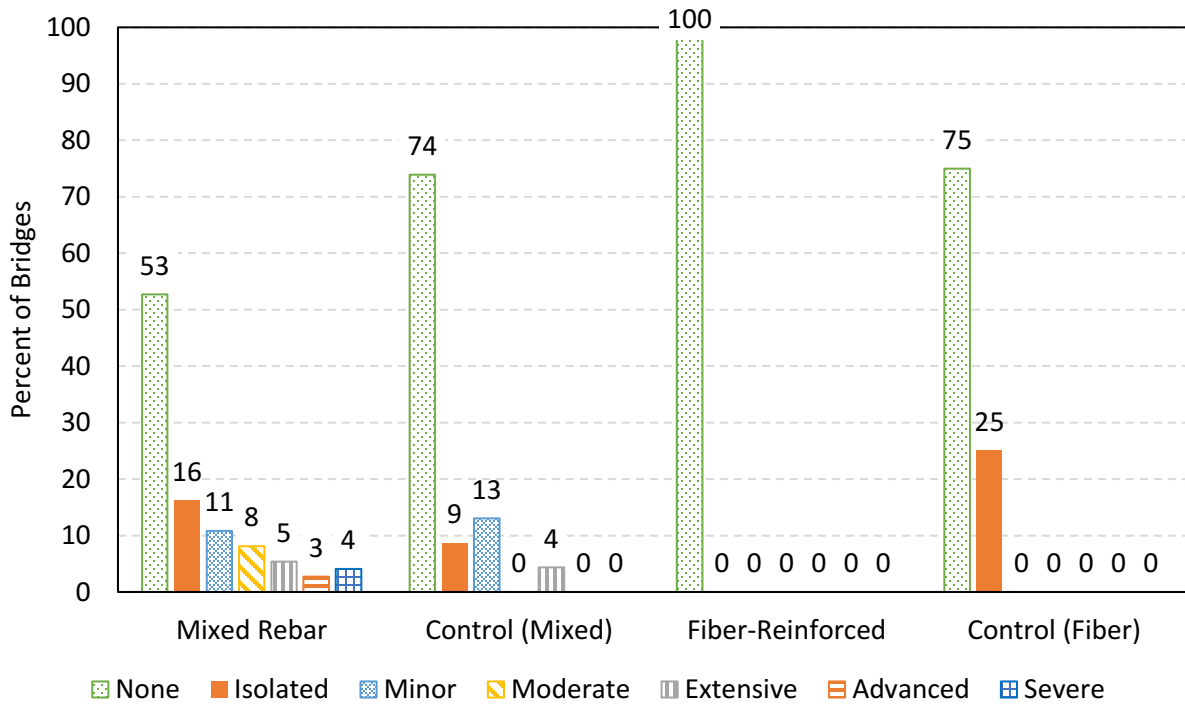
Figure 3.7 Percent of bridges visually inspected at each category for spalling with exposed rebar

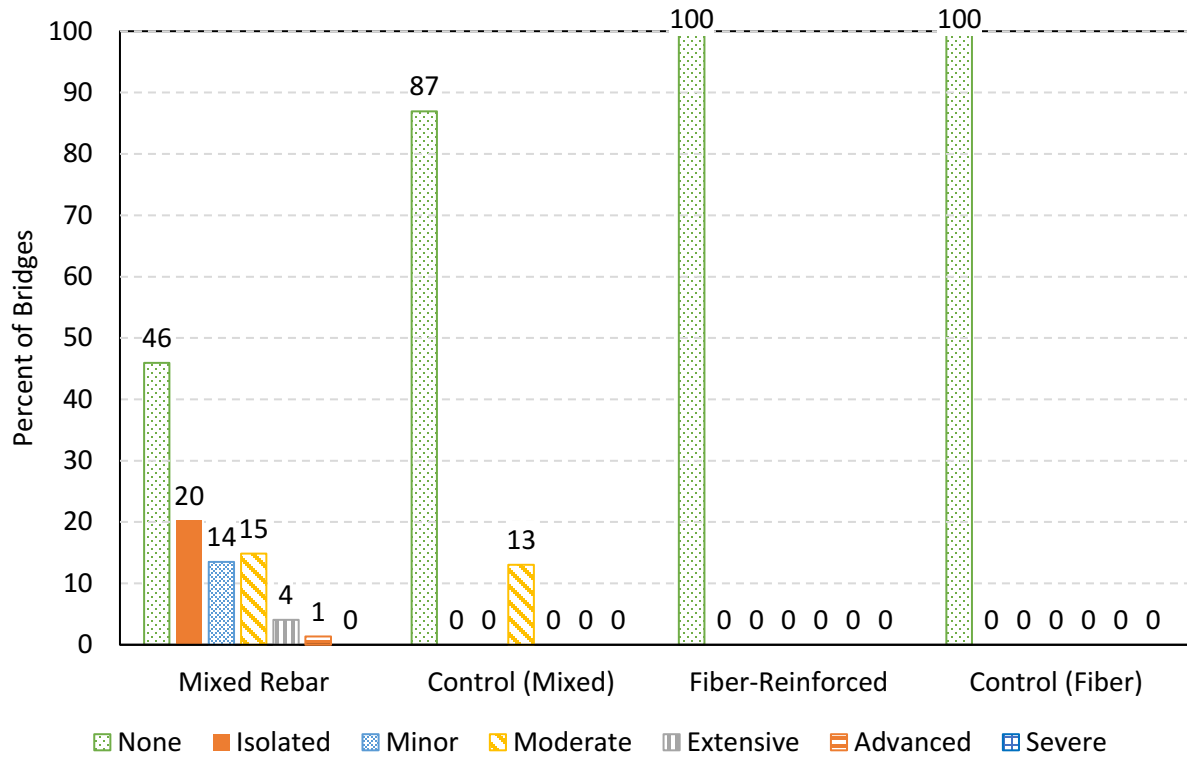
Figure 3.8 Percent of bridges visually inspected at each category for delamination

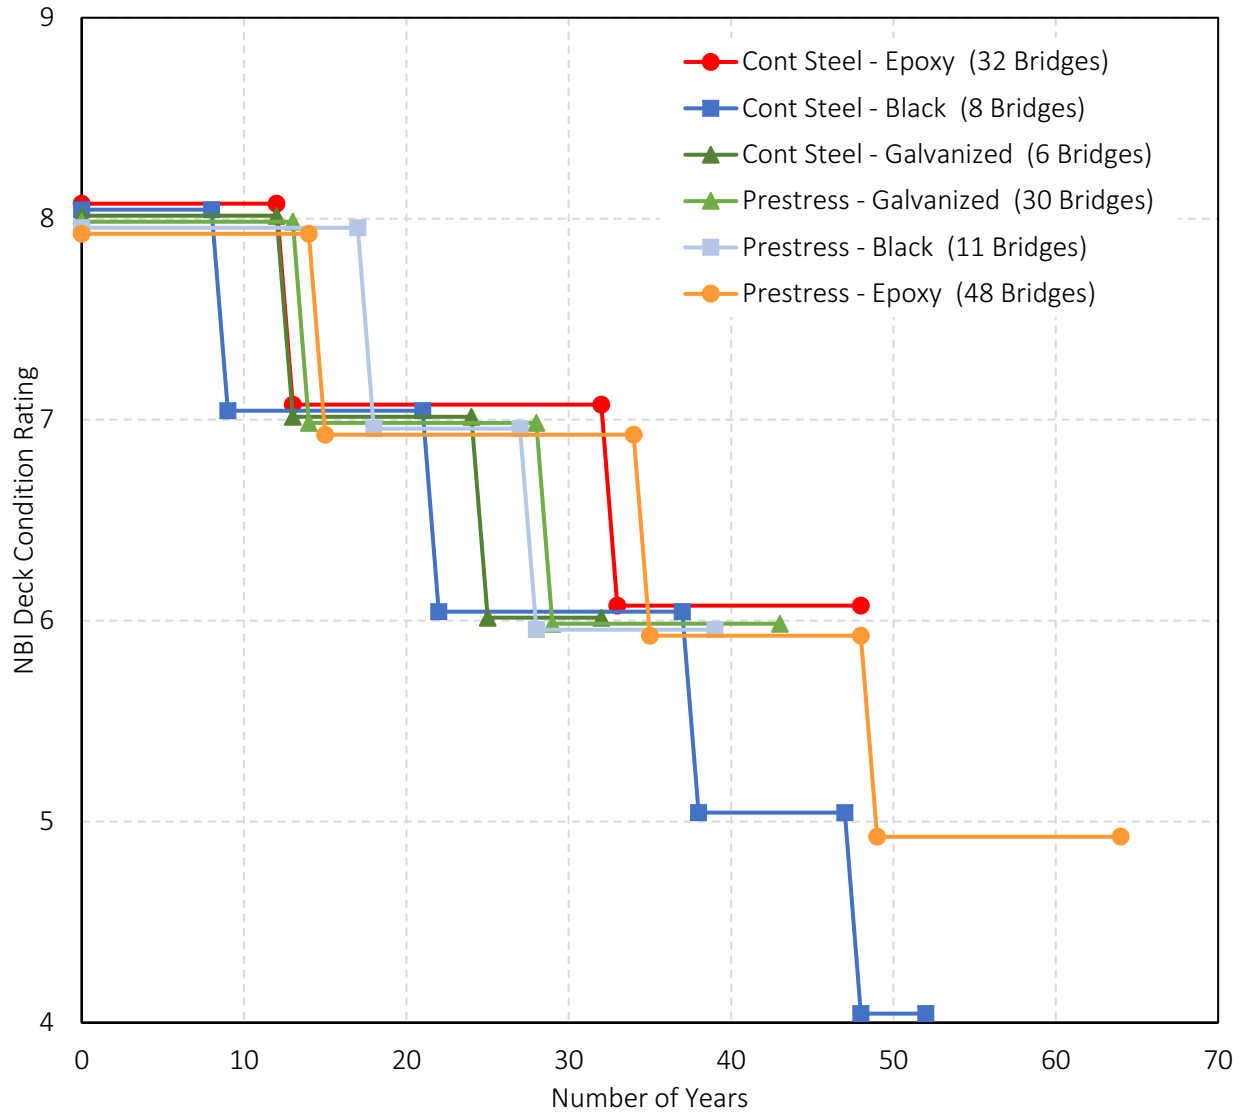
Bridge deck deterioration rates were compared based on the type of superstructure present and type of rebar in the deck. The average number of years that a bridge stayed at a certain Deck NBI rating was determined for decks with each type of rebar and superstructure. The results were plotted and are shown in Figure A-3.

Figure A-3 Deck deterioration rates based on superstructure and reinforcement type

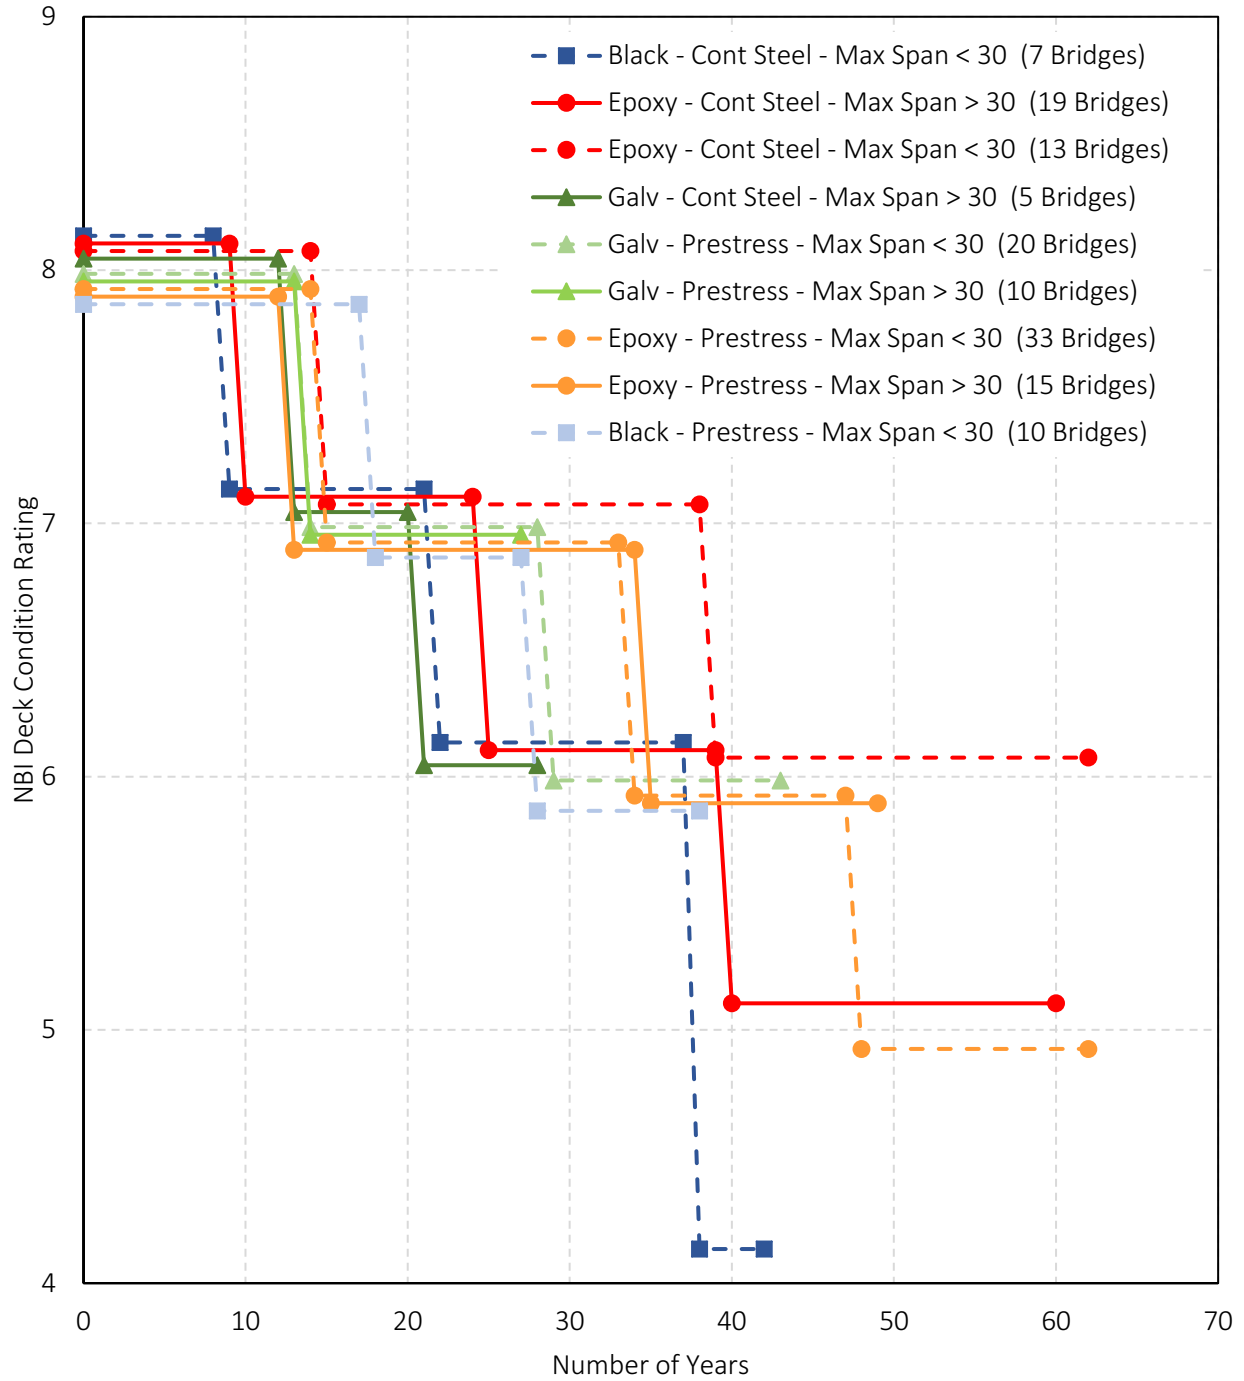
Additionally, the maximum span length of bridges was considered. While Zimmerman et al. (2007) found that bridge decks with maximum span lengths greater than 100 feet deteriorated at faster rate, none of the bridge decks in this study had a span length greater than 65 feet. To evaluate how span length may affect deck deterioration rates, bridges were grouped based on superstructure, reinforcement type, and if there were maximum span lengths greater than 30 feet. The average number of years that a bridge stayed at a certain Deck NBI rating was determined for decks with each type of rebar, superstructure, and maximum span length. The results were plotted and are shown in Figure A-4.

Figure A-4 Deck deterioration rates based on superstructure, reinforcement type, and maximum span length
