Optimized Taconite-Based Pavement Repair Compound and Deployment System

Lawrence Zanko, Principal Investigator
Natural Resources Research Institute
University of Minnesota-Duluth

December 2019

Research Project
Final Report 2019-46

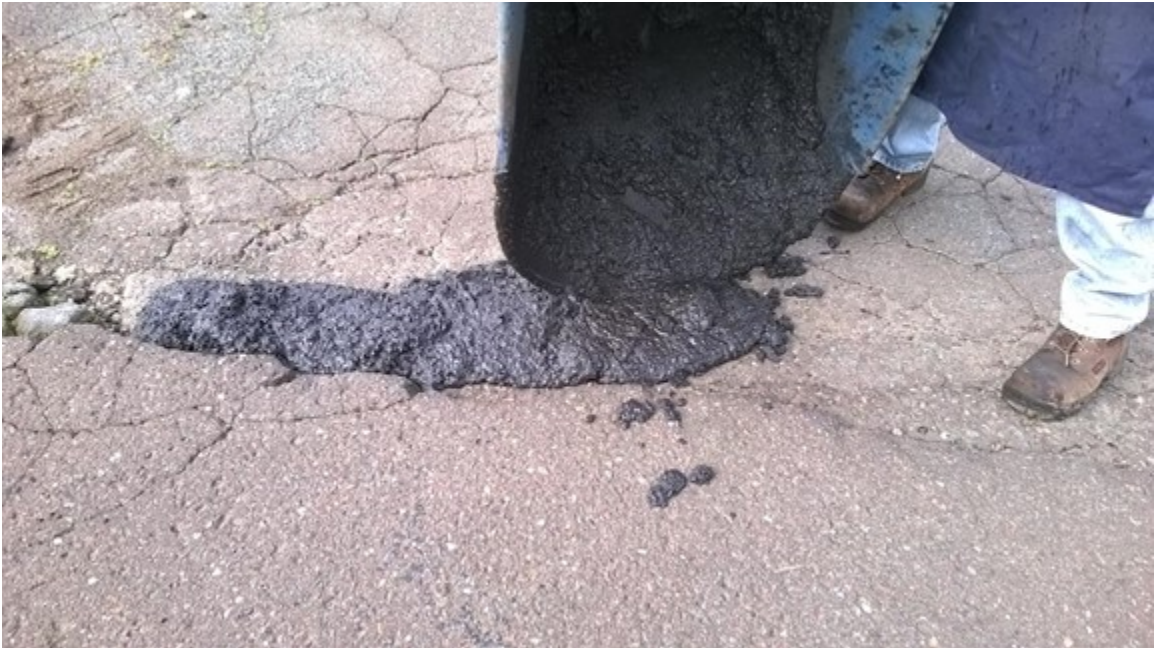
Figure 2.26 Pouring October 5, 2017, test repair in NRRI parking lot.

Following pouring, the mixture was workable and “screedable” for about two minutes before it started to firm. The total time from initial mixing in the paddle mixer to a “drivable” (set) repair was about 15 to 18 minutes. The air and the pavement temperatures were about 60 ° F. The investigators have concluded that the cooler the ambient air and pavement temperatures, the longer the workability and set time. Under warmer conditions, the workability and set time would be somewhat shorter. The condition of this and other project test repairs was followed and documented throughout Task 2 and is presented in Section 3.

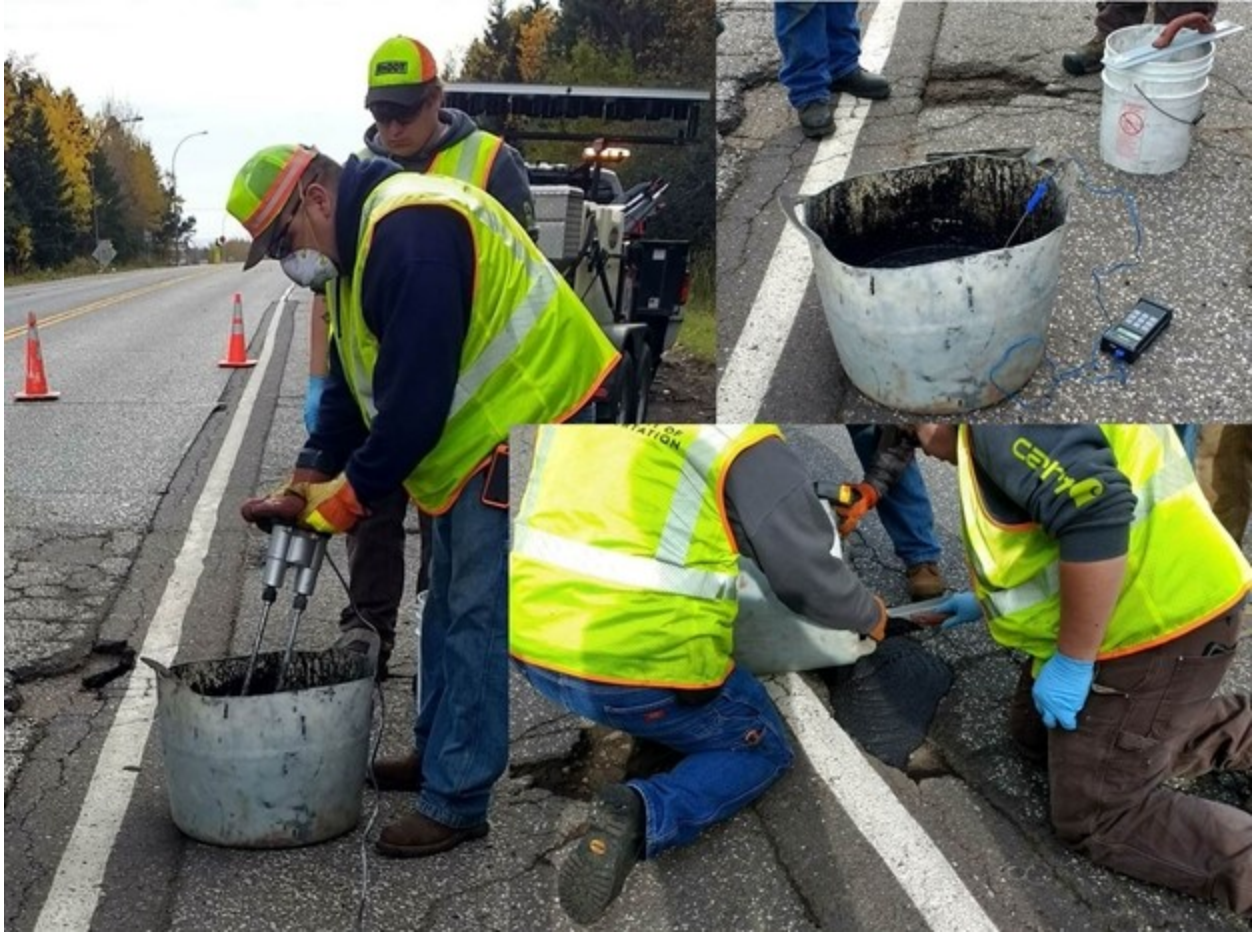
Figure 2.32 MnDOT crew preparing and installing repair compound, October 18, 2017.

All repairs were estimated to be drivable within 15 to 20 minutes. The entire field deployment test went smoothly and gave the investigators additional insights and ideas. Importantly, the field results closely matched what the NRRI's preliminary lab and parking lot tests had predicted.

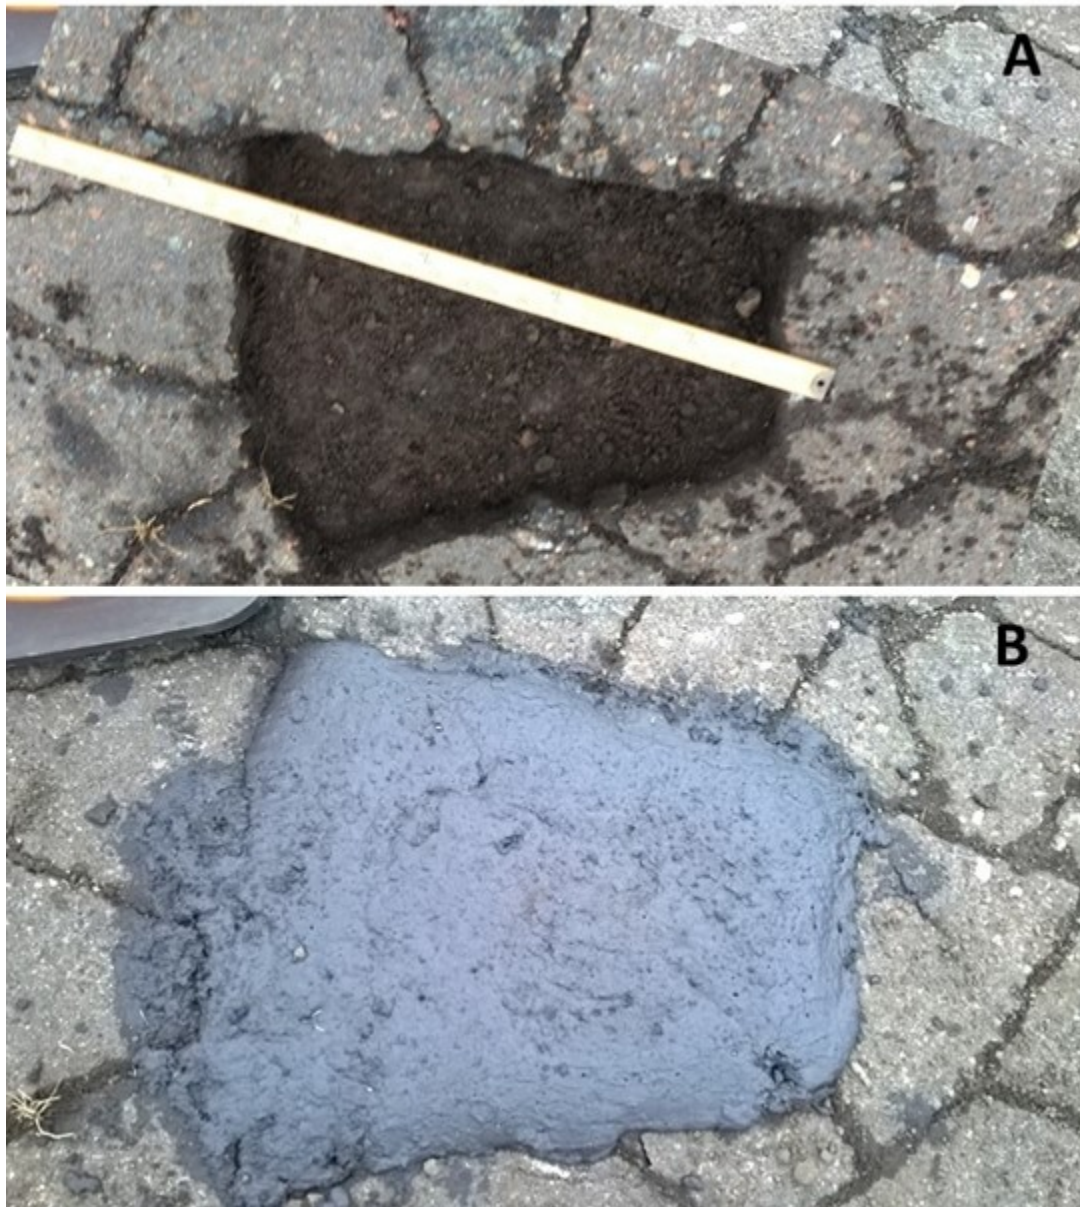
On October 31, 2017, the first larger-scale cold temperature test repair was performed in the NRRI rear parking lot by removing a section of alligatored asphalt pavement to “make” a pothole. The hole measured approximately 14 in wide x 20 in long x 2 in deep. Because only a single layer of asphalt was put down in this section of the parking lot, the base of the hole was compacted gravel, not asphalt. Figure 2.36 shows the pothole pre- (A) and post- (B) repair. The pavement temperature was 32 ° F (0 ° C), the liquid activator 45 ° F, and the dry reactive aggregate components 38 ° F. The center of the repair

firmed up in about 30 minutes but was softer nearer the edges. The edges began firming up in about 45 minutes. Overall, the repair took about 60 minutes to reach a drivable state.

Figure 2.35 October 31, 2017, cold temperature pothole repair test at NRRRI; before (A) and after (B).

As reported previously, this was the first larger-scale cold temperature test repair performed in the NRRI rear parking lot. The pavement temperature was 32 ° F (0 ° C), the liquid activator 45 ° F, and the dry reactive aggregate components 38 ° F. The hole measured approximately 14 in wide x 20 in long x 2 in deep. The base of the hole was compacted gravel, not asphalt (see Fig. 2.36). To reiterate, the center of

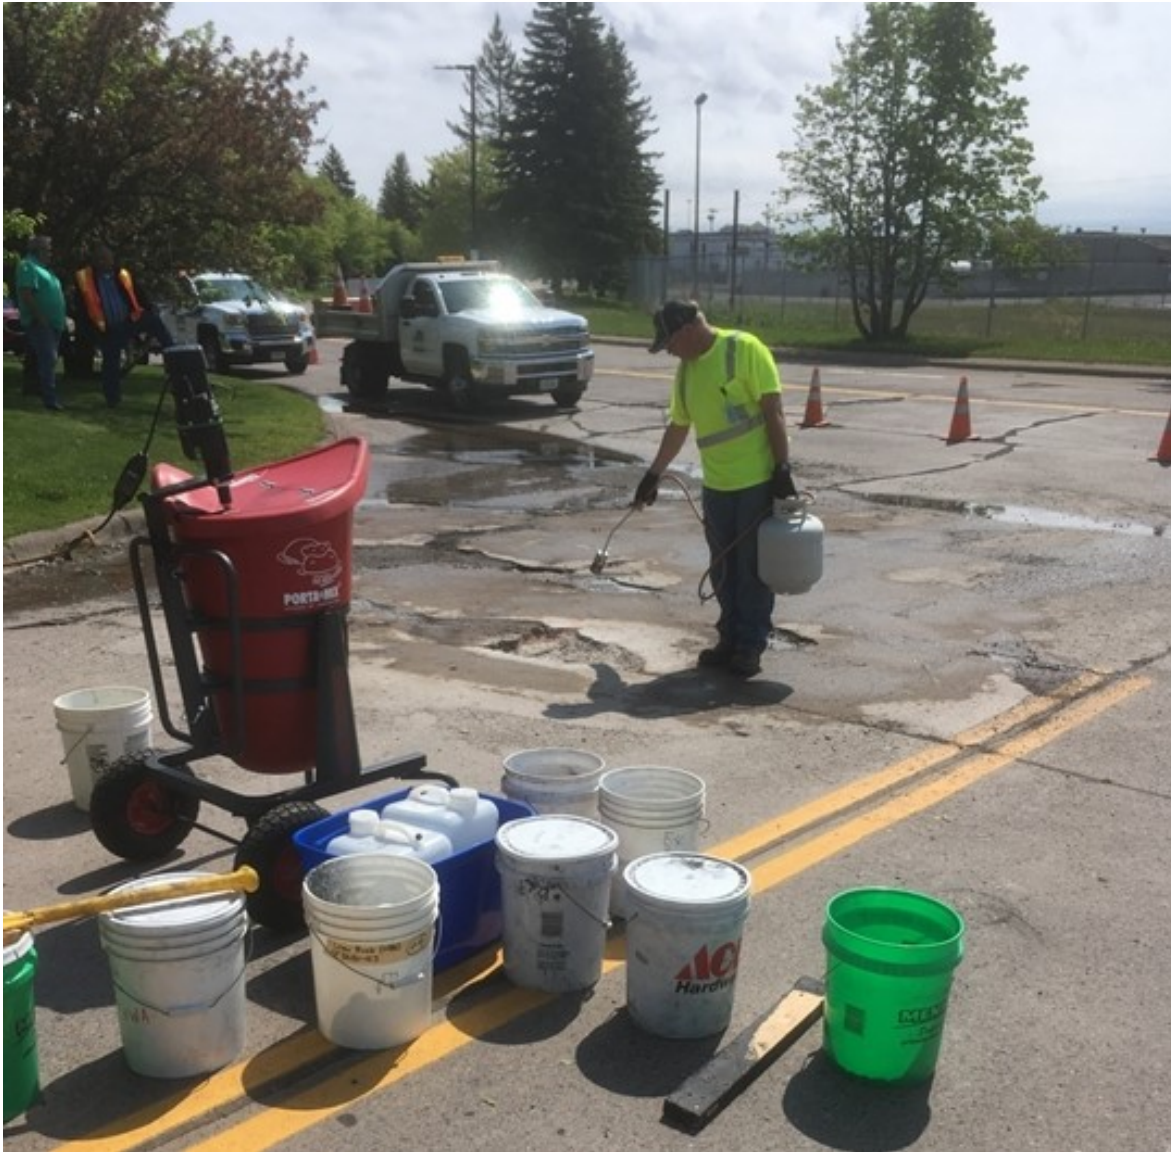
Zanko and Drazan used shovels and hoes to remove loose material from the holes and to make vertical to slightly inclined edges for the potholes. The slight incline (edge bottom being in further than the top) allows for a stronger bond between repair materials and the surrounding road. Duluth public employees

prepped each pothole by removing loose gravel, dirt, and debris, flushed out excess water with a leaf blower, and dried the potholes with a propane torch (Fig. 2.42).

Figure 2.41 Pothole repair setup and preparation, June 6, 2018, Duluth field trial location.

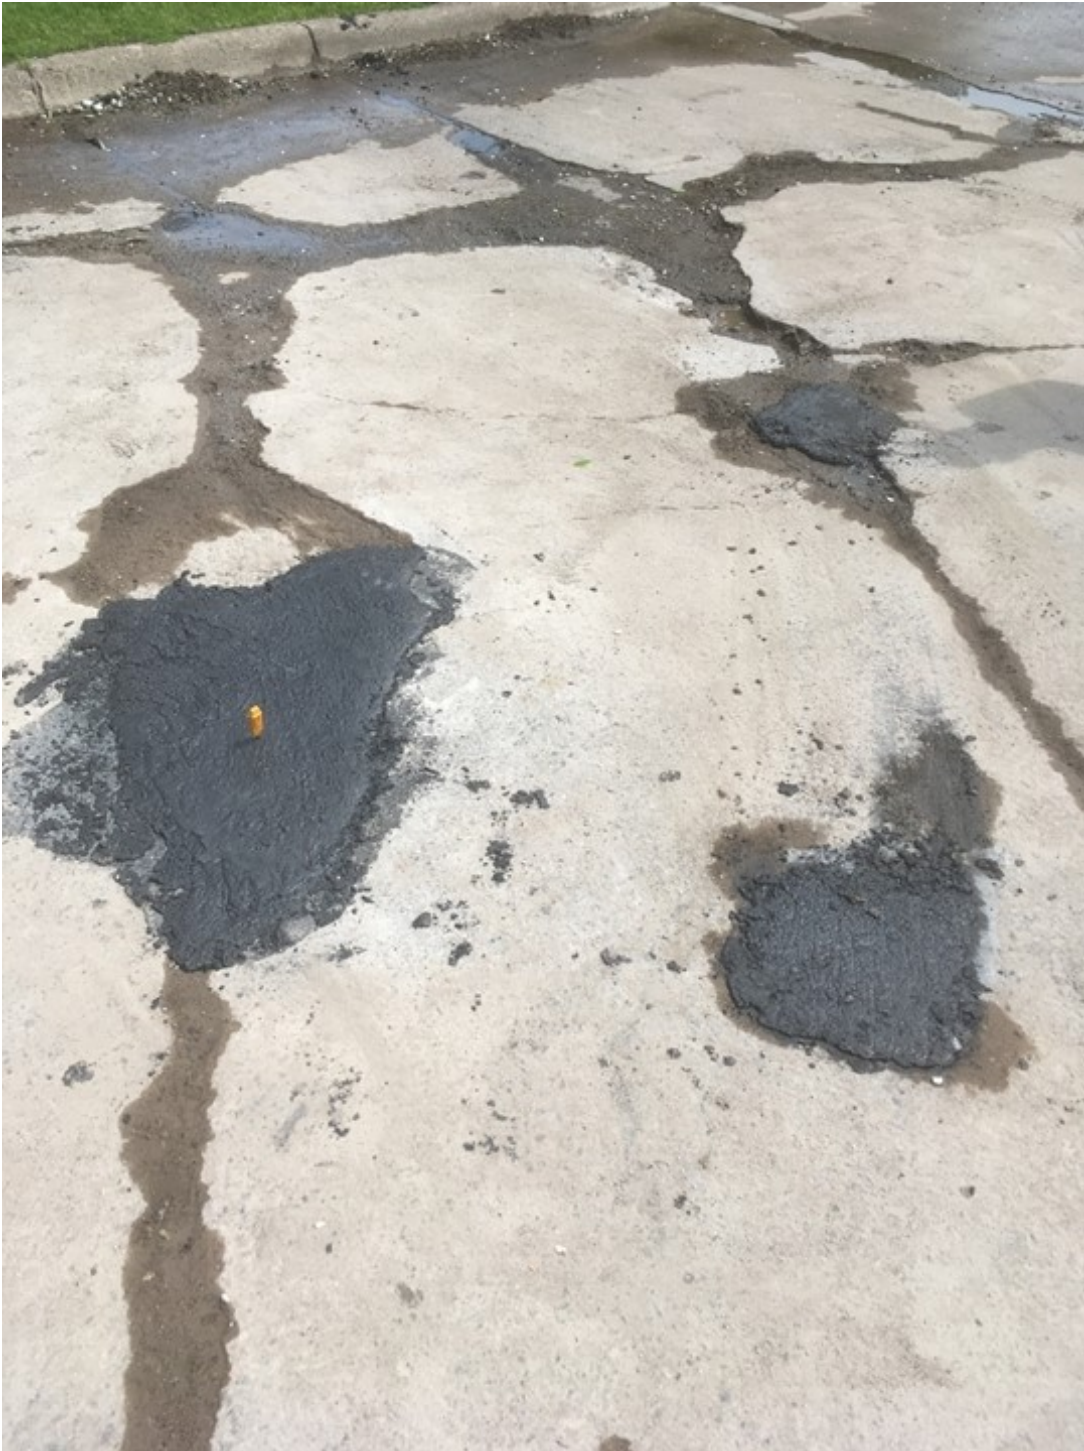
inconsistencies of setting/drying were noticed for Batch 2. The pothole repair increased in temperature more quickly than the small pothole (approximately 5 minutes) to reach 101 ° F and plateau. Excess mixer material from Batch 2 was used to fill smaller potholes adjacent to the large pothole (Fig. 2.43). These were not monitored as closely since they were not prepped as scrupulously as the first two pothole repairs.

Figure 2.42 Finished Batch 2 repairs: June 6, 2018, Duluth field trial location.

The performance and condition of the remaining repairs at the Chestnut Street and Truck Center Drive field trial location has ranged from good to excellent. Two representative examples are shown in Figure 2.79 (June 6, 2018 repair) and Figure 2.80 (September 27, 2018 repair). Refer back to Figures 2.43 and 2.49 to view the respective freshly completed repairs.

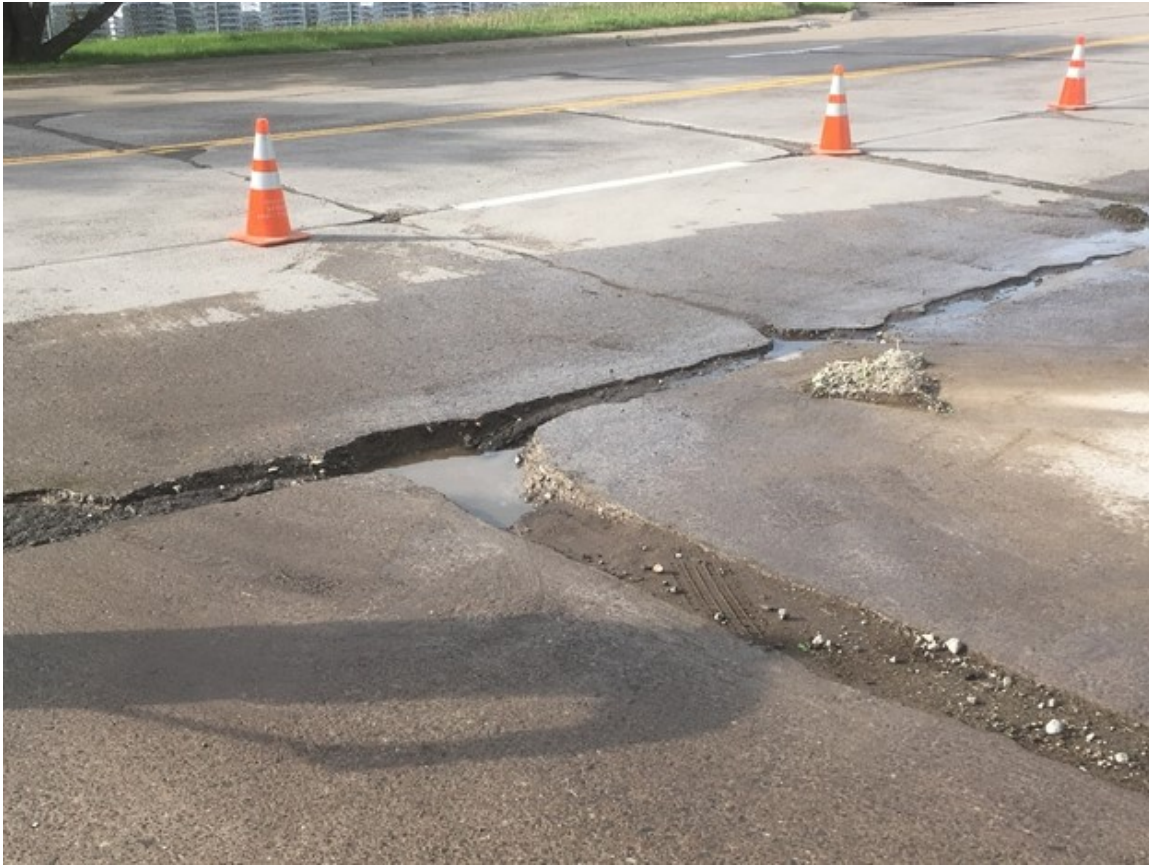
City of Duluth employees arrived at the Chestnut Street and Truck Center Drive location to provide traffic control and prepare the pothole (pavement failure between concrete panels) and adjacent areas for repair. The intended pothole repair contained standing water (Fig. 2.44) coming from an up-road water leak. Duluth city employees temporarily stopped the water flow from entering the pothole with sandbags and used a vacuum truck to empty the standing water (Fig. 2.45). Next, the pothole’s “arms” were shortened, and the wet bottom of the main pothole was filled with 1 to 2 in of hot mix asphalt to provide a reasonable (and dry) base for the repair (Fig. 2.46). The asphalt edges were made vertical with a pick and shovel.

Figure 2.43 Target pavement repair: June 7, 2018, Duluth field trial location.

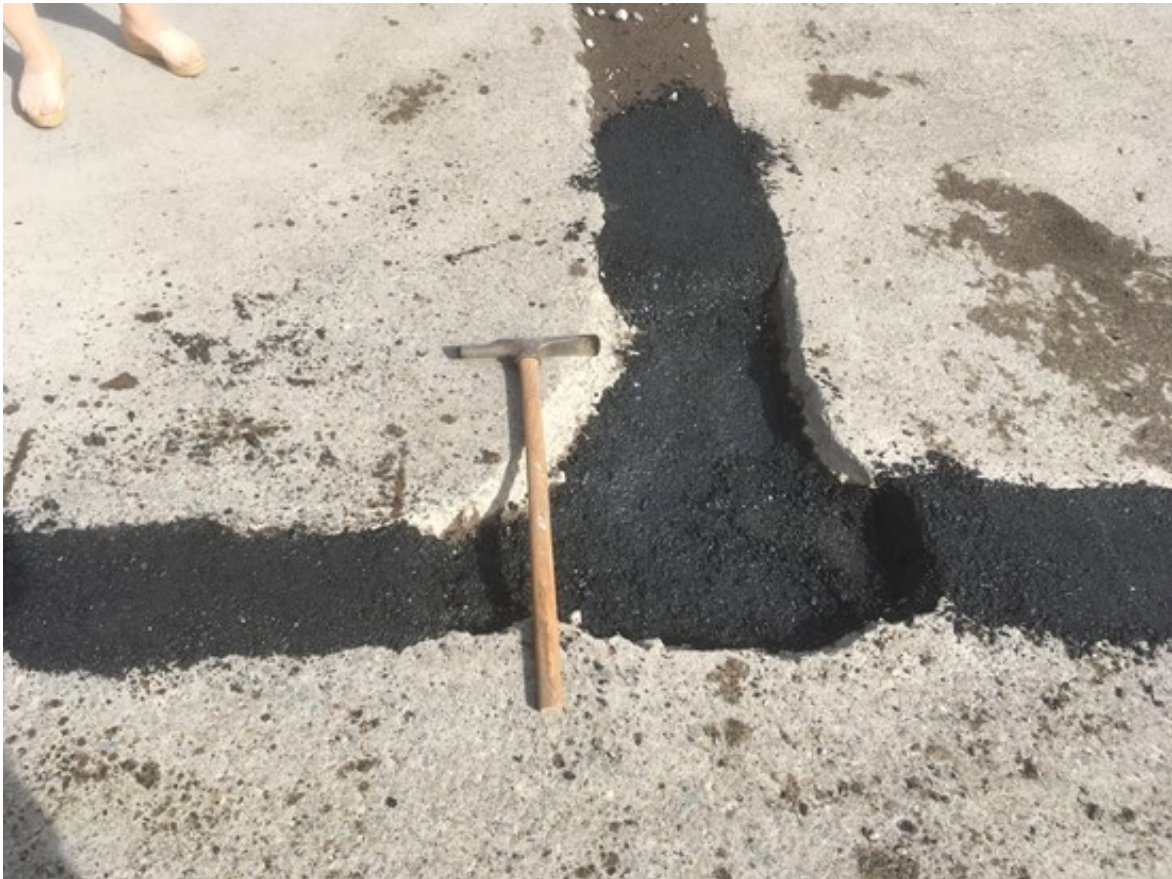
Figure 2.45 Target pavement repair prepared with hot mix asphalt: June 7, 2018, Duluth field trial location.

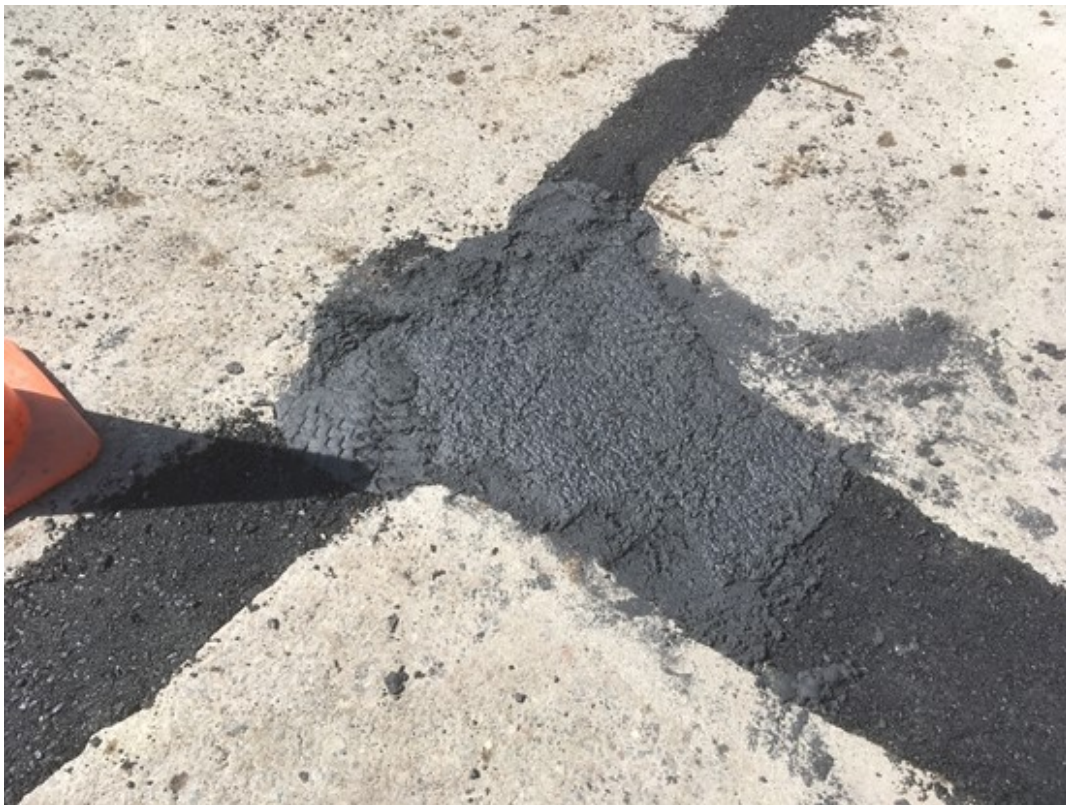
Immediately after pouring the mixed material and spreading evenly across the bottom of the pothole, Zanko and Drazan began prepping and mixing Batch 4 for the top layer. Batch 4 contained 100 lb of reactive taconite materials. It differed from Batch 3 in that it included a significantly higher percentage of the most-reactive mineral component. Eighteen pounds of liquid activator were poured into the Mega Hippo device and mixed for 15-30 seconds, followed by the solid reactive minerals components. The liquid and solids were mixed for approximately 1 minute. The Mega Hippo was transported directly to the same pothole, where Zanko tipped the Mega Hippo and Drazan used the paddle to scrape out material and distribute the material as needed with help from Duluth city employees. Batch 4 set faster than the underlying Batch 3, taking around 4 minutes to start setting. The warmth of the underlying layer may have contributed to the faster set, as well as the higher percentage of the most reactive mineral component. Approximately 11 minutes after the pothole was filled with Batch 4, it was drivable (Fig. 2.47). The repair mixture plateaued at a temperature of 109.2 ° F, 13 to 16 minutes after being placed.

Figure 2.46 Completed repair: June 7, 2018, Duluth field trial location.

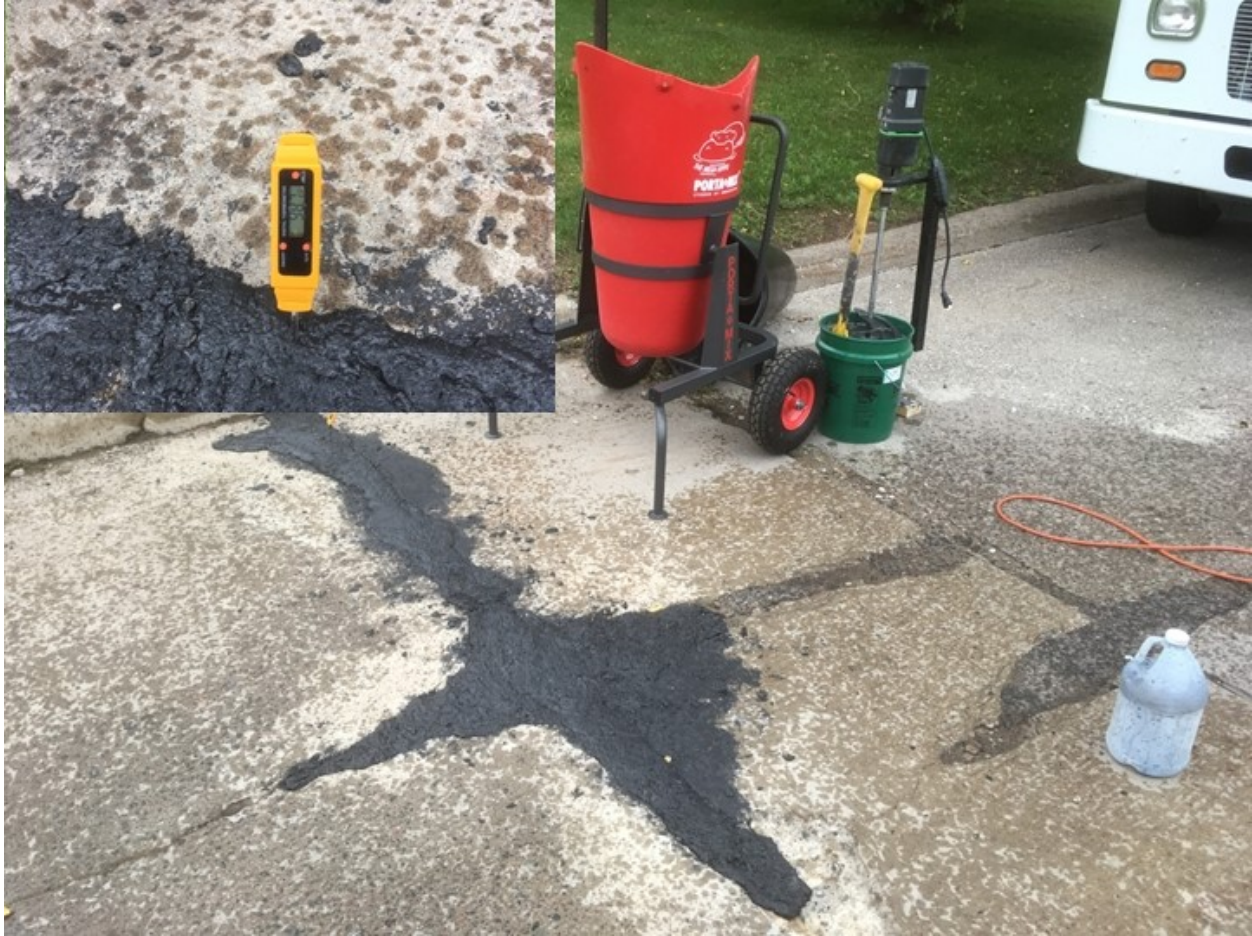
A combination field demonstration/media event with the city of Duluth took place on Thursday, September 27, 2018, using two updated repair formulations, again at the Chestnut Street and Truck Center Drive location (refer to Fig. 2.41). Repairs were again performed in the street's concrete pavement in linear failures that formed between panels. The failures were from 2- to 3-in (5 to 7.5 cm) deep and varied in width. Two (2) 50-lb batches of dry reactive mineral material were used to fill about 0.85 ft³ of pavement failures. Each 50-lb batch was mixed with 9 lb of liquid activator (18% by weight). Following their placement, the two repair formulations set to a probable drivable state within about 15 minutes. The air temperature was 59 ° F (15 ° C). The internal temperature of the repairs peaked at about 100 ° F (38 ° C), which coincided with a "drivable" set. The temperature and set time result correlated well with prior laboratory testing. Figure 2.49 shows the final repair, with the inset showing the temperature.

Figure 2.48 Completed repair: September 27, 2018, Duluth field trial location (inset showing curing temperature).

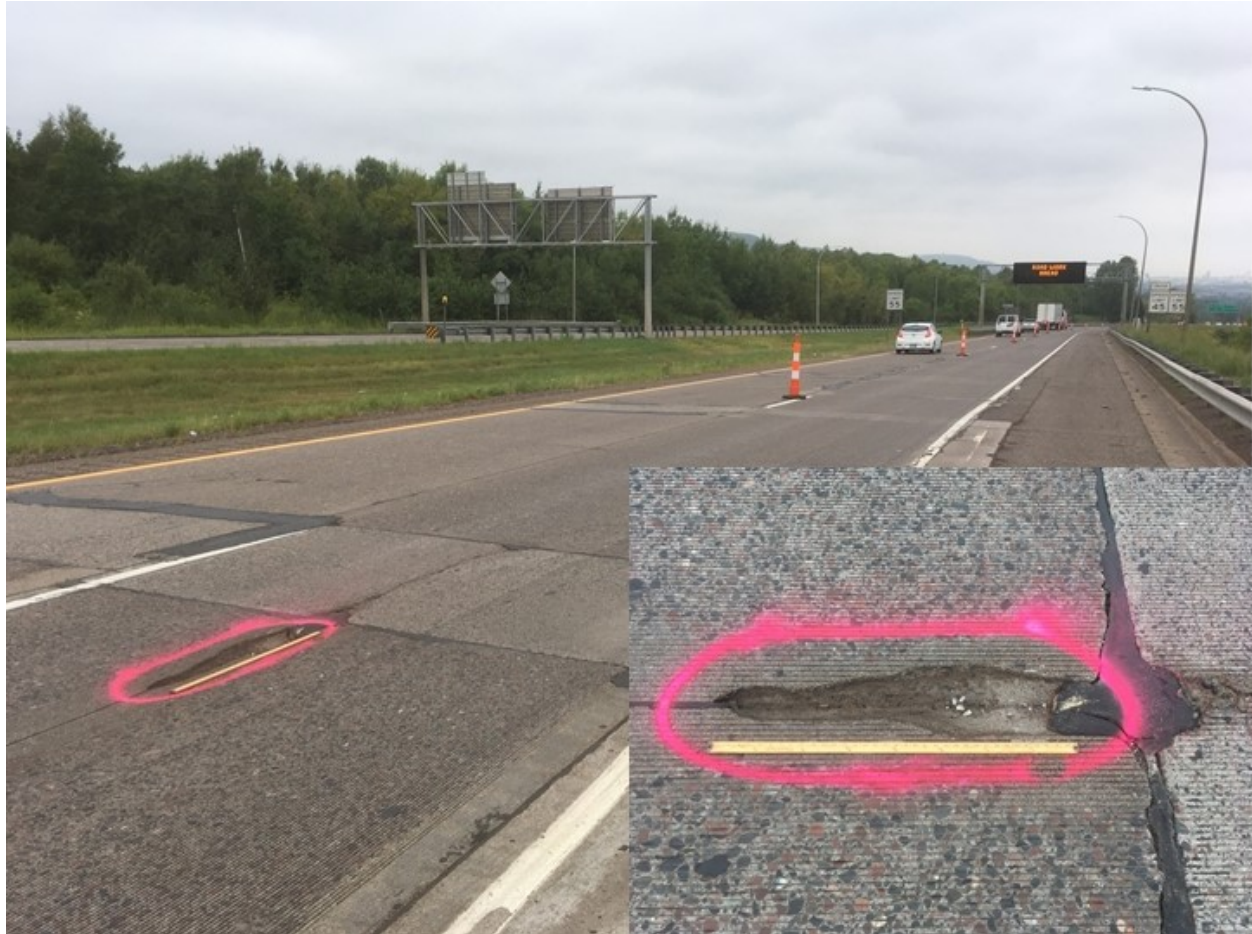
In late August 2018, prospective repair locations on the Thompson Hill to Central Avenue portion of I-35 in Duluth were discussed with MnDOT D1 personnel and were identified, photographed, and marked for potential future repair (Fig. 2.53). It was originally thought those repairs would be done in the fall of

Figure 2.52 Potential southbound I-35 repair: Thompson Hill, Duluth (inset shows detail).

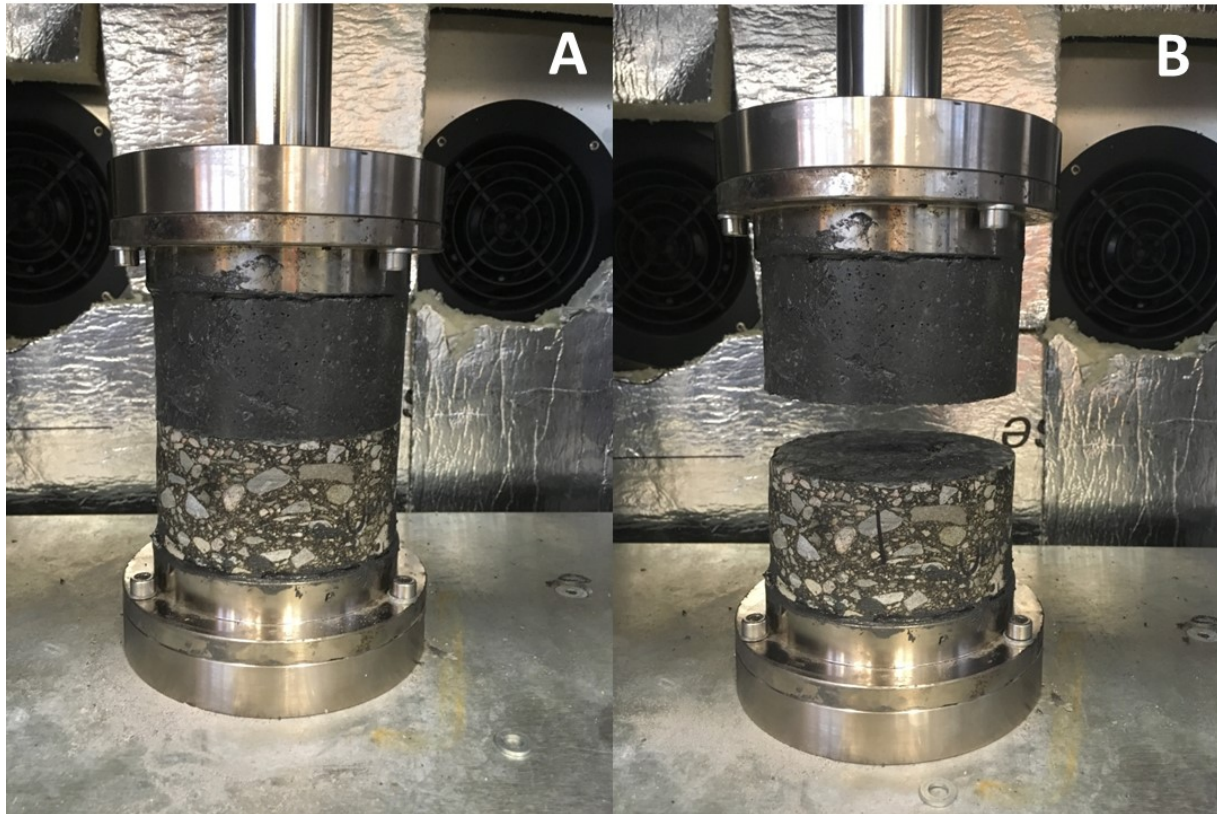
Figure 2.55 Bond strength testing apparatus and specimen (road patch material topping asphalt pavement core): before (A) and after (B).

As reported by the UMD postdoc investigator, two of the three samples broke at the interface, while one sample broke in the asphalt portion. The test was very quick (within a second), and the peak load to break the bond was around 3-4 kN (675-900-lb force). It was observed that the asphalt test specimens were probably too smooth (diamond-sawn face) and were not necessarily a good representation of real-world (field) conditions. A typical pavement (or pothole) would have a rougher surface texture.

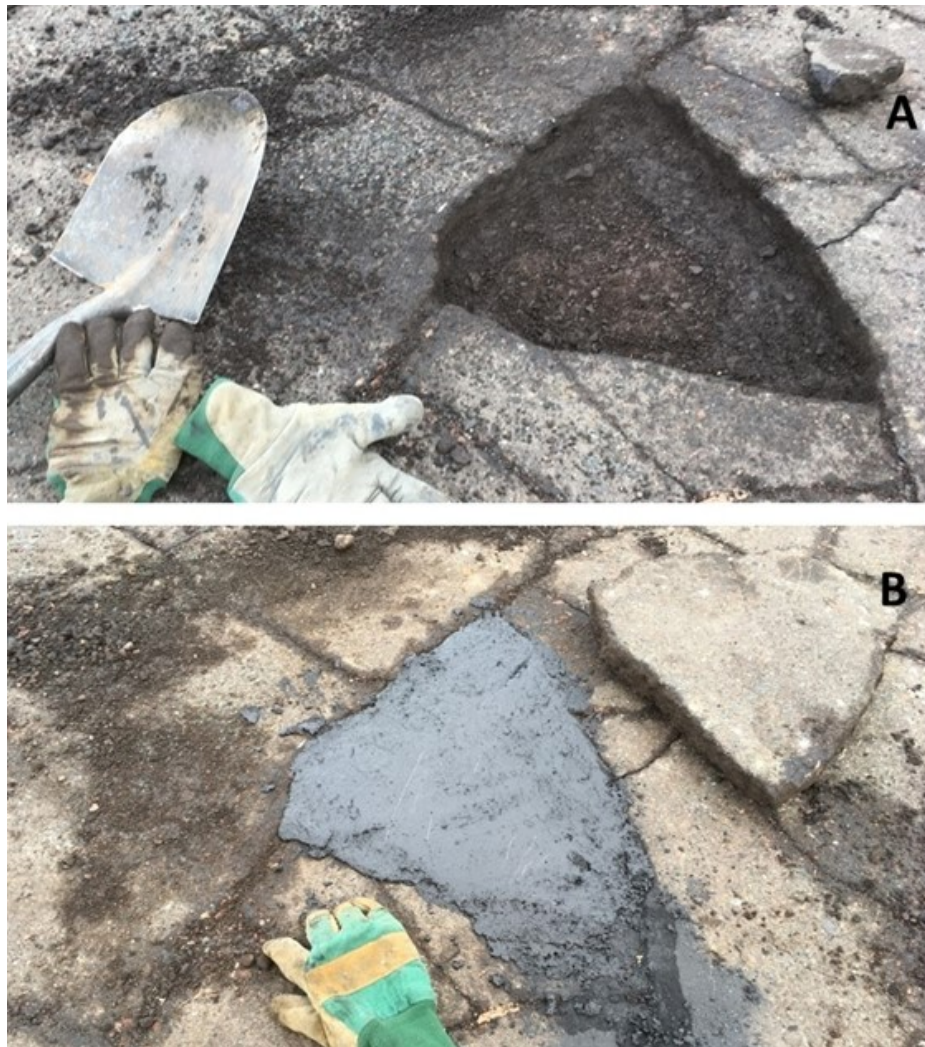
The condition of a second cold weather repair, installed on November 20, 2017, was also monitored into 2019. The 18 in to 24 in x 2-in-deep triangular pothole, “made” in the NRRI rear parking lot (Fig. 2.64). Gravel was exposed at the hole’s center. Frost was also visible in the bottom of the hole after the triangular slab of asphalt was removed. The repair was made when the ambient temperature was in the

Figure 2.63 November 20, 2017, cold temperature pothole test at NRRI; before (A) and after (B).

mid-30s ° F. For this repair, the dry and liquid components were mixed for 2 minutes in a five-gallon bucket at their ambient (indoor) temperature of 61 ° F rather than being allowed to cool, as the October 31, 2017, repair components had. The center of the repair was firm at about 19 minutes but still somewhat soft at the edges. It was estimated that this repair was probably drivable at about the 35-minute mark, compared to the 60-minute mark for the October 31 repair.

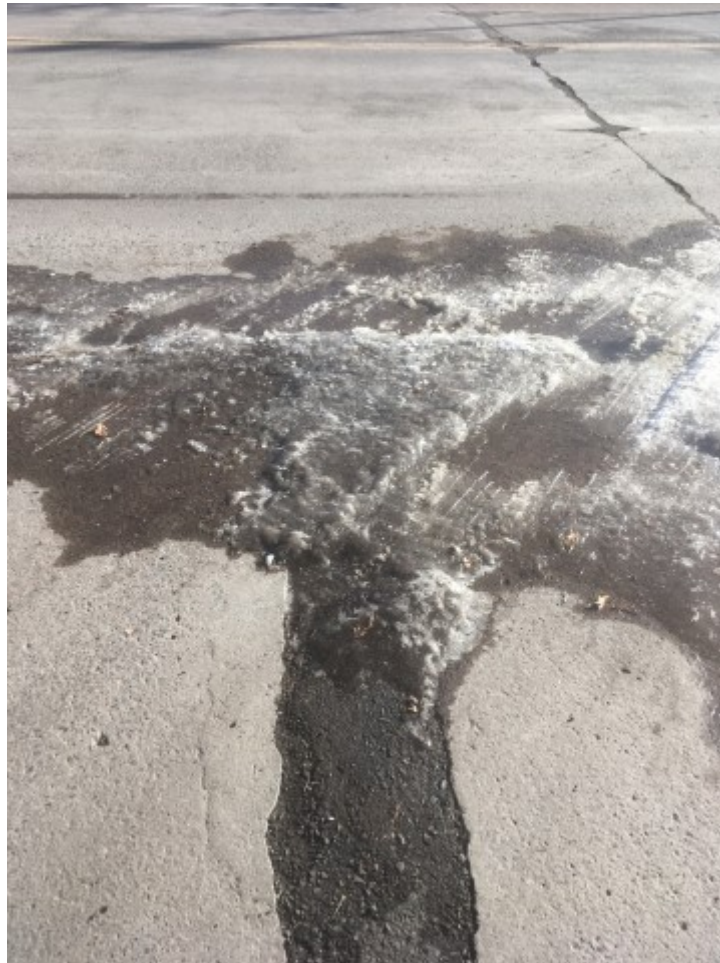
As Figure 2.75 shows, the condition of the repair on October 2, 2018, was good. A follow-up inspection on November 17 confirmed the problematic (wet) conditions at this location, which were present at the time of the June 7 installation. Aside from the location's slow drainage and tendency to pond precipitation, the location also received input of water from an "upstream" water leak originating on Truck Center Drive. As Figure 2.76 shows, the taconite-based repair was completely covered with ice on November 9, 2018.

Figure 2.75 Ice-covered condition of June 7, 2018, Duluth field trial repair on November 17, 2018.

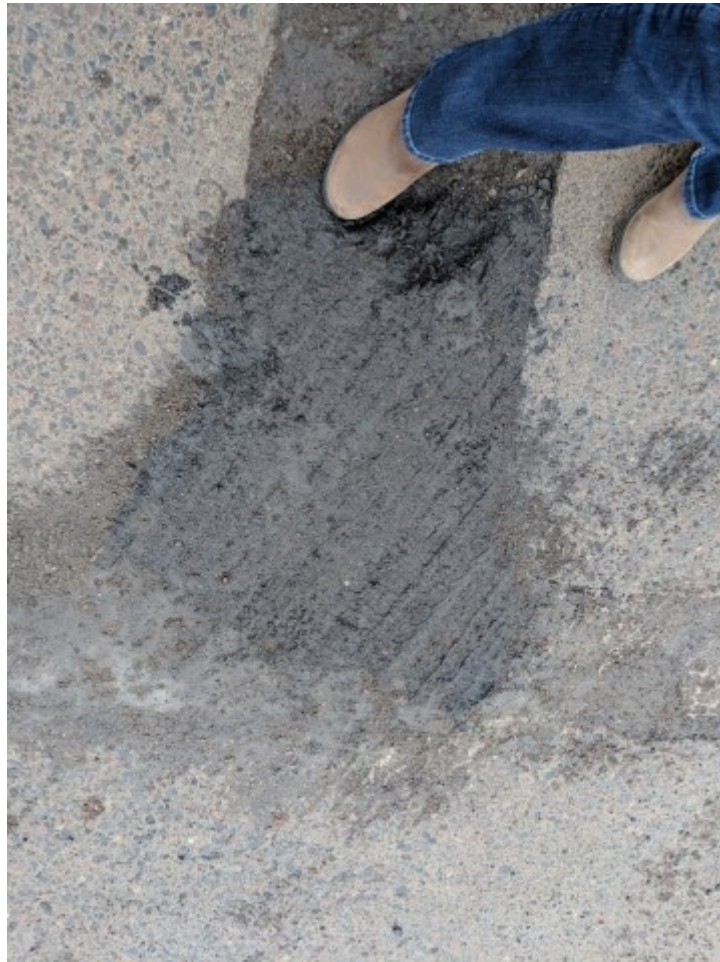
It was not until the next inspection took place – performed under drier conditions on December 12, 2018 – that the deteriorating condition of the repair was revealed (Fig. 2.77). As the tire tracks and footprint show, the surface of the repair had softened considerably in the intervening month.

Figure 2.76 Condition of June 7, 2018, Duluth field trial repair on December 12, 2018, showing deterioration.

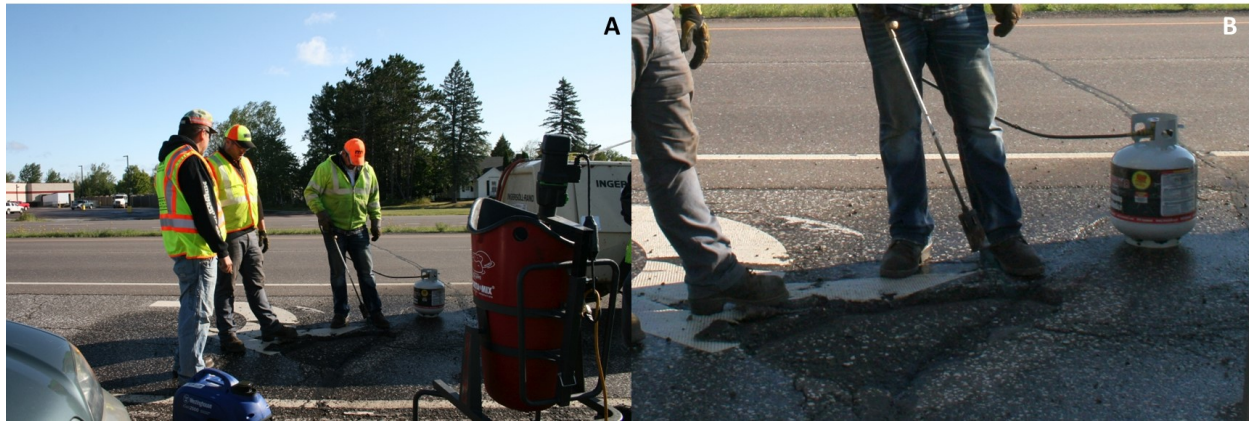
Figure 2.84 MnDOT District 1 crew preparing pothole for repair (A) and driving moisture from the pothole with a propane torch (B).

MnDOT District 1 personnel prepared the pothole by removing loose debris with high-pressure air and driving out excess moisture with a propane torch (weed burner) (Fig. 2.85A and B).

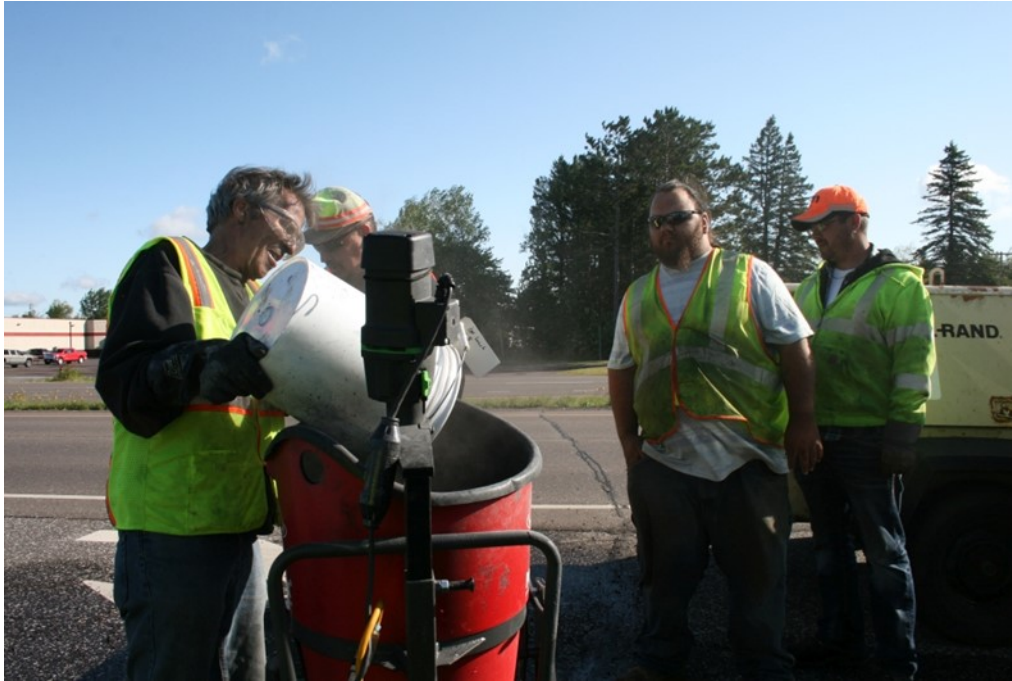
Figure 2.85 Adding and mixing repair compound components at the U.S. Highway 53 field trial location.

Mixing commenced by first placing 21.6 lb of liquid activator (18% of 120 lb) in the mixer’s flexible liner and starting the mixer. The two supplemental mineral components were then added to pre-mix with the liquid activator, followed immediately by the taconite components. (NOTE: Under normal circumstances, all dry mineral components would be pre-blended and added in 40-lb increments together.) The mixer was run for about 1 minute (Fig. 2.86). The mixing apparatus was then removed from the mixer, with the mixing blade end placed in a five-gallon bucket of water. This step makes the mixing end easy to clean and prevents the compound from hardening on the blades. The repair compound was allowed to “rest” for two more minutes as the exothermic reaction between the mineral components and liquid activator took place. A small amount of gas (hydrogen) is generated by the reaction and causes the mixture to expand slightly, like rising bread dough. A large plastic mixing spatula was used to give the repair compound a final “de-gassing” stir before tipping the “Mega Hippo” mixer to dispense the compound into the hole (Fig. 2.87). A short length of a wood 2 x 4 was used to spread and

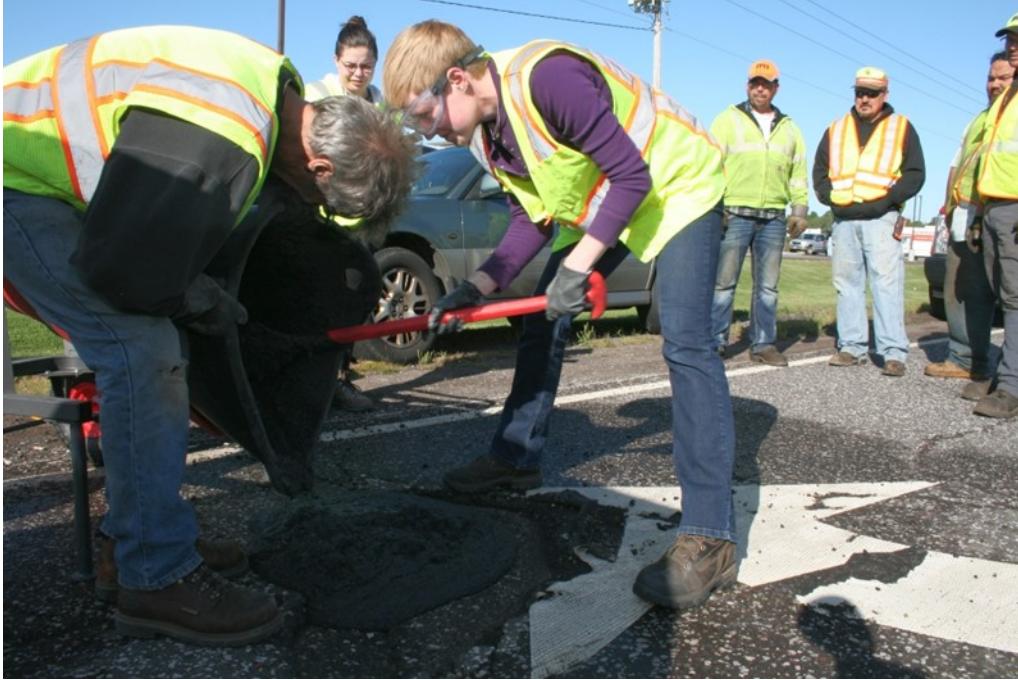
Figure 2.86 Dispensing the repair compound into the pothole at the U.S. Highway 53 field trial location.

level the compound, and a metal mortar spatula was used to smooth the repair's surface (Fig. 2.88). The repair began to set within 6 minutes of initial mixing and likely could have accepted traffic in about 10 minutes. Photographs taken with a thermal imaging camera before (Fig. 2.89A) and after (Fig. 2.89B) placing the repair compound to illustrate the exothermic nature of the reaction. The surface temperature of the repair compound at the time the image was taken had risen by 13.2 ° C (23.8 ° F), to 29.1 ° C (84.4 ° F).

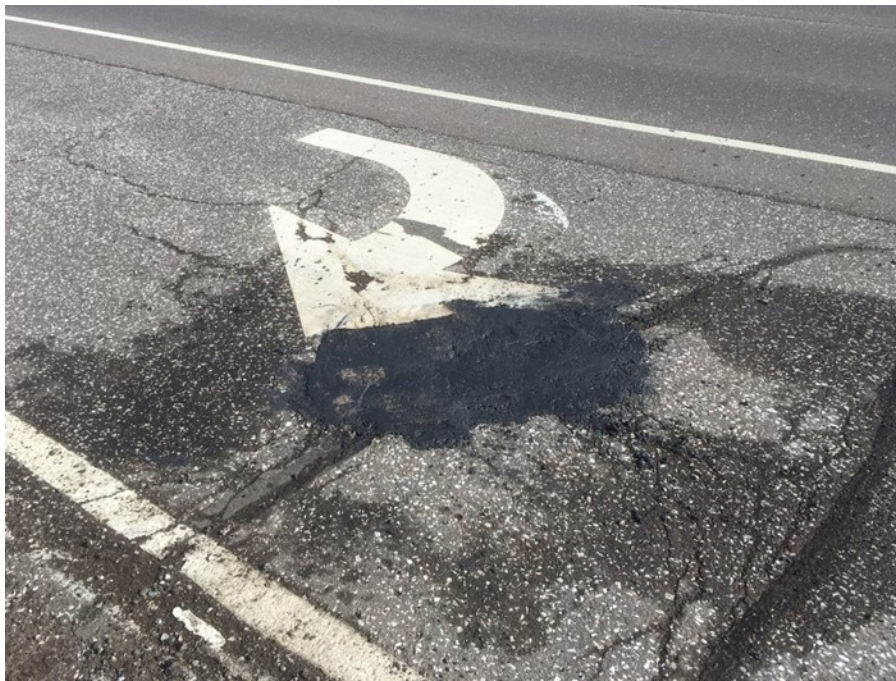
Figure 2.89 Completed repair at the U.S. Highway 53 field trial location (August 29, 2019).

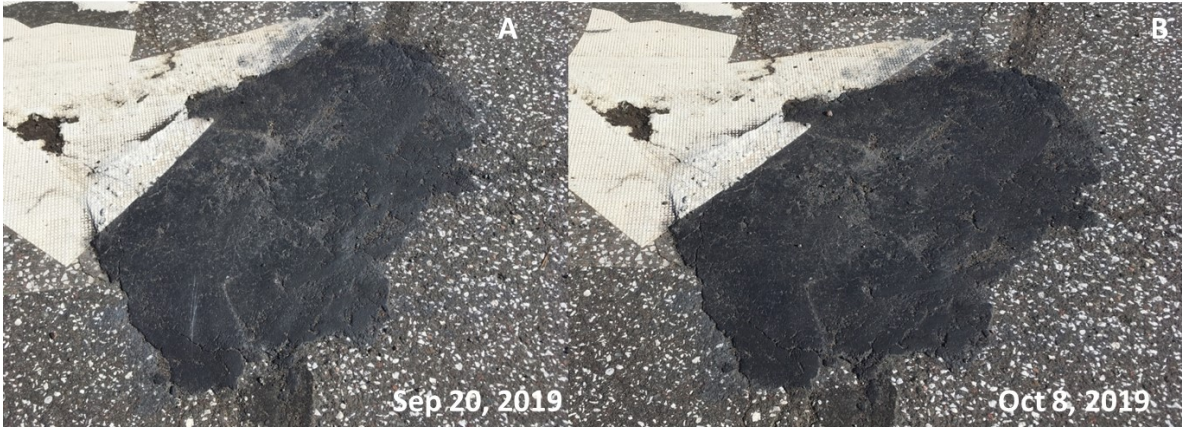
The finished August 29, 2019 repair is shown in Figure 2.90. The condition of the repair is shown on September 20 (Fig. 2.91A) and October 8, 2019 (Fig. 2.91B). The NRRI will continue to monitor and document the condition of the repair beyond the completion of this project.

Figure 2.90 Follow-up photographs of the August 29, 2019, U.S. Highway 53 field trial repair on September 20, 2019 (A) and October 8, 2019 (B).

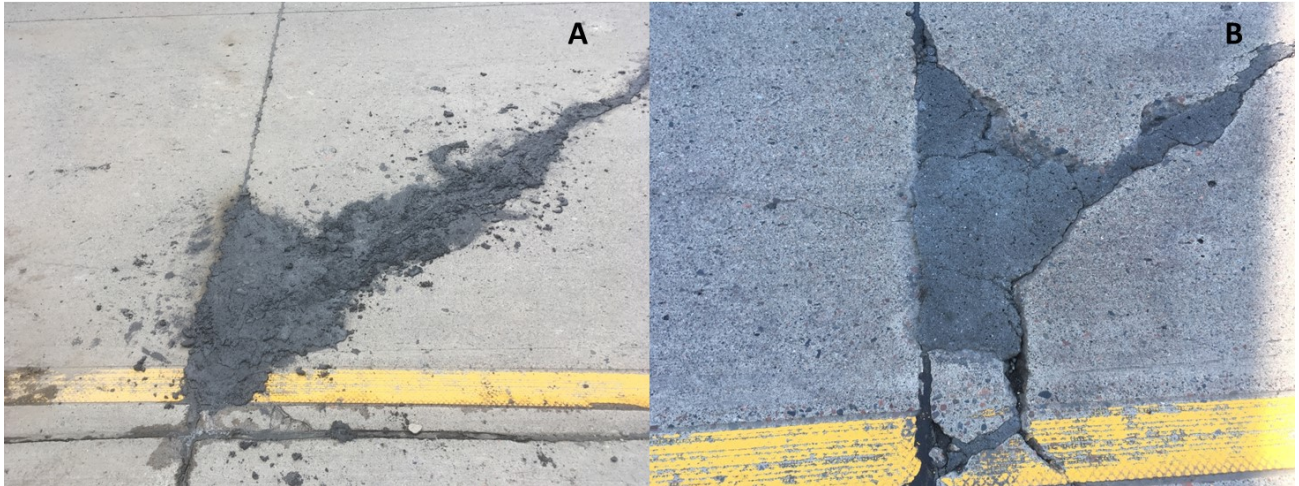
Figure 2.95 shows the finished repair on August 29, 2019 (Fig. 2.95A) and the condition of the repair as of October 8, 2019 (Fig. 2.95B). The roadway’s heavy traffic has worn away excess repair material that thinly coated the pavement. The NRRRI will continue to monitor and document the condition of the repair beyond the completion of this project.

Figure 2.94 Finished repair at U.S. Highway 2 and I-35 Thompson Hill field trial location on August 29, 2019 (A); and repair as of October 8, 2019 (B).
