Optimized Taconite-Based Pavement Repair Compound and Deployment System

Lawrence Zanko, Principal Investigator
Natural Resources Research Institute
University of Minnesota-Duluth

December 2019

Research Project
Final Report 2019-46

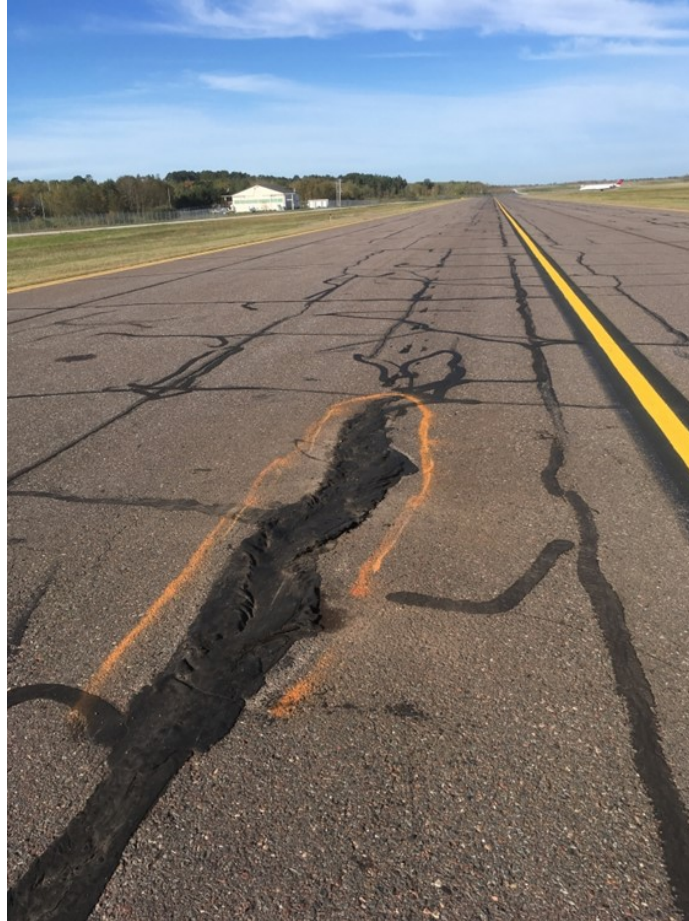
On September 27, 2019, NRRI project investigators met with DAA personnel to inspect and discuss potential repair options. Two pavement distresses in the taxiway’s HMA pavement were examined, measured, and photographed. The larger was chosen for repair. The previous repair had been done with mastic, which was debonding from the pavement (Fig. 2.98). DAA maintenance personnel prepared the pavement distress by removing the loose mastic, blew out debris with compressed air, and drove out excess moisture with a propane torch (weed burner). The DAA also provided cleanup water for tools and a generator to power the “Mega Hippo” mixer.

Figure 2.97 Target pavement distress and condition of mastic repair on airport taxiway (September 27, 2019).

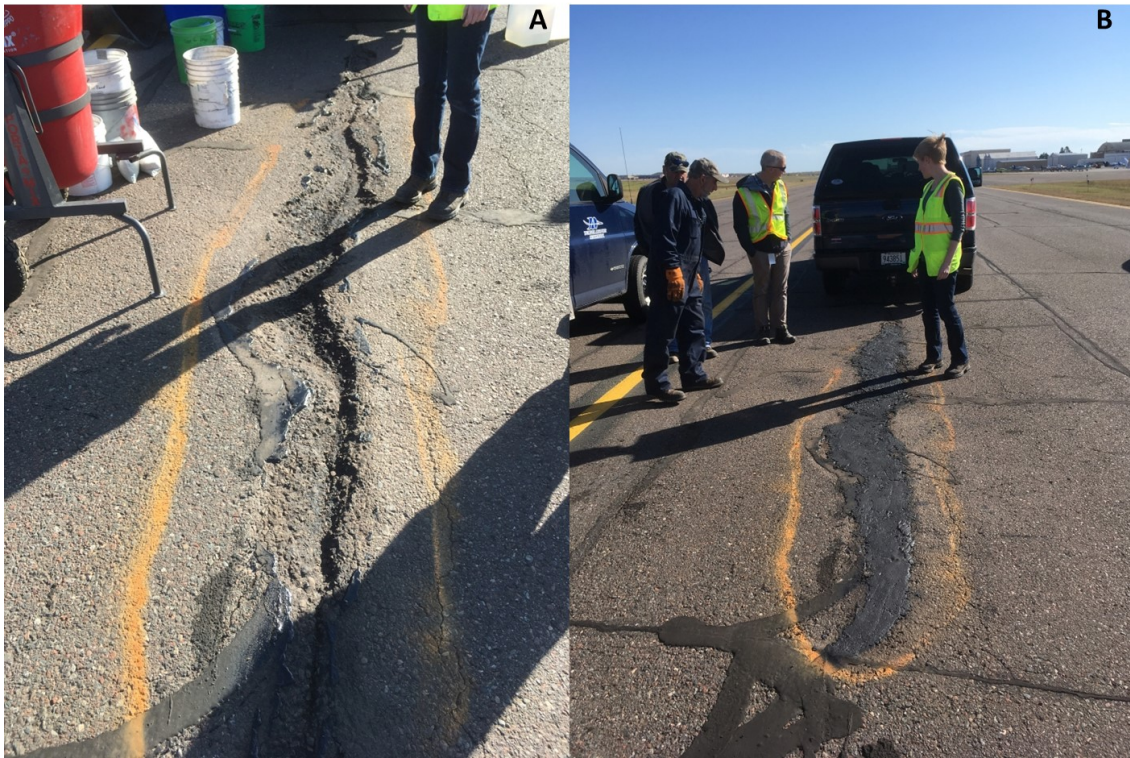
Figure 2.98 Duluth Airport Authority taxiway repair before (A) and after (B); October 8, 2019.

The NRRI performed the repair, using 120 lb of repair compound and 21.6 lb of liquid activator (18% of 120 lb). An initial 80-lb batch filled 2/3 of the distress, and a second 40-lb batch filled the remaining 1/3. The same repair compound used for the August 29 MnDOT repairs was used for the taxiway repair. Again, the compound was comprised mostly of taconite materials and small quantities of two supplemental mineral components, plus an additive that appears to provide additional tensile strength to the final repair; this additive was pre-mixed with the liquid activator.

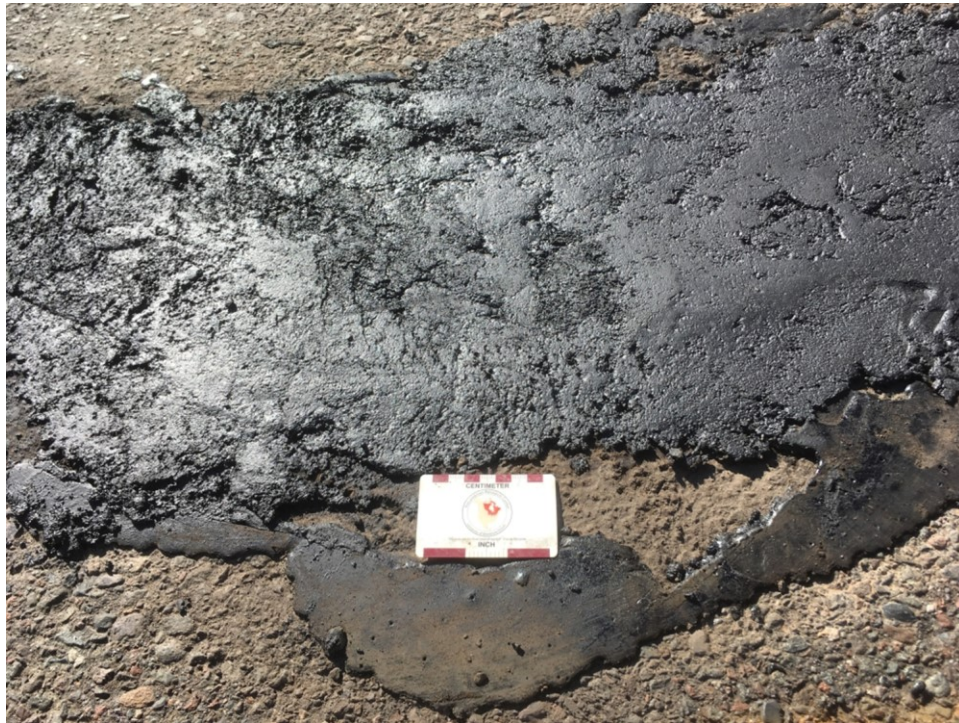
Figure 2.99 Closeup of finished taxiway repair and adjacent mastic.

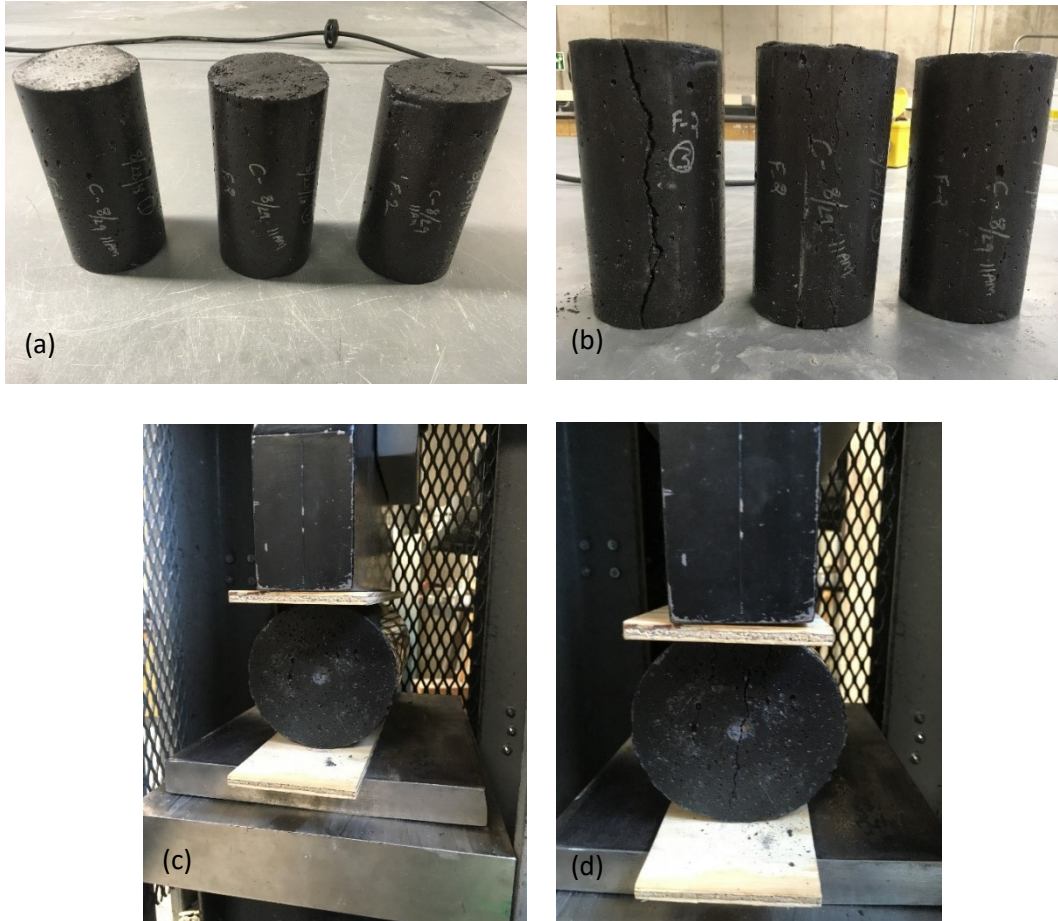
Figure A3. Pictures of typical samples before and after testing (a) Samples (F-2) before testing (b) Samples (F-2) after testing (c) Loaded sample before the test (d) Failed sample after the test.

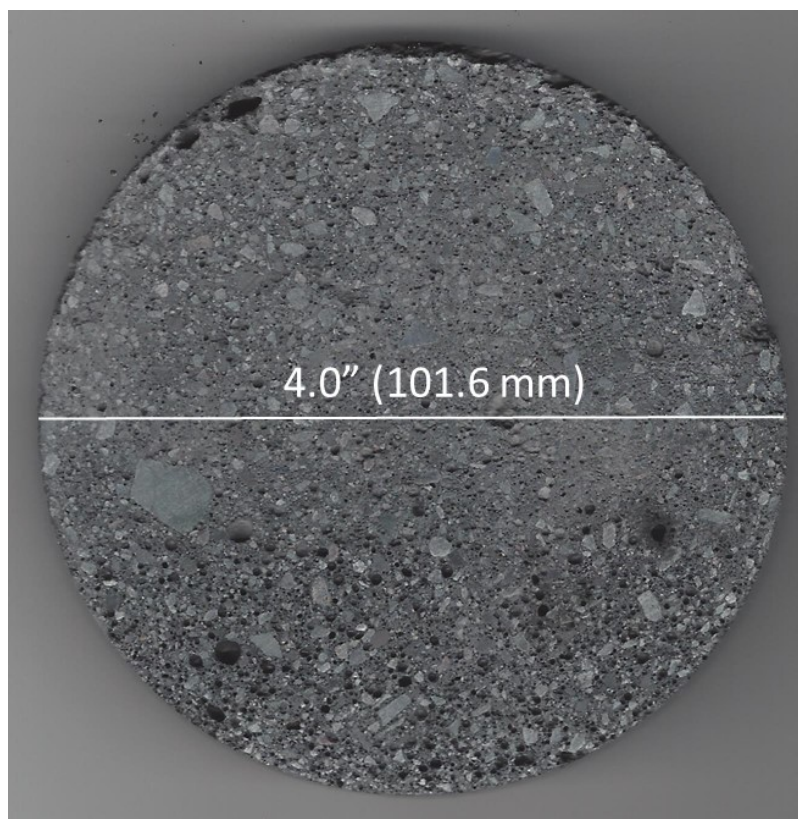
The road repair compound’s “built-in” air-entrainment could be a positive attribute relative to freeze-thaw resistance. However, strength can be compromised if the percentage of air voids is too high. Figure B2 is a photograph of a diamond-sawn section of a 4-in cylinder, showing the air/gas voids as well as the distribution of taconite aggregate.

Figure B2. Photograph of a diamond-sawn section of a 4-in cylinder.

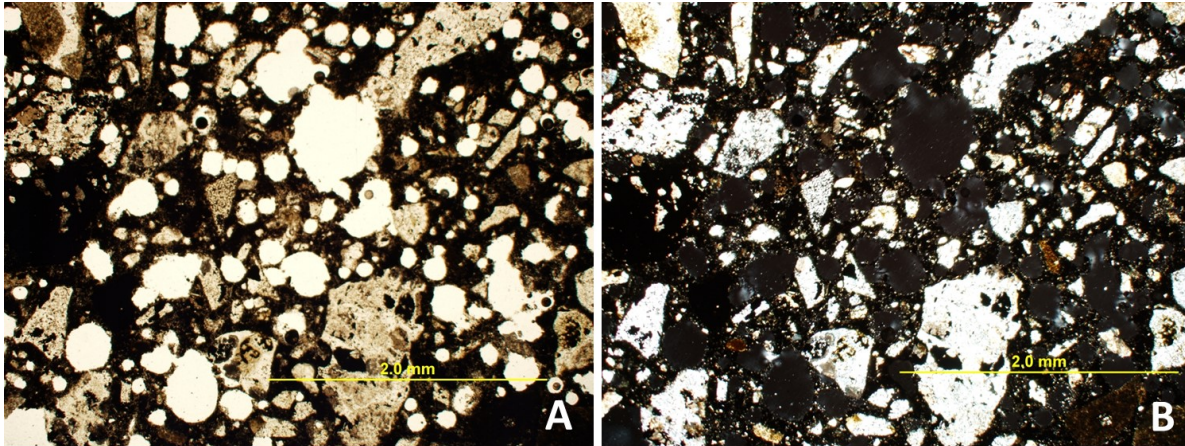
Figure B3 (A and B) is a photomicrograph showing the air voids on a microscopic scale. The image on the left (Fig. B3A) is viewed with simple transmitted light, in which the air voids show as generally rounded and bright white. The image on the right (Fig. B3B) is the same slide, but with viewed with polarized light. The air voids show as correspondingly dark gray to black. A 2 mm scale bar is included in both images.

Figure B3. Photomicrograph showing air voids on a microscopic scale, shown with transmitted light on left (A) and polarized light on the right (B).
