CONDITION ASSESSMENT OF THE MASTS OF HIGHLANDER SEA

November 2006
Project No. 187-2419
NRRI/TR-2006/24

Prepared for:
Captain Micah David Faust-Allnutt
Highlander Sea, Inc./Acheson Ventures
2336 Military St.
Port Huron, MI 48060

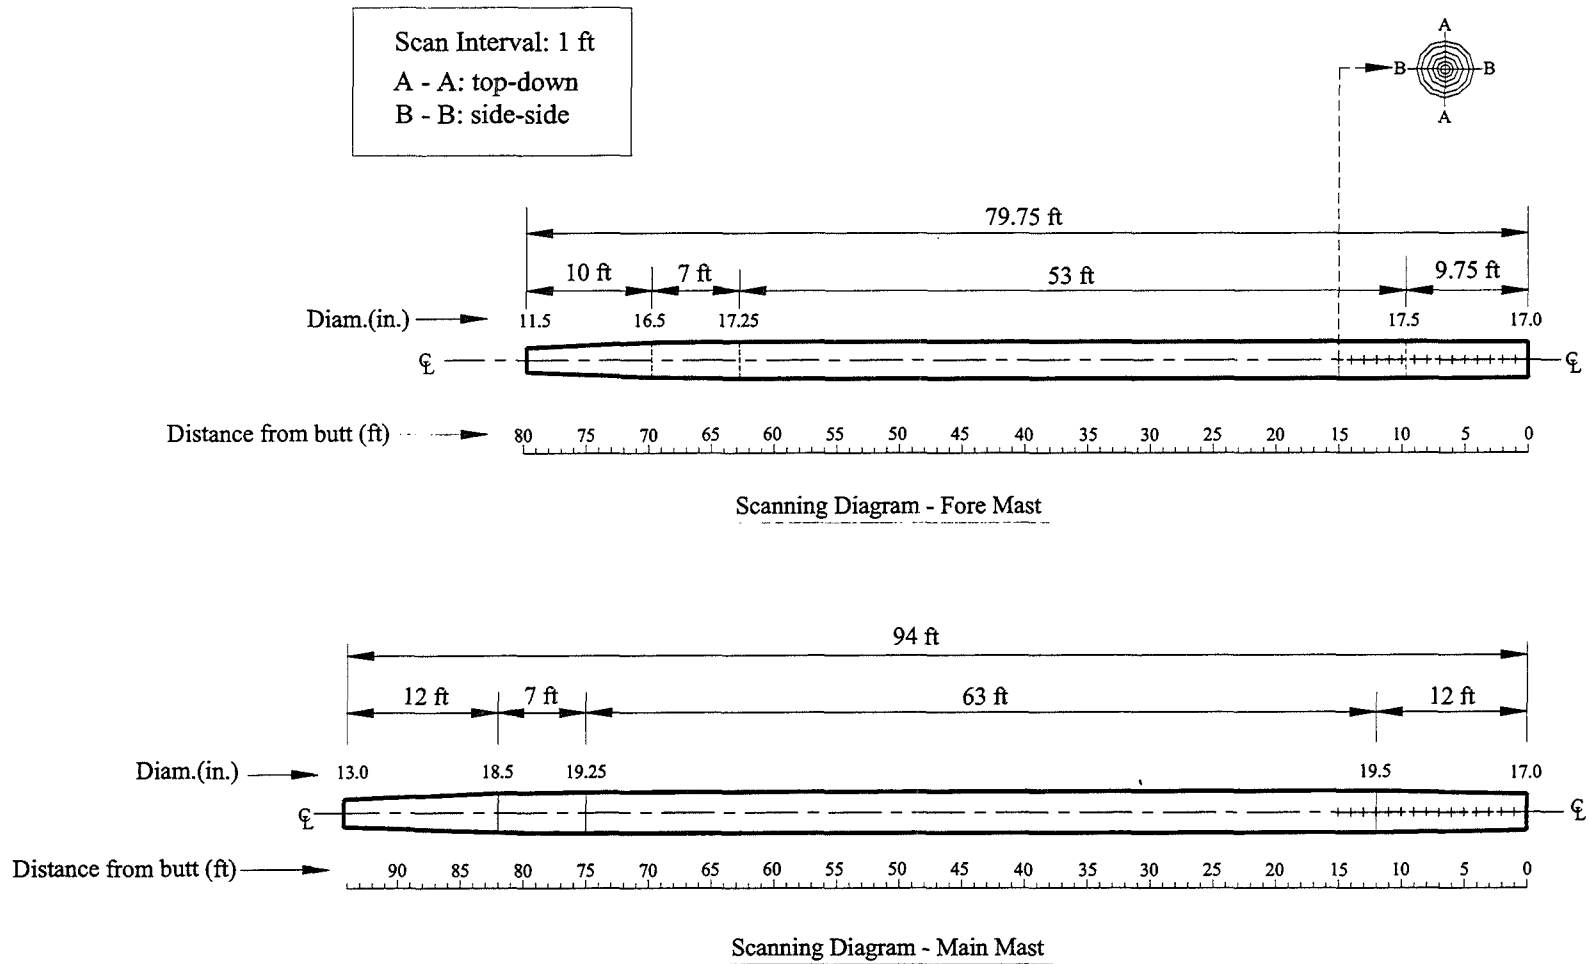
Figure 2. Diagram of stress wave scanning on the masts.

A stress wave scanning diagram was created assigning identification numbers to each scanning point in the masts (Figure 2). Stress wave scanning was performed on the masts using a Fakopp Microsecond Timer, with an interval of 1 ft between two scanning points. At each scanning point, measurements were conducted in two directions, A-A: top-down (vertical); B-B: side-side (horizontal).
