**Vol 2**

**COUNTERMEASURES TO PROTECT BRIDGE PIERS  
FROM SCOUR**

**FINAL REPORT**

**NCHRP 24-7**

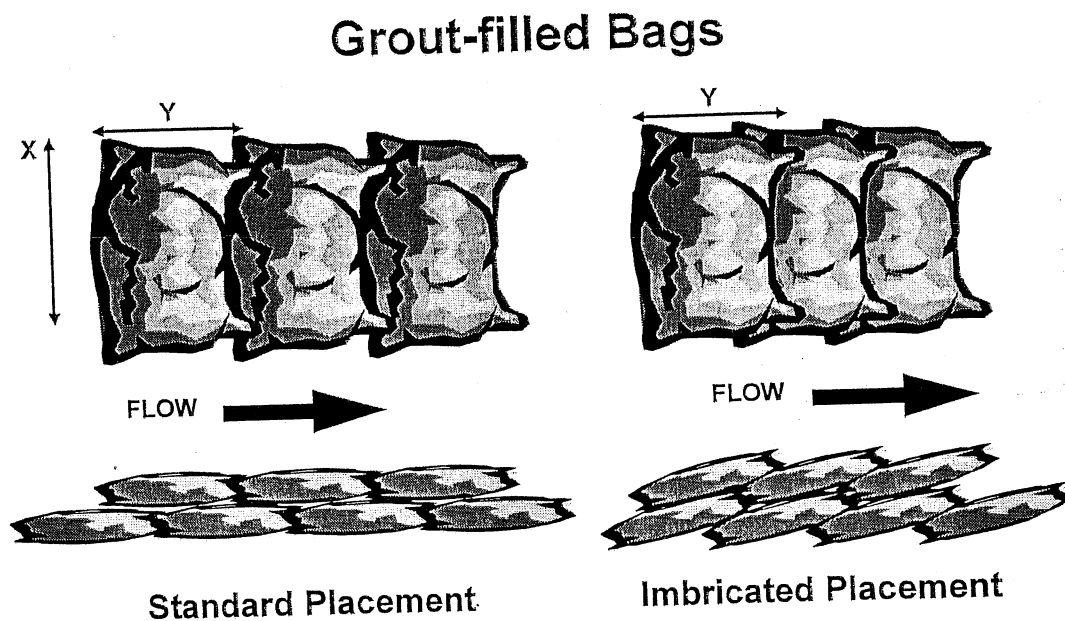
Concrete-filled bags are fabric shells that are filled with concrete (Figure 2.16). They thus represent a kind of artificial riprap. One version, the grout filled mat is a single, continuous layer of fabric with pockets, or cells that can be filled with concrete. Grout filled bags are smaller units that can be stacked in a manner reminiscent of riprap. Sacked concrete can be rapidly deployed, especially in smaller streams. As an alternative to riprap, it can be cost-effective where riprap is not readily available, procurement is delayed or where environmental restrictions prohibit the use of riprap.

Figure 2.16. Grout filled bags.

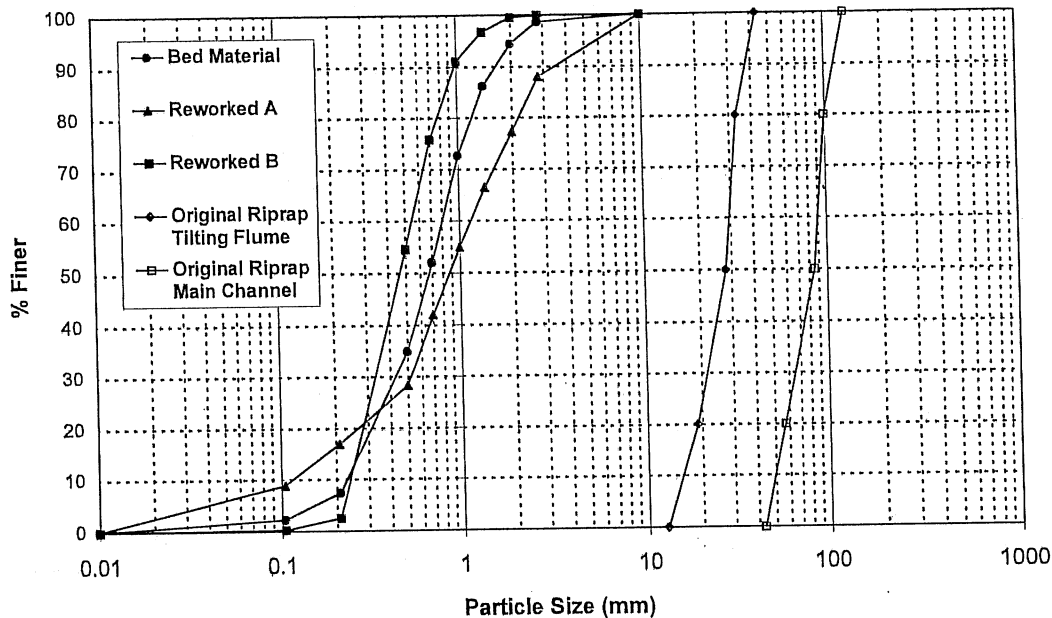
The ambient bed sediment was sized in order to allow for modeling of fairly typical sand-bed streams. The grain size distribution of the sand as installed is given in graphical form (Figure 3.5) and in tabular form (Table 3.2). In the course of the experiments a finer portion of this mix washed out, resulting in the somewhat coarser reworked distribution A of the same figure and table. The  $d_{50}$  size, for example, increased from about 0.7 mm to about 0.87 mm. Subsequently, a small but steady supply of 0.4 mm sediment from the Mississippi River caused the sediment to eventually become finer, according to reworked distribution B. The median size  $d_{50}$  for this distribution was near 0.50 mm, which was taken as characteristic of all the SAFL runs.

Figure 3.5. Grain size distributions of the sediment and riprap.

In general, the sediment is graded, with significant content between 0.2 and 4 mm. The size distribution is within the typical range for sand-bed streams. The specific gravity of the sand is close to 2.65.

Riprap was constructed from the same highly angular crushed limestone quarry run that is commonly used as riprap by the Minnesota Department of Transportation. This material has a specific gravity close to 2.7. Sizing was done using the relations of Parola (1991) and Quazi and Peterson (1973). The original size distribution is given in graphical form in Figure 3.5, and in tabular form in Table 3.3a (Main Channel) and Table 3.3b (Tilting Flume); the median riprap size  $D_{r50}$  was 3.1 in (79.5 mm) and 1.1 in (26.9 mm), respectively. It was found that this original distribution was too coarse to allow for consistent failure due to entrainment at the highest flows of the experiments. In order to ensure that this condition could be studied, the riprap was reconstituted using the finer two-grain size ranges in each case. The reconstituted median size of the riprap,  $D_{r50}$ , was 2.1 in (53.8 mm) in the Main Channel and 0.85 in (21.6 mm) in the Tilting Flume. The first two sets of experiments on riprap in the Tilting Flume were done using the original coarse riprap; the rest were done using the modified riprap. All of the riprap experiments in the Main Channel were done using the modified riprap. More details concerning the selection of experimental riprap size are given in the section, Run Protocol.

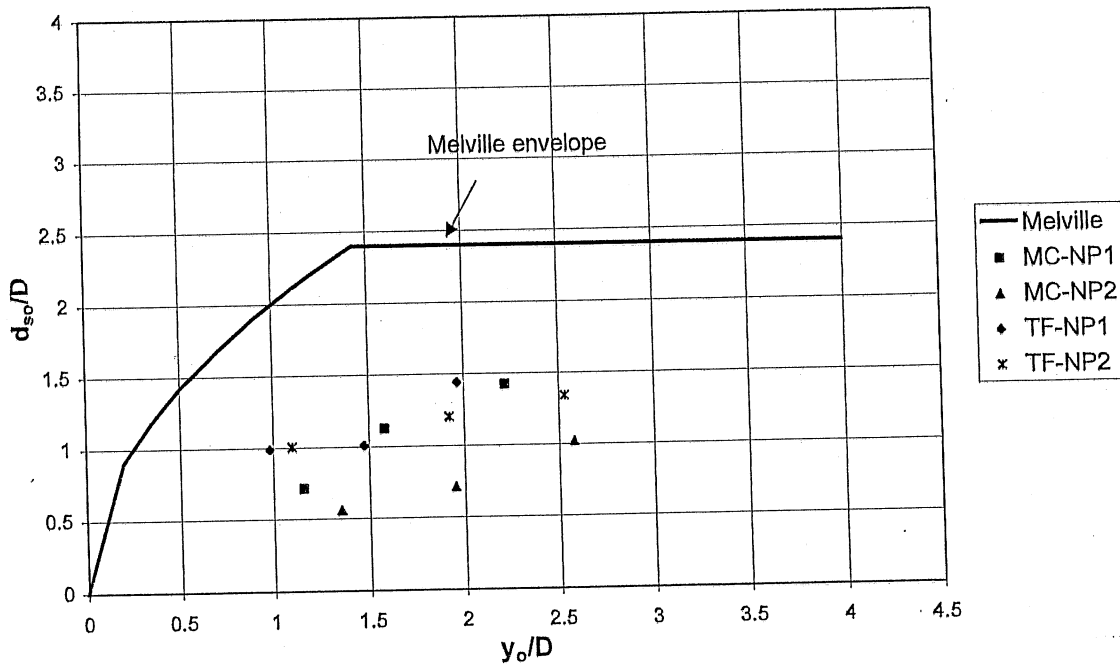
Figure 3.6a. Results for unprotected scour at circular piers.

Melville (1997) provides a set of relations for predicting an envelope of maximum scour depth as a function of a variety of parameters. A perusal of those relations suggests that for each pier type (circular and rectangular) the only parameter that should limit the envelope from achieving its maximum values of dimensionless scour depth  $d_{so}/D$  in the absence of protection of 2.4 (circular pier) and 2.64 (rectangular pier) should be the ratio of depth to pier width  $y_o/D$ . Figures 3.6a and 3.6b show plots of  $d_{so}/D$  versus  $y_o/D$  for the circular and rectangular pier data, respectively. Also shown are the envelopes due to Melville.

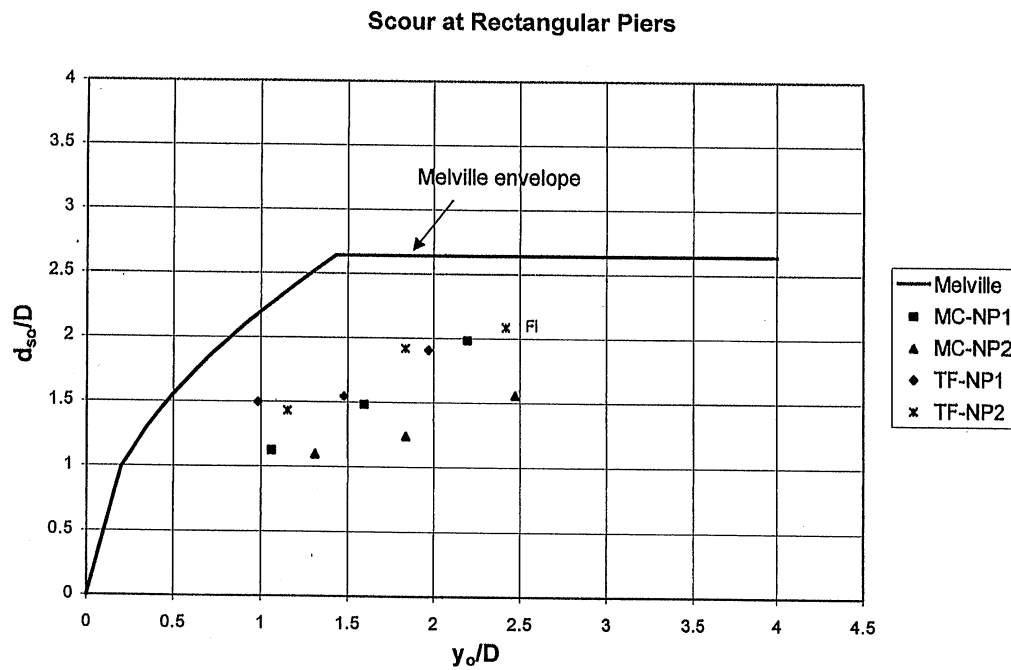
Figure 3.6b. Results for unprotected scour at rectangular piers.

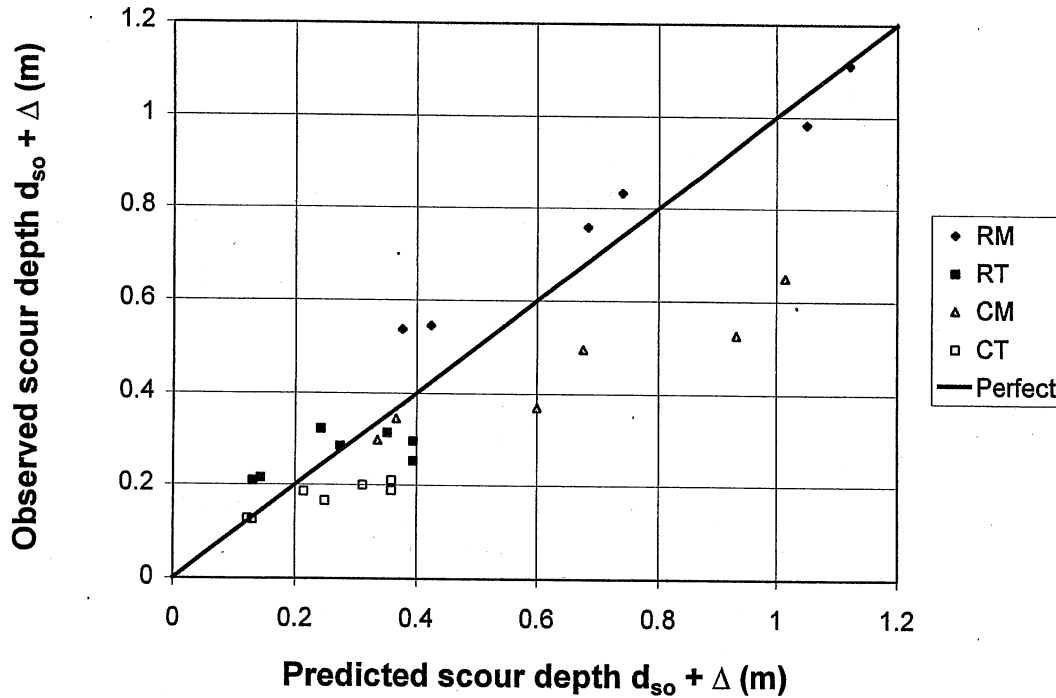
The unprotected scour depth  $d_{so}$  as defined at the beginning of this chapter represents the maximum average scour depth below the mean elevation of the bed. This is the appropriate value to use in the Melville (1997) formulation. The Colorado State University predictor for maximum scour depth at unprotected piers is given in HEC-18 (Richardson et al., 1992). The scour depth it predicts is not  $d_{so}$ , but rather  $d_{so} + \Delta$ , where  $\Delta$  denotes bedform height. This parameter can be computed from the values of  $d_{so}$  in Tables 3.9a – 3.10d and the dune heights given in Table 3.12. A comparison of the data against the Colorado State University predictor is given in Figure 3.6c. In that figure RM denotes the rectangular pier in the main channel, RT denotes the rectangular pier in the tilting flume, CM denotes the circular pier in the main channel and CT denotes the circular pier in the tilting flume. The comparison between the observed and predicted values is generally good, but scour depths are overpredicted in the case of the

Figure 3.6c. Comparison of the data for unprotected scour with the Colorado State University predictor.

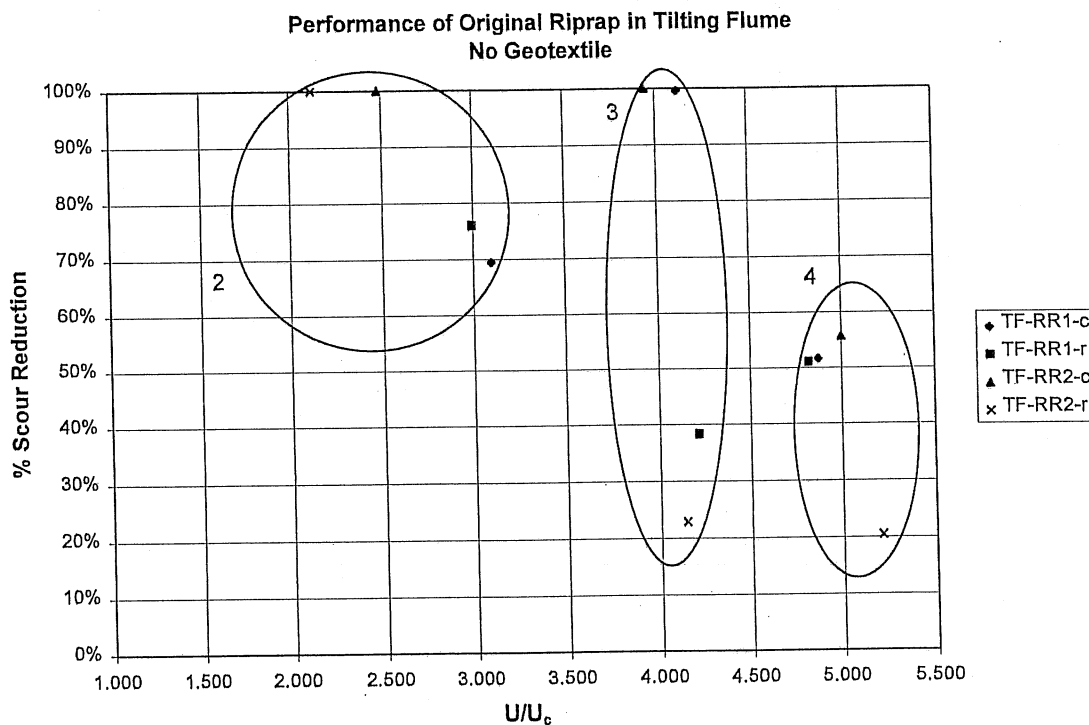
**Figure 3.12.** Performance of the riprap in series TF-RR1 and TF-RR2. In the legend, "c" denotes the circular pier and "r" denotes the rectangular pier.

Significant degradation of scour protection offered by riprap was thus observed in these runs even though the riprap layer never failed by entrainment. This is illustrated in Fig. 3.12. In the figure all of the results corresponding to the conditions of Run 2 (3, 4) have been enclosed with an ellipse and numbered 2 (3, 4) for ease of identification. This format is preserved in similar figures in this section of the report. In order to interpret this and similar figures, the following qualitative criteria are used.

In the case of the circular pier, the riprap performance is seen to be acceptable or marginal at Run 2, acceptable at Run 3 and marginal verging on unacceptable at Run 4. In the case of the rectangular pier, the performance is acceptable at Run 2, unacceptable at Run 3 and marginal or unacceptable at Run 4. Especially in the case of the rectangular pier, the countermeasure can be said to have failed even though the riprap never raveled catastrophically in response to the flow.

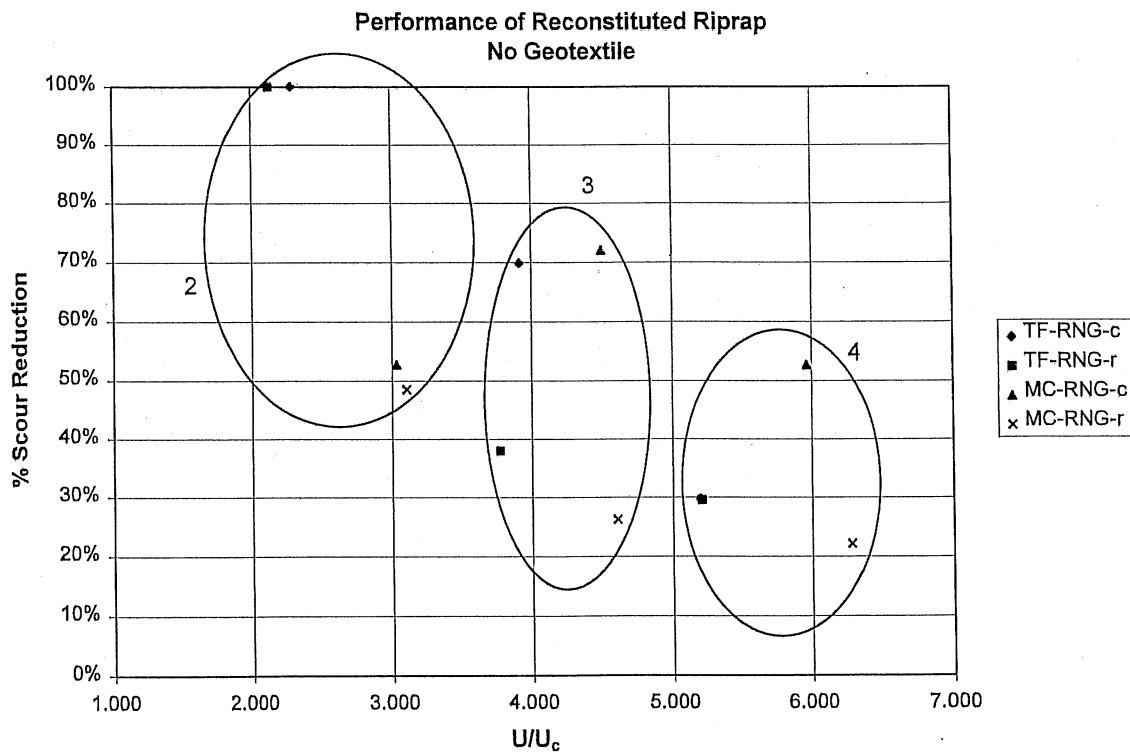
**Figure 3.13.** Performance of the riprap in series MC-RNG and TF-RNG.

The results of the tests are shown in Tables 3.15 a and 3.15b for the Main Channel and 3.16a and 3.16b for the Tilting Flume. They are also shown graphically in Figure 3.13.

It is quickly apparent from the tables and figure below that at the conditions of Run 4 the riprap was offering very little protection. That is, in the case of the rectangular pier the scour reduction was only 22% in the Main Channel and 30% in the Tilting Flume. In the case of the circular pier the corresponding values are 53% in the Main Channel and 30% in the Tilting Flume. At this condition the riprap was observed to have failed by direct entrainment into the flow, as expected.

The performance of the riprap should then be judged based on the results of Runs 2 and 3. In the case of Run 2, some degradation of riprap performance is already evident. By Run 3 the performance is quite unacceptable in the case of the rectangular pier, with little scour protection being provided. The results are better in the case of the circular pier, where the performance is at the border between acceptable and marginal. It is suggested here that the results for the rectangular pier be accepted as definitive, as dune height was more developed at the rectangular pier.

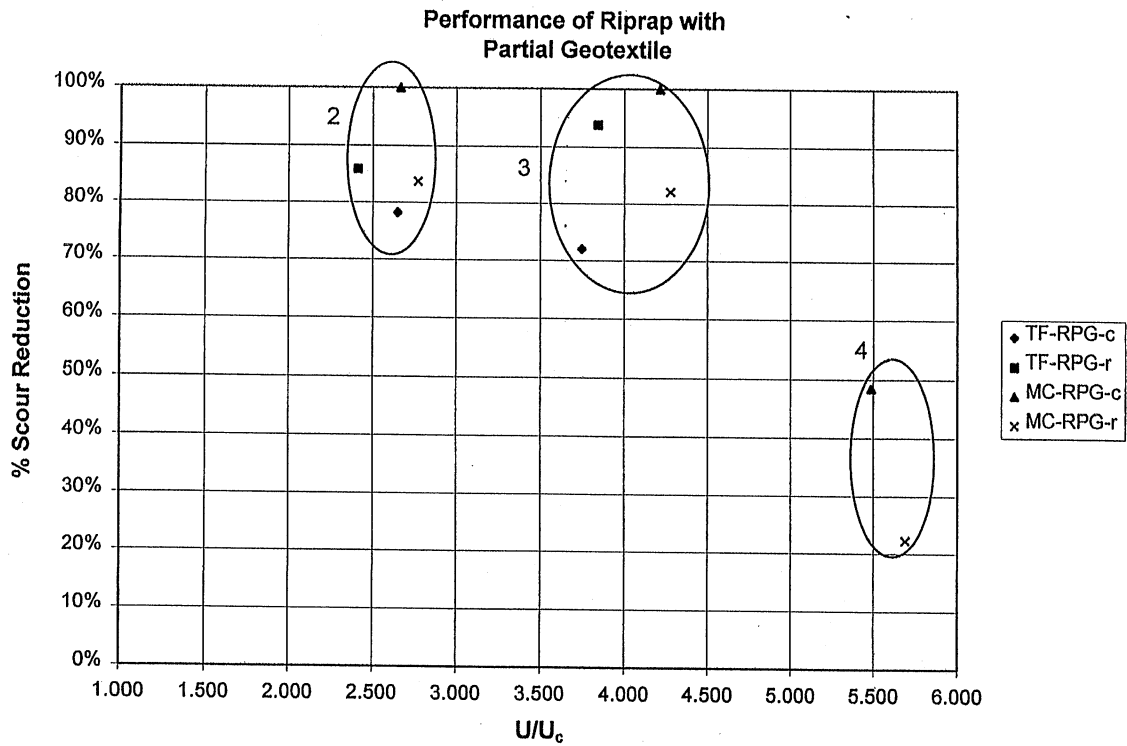
**Figure 3.18.** Performance of the riprap with partial geotextile for series MC-RPG and TC-RPG.

The performance of this countermeasure is documented in Tables 3.18a and 3.18b in the case of the Main Channel and Tables 3.19a and 3.19b in the case of the Tilting Flume. The results are documented graphically in Figure 3.18.

The improvement in performance as compared to the corresponding runs without a partial geotextile, i.e. series MC-RNG and TF-RNG is dramatic. Performance is in the acceptable range for all experiments at the conditions of Run 2 and Run 3. The failure of the countermeasure at Run 4 was caused by the expected mobilization of the riprap at that flow. The good performance is further documented in Figures 3.19a – 3.19c, which show the rectangular pier in the Main Channel at the end of Run 3. The layer of riprap around the pier is seen to be essentially intact. Excavation into the sand on the upstream face and one lateral face of the pier reveals how edge failure of the riprap has securely anchored the geotextile in place. In Figure 3.19c the placement of the three vertical rulers serves to illustrate this. The vertical ruler nearest the pier denotes the lateral position of the outer edge of the geotextile. The vertical ruler in the middle denotes the outer position of the riprap as placed. The outer vertical ruler denotes the outer edge of the riprap after settling.

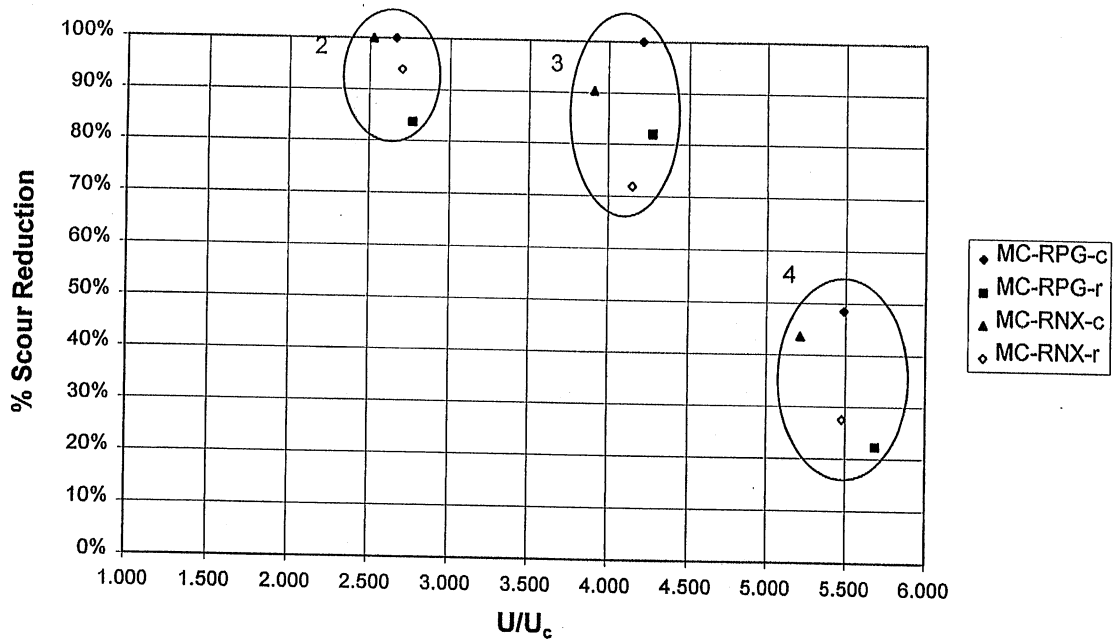
**Figure 3.23.** Performance of the dumped riprap with partial geotextile for series MC-RNX as compared to the case with prior excavation, series MC-RPG.

The results of the experiments are shown in Tables 3-20a and 3-20b. The percent scour reduction is compared with the results of series MC-RPG, i.e. the corresponding series in the Main Channel with excavation before installation, in Figure 3.23. In the case of Runs 2 and 3 the performance is seen to be quite acceptable, and almost as good as that of excavated riprap. The riprap fails due to entrainment at Run 4, as expected.

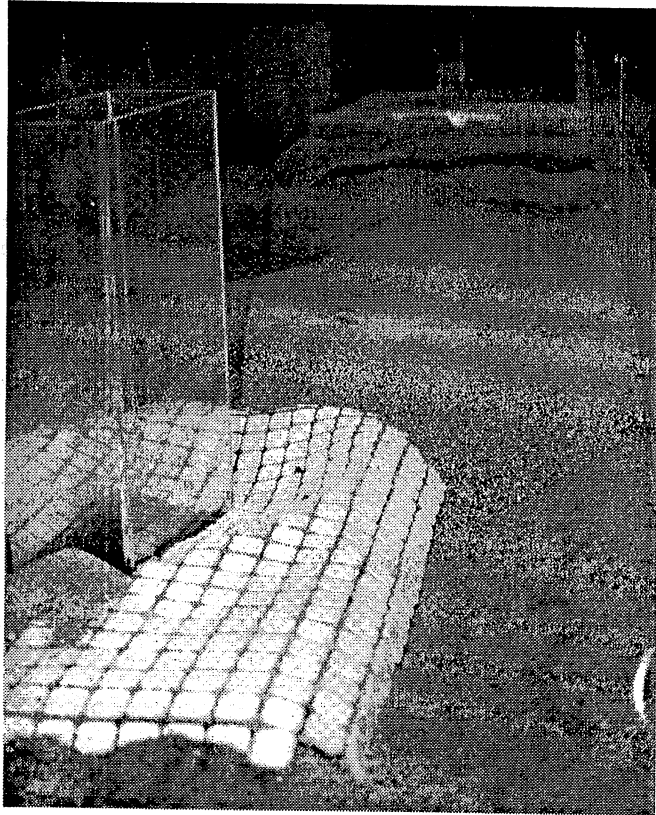
**Figure 3.29.** a) Close-up view of the cylindrical pier at the end of Run 3 of series TF-CB. The mattress of cable-tied blocks has settled, and the leading edge of a dune is passing over it. b) View of the rectangular pier at the end of Run 3 of series TF-CB.

In the absence of a geotextile, the block mattress tended to settle with the passage of dunes in a manner reminiscent of riprap without a geotextile. The primary cause of the settling appeared to be the leaching of sand from the pores of the mattress. Edge scour, on the other hand, often had the beneficial effect of helping to further bury and anchor the mattress. Views of the performance of the cable tied blocks at the end of the conditions of Run 3 are provided in Figure 3.29.

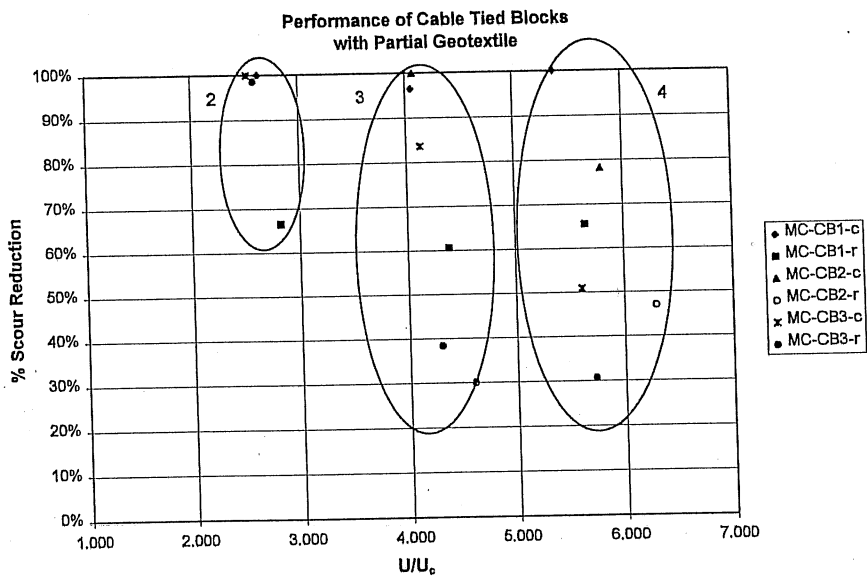
**Figure 3.35.** Comparison of the performance of cable tied blocks in the runs of series MC-CB1, MC-CB2 and MC-CB3.

The results for scour depth are presented in Tables 3.23a – 3.23f and Figures 3.34 and 3.35. In the case of the circular pier the performance of the cable tied blocks with partial geotextile was essentially flawless even under conditions of Run 4 of series MC-CB1. In the case of the rectangular pier for the same series, the performance appears as marginal in terms of  $r_s$ , with reductions in maximum scour of 66% for Run 2, 61% for Run 3 and 65% for Run 4. It can be seen, however, from Figure 3.34 that the performance of the cable tied blocks in series MC-CB1 was much better than that of TF-CB, implying that the addition of a geotextile results in a major improvement.

Both the tables and the figures document a gradual degradation of performance as the mattress is made lighter. In the case of the circular pier, the performance is always acceptable at Runs 2 and 3. In the case of the rectangular pier the performance is always unacceptable at Run 3. Under the conditions of Run 4 of series MC-CB3, incipient uplift failure was observed at the circular pier and actual uplift was observed at the rectangular pier.

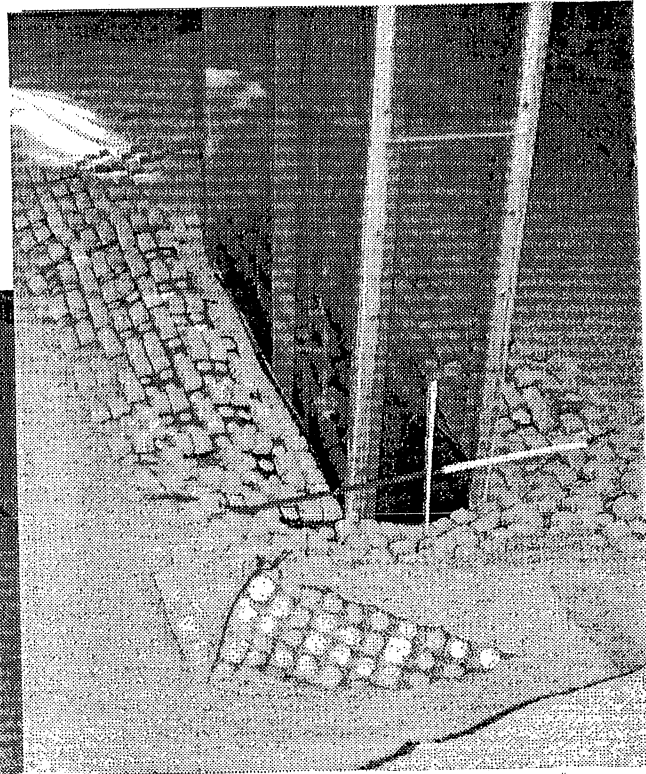
**Figure 3.38.** a) View of uplift failure at the rectangular pier at the end of Run 4 of series MC-CB3. b) Another view of the uplift failure.

Photographic documentation of the performance of the cable tied blocks is provided in Figures 3.36, 3.37 and 3.38. The first of these, taken at the end of Run 2 of series MC-CB2, documents the ability of the block mattress to anchor the geotextile. Note, however, the scour at the upstream end of the rectangular pier. This was caused by the leaching of sand from the gap between the geotextile and the pier. The second of these figures documents the state of the mattresses at the end of Run 4 of series MC-CB3. A better view of the uplift failure at the rectangular pier at the end of Run 4 of series MC-CB3 is given in the last of these figures.

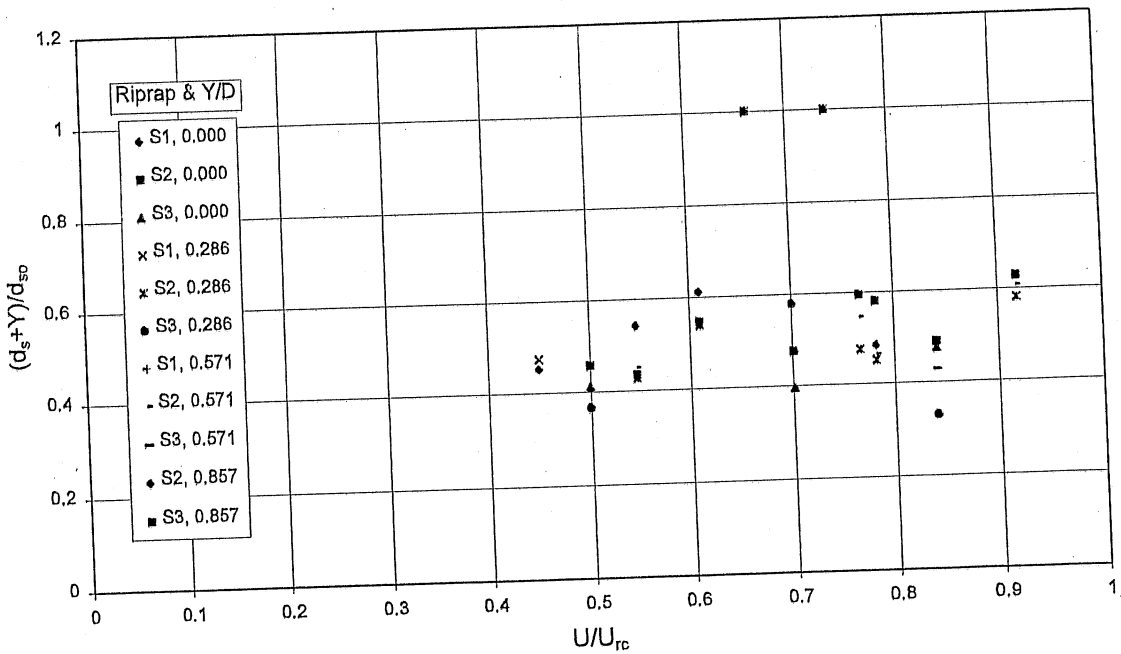
The data are plotted in Figure 4.6 to show the scour depth in the riprap measured from the undisturbed bed surface ( $d_s + Y$ ), as a function of  $U/U_c$ .  $Y/D$  values of 0.00 can be compared to data collected by Lim and Chiew (1996), who placed the riprap at the bed surface for all their experiments, and experienced a similar asymptotic trend towards a  $d_s/d_{s0}$  of 1.0 in the upper dune regime. They concluded

Figure 4.6. Depth of scour measured from the original bed surface versus  $U/U_{rc}$ . In the legend, S1 denotes the 7.8 mm riprap, S2 denotes the 16 mm riprap and S3 denotes the 22 mm riprap.

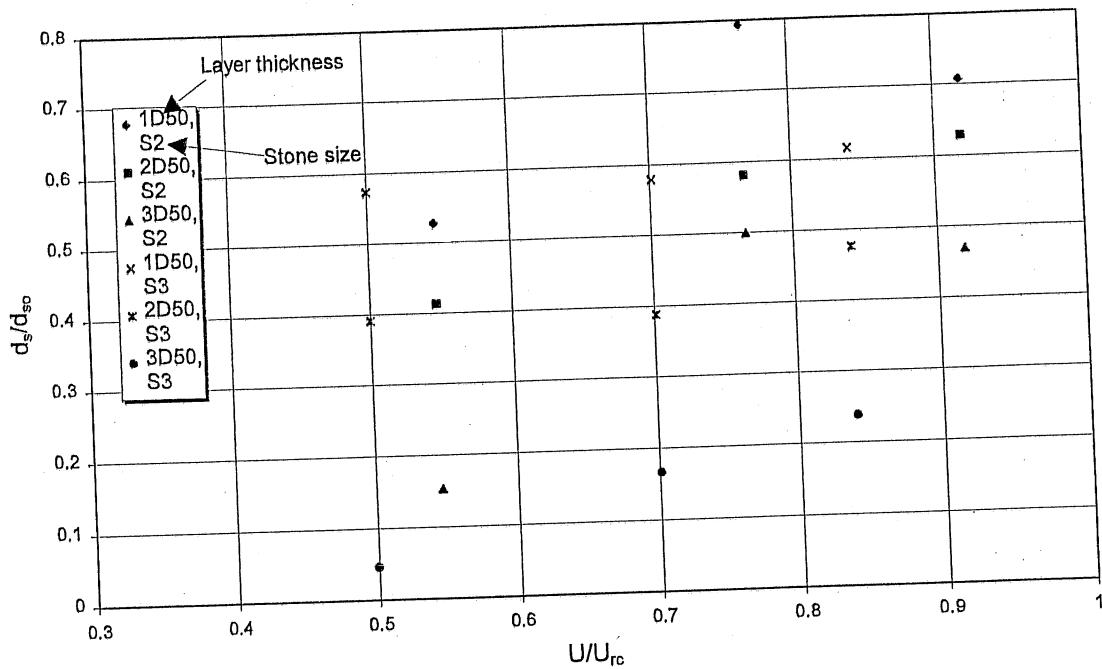
**Figure 4.9a.** Riprap protection for differing thicknesses with  $Y/D = 0$ . In the legend the notation 1D50 denotes the value  $t = 1 D_{r50}$  etc., S2 denotes 16 mm riprap and S3 denotes 22 mm riprap.

Thicker riprap layers ( $3D_{r50}$ ) resulted in less scour at the pier face under the same flow conditions as previous  $t = 2D_{r50}$  runs. A comparison of results is plotted in Figures 4.9a for  $Y/D = 0$  and 4.9b for  $Y/D = 0.286$ . The same asymptotic trend towards  $d_s/d_{s0} = 1.0$  is shown. It appears that overall the scour reduction experienced in the  $3D_{r50}$  layers is similar for all flow conditions tested and the result of this is that the range of flow conditions suitable for each particular stones size is extended. Figures 4.8a and 4.8b illustrate schematically the failure of  $3 D_{r50}$  and  $1 D_{r50}$  thick riprap layers, respectively.

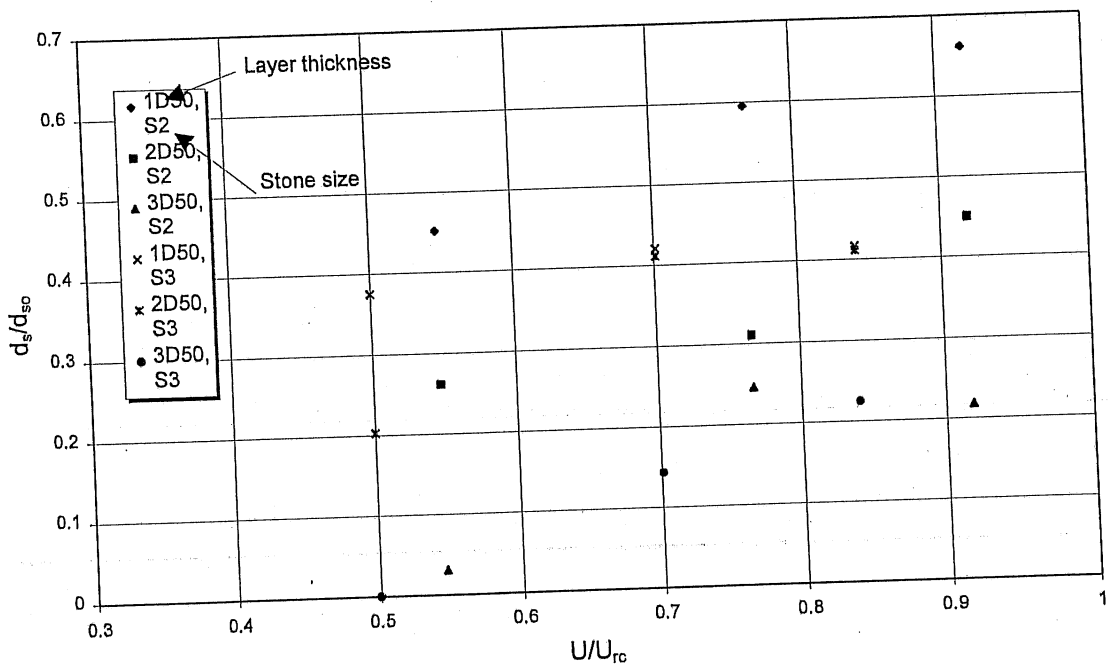
**Figure 4.9b.** Riprap protection for differing thicknesses with  $Y/D = 0.286$ . In the legend the notation 1D50 denotes the value  $t = 1 D_{r50}$  etc., S2 denotes 16 mm riprap and S3 denotes 22 mm riprap.

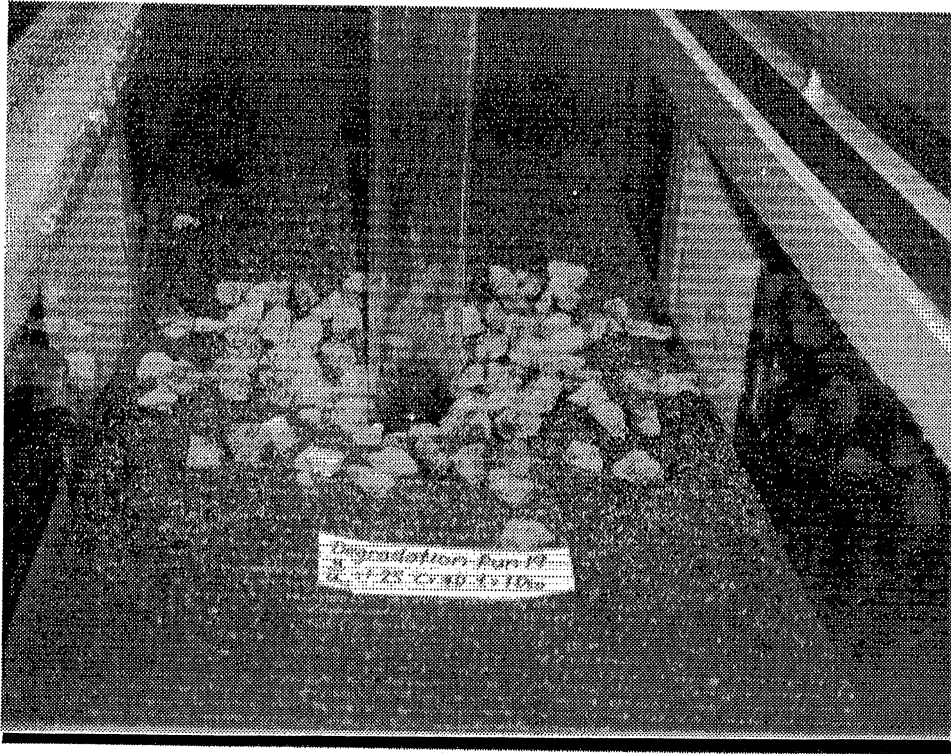
**Figure 4.18.** View of the sediment bed following a typical degradation experiment.

The sudden increase in scour depths coincides with a rapid change in riprap layer thickness as noted previously. In Run 4 the initial scour development and gradual increase could be due to the presence of an increased amount of finer material beneath the layer, especially against the pier. Figure 4.18 shows the sediment bed following a typical degradation experiment.

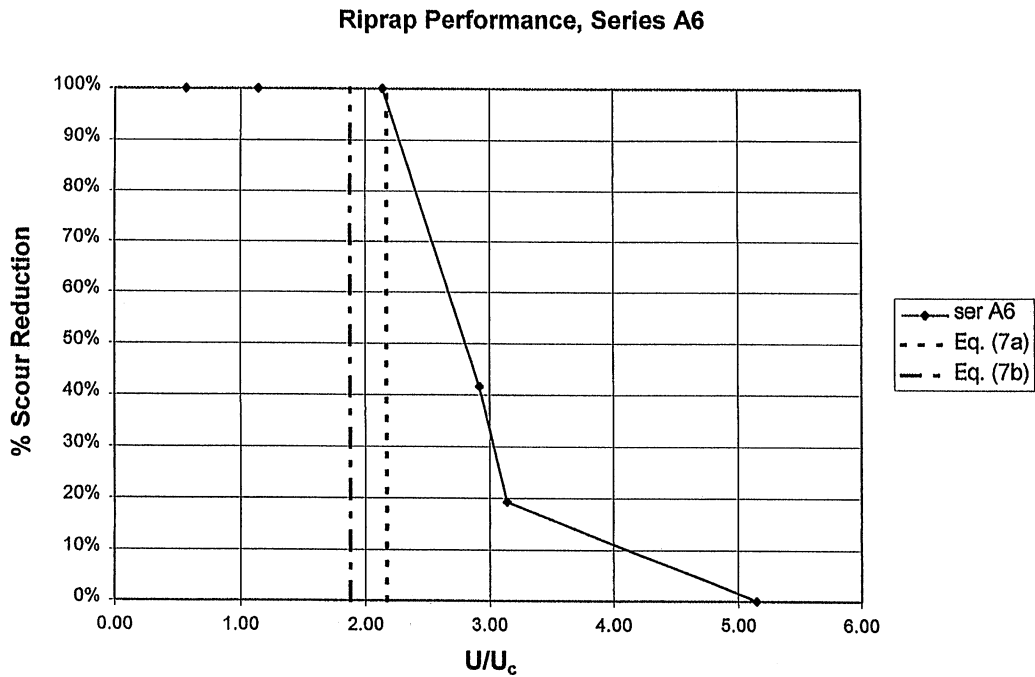
**Figure 5.5.** Riprap performance for series A6. The vertical lines denote values of  $U_r/U_c$  from Eqs. (3.7a) and (3.7b).

Results concerning scour depths are best presented in the groups of Table 5.4, as the experiments within each grouping have common values of  $U_{rc}/U_o$ . These are presented in Figures 5.2 – 5.7 below, in which the percent scour reduction  $r_s$  is given as a function of  $U/U_o$ . Also given in each of these figures is the value of  $U_{rc}/U_o$  associated with riprap failure from Eqs. (3.7a) and (3.7b).

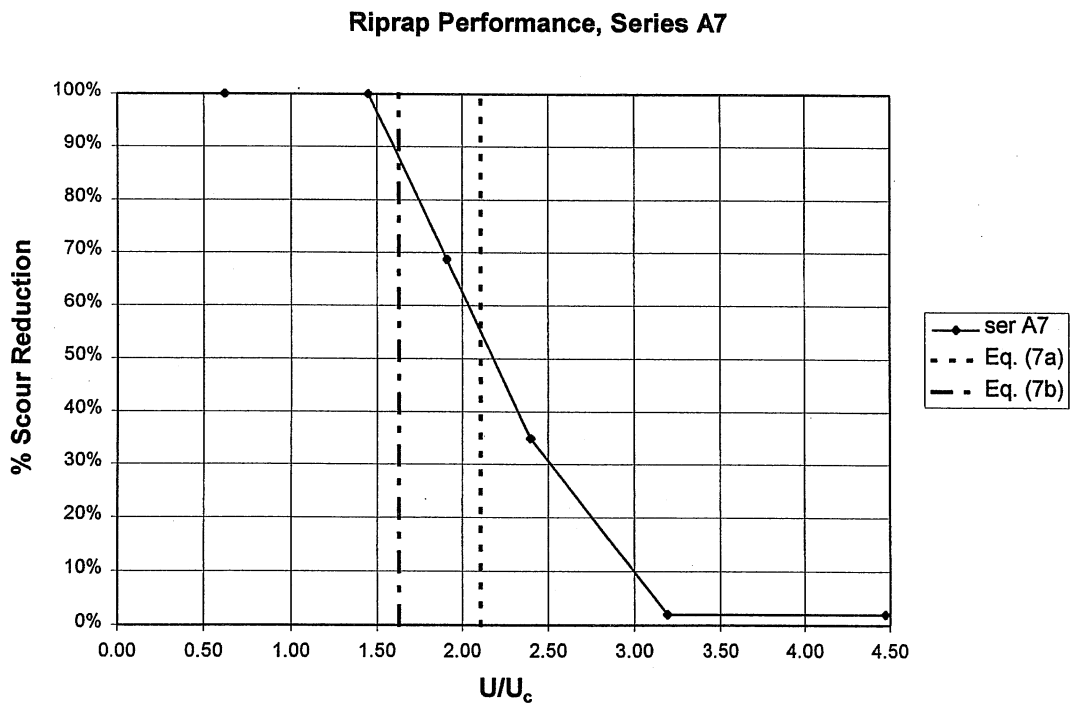
**Figure 5.6.** Riprap performance for series A7. The vertical lines denote values of  $U_r/U_c$  from Eqs. (3.7a) and (3.7b).

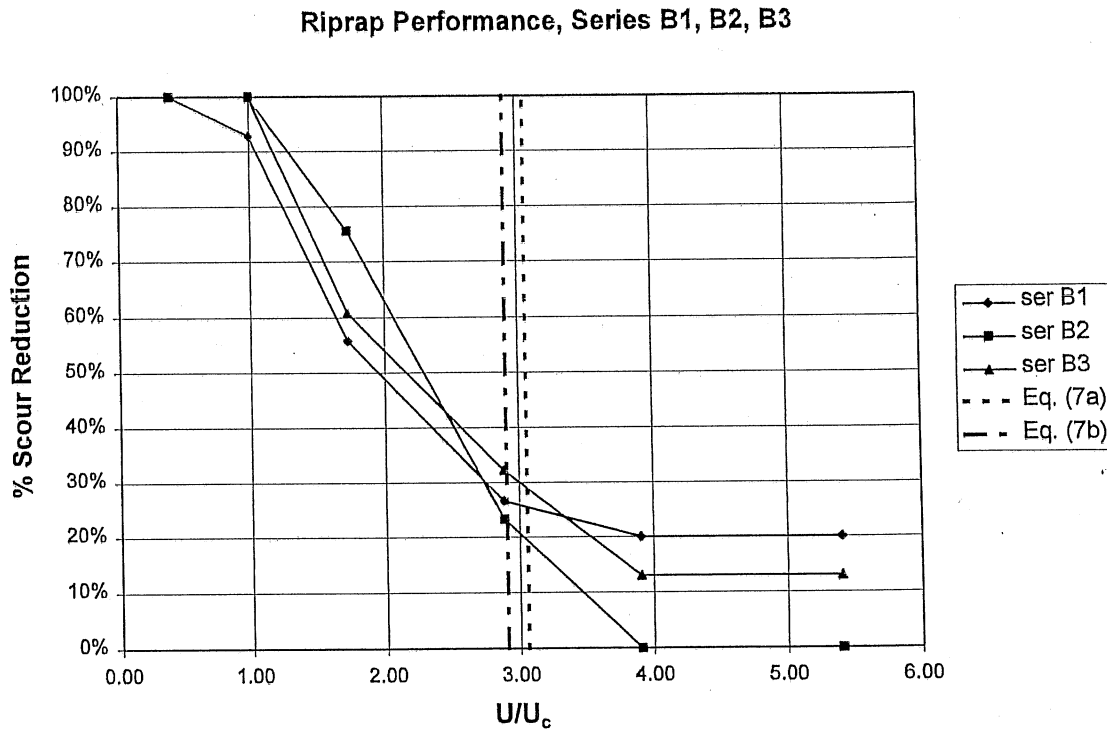
**Figure 5.7.** Riprap performance for series B1, B2 and B3. The vertical lines denote values of  $U_{tr}/U_c$  from Eqs. (3.7a) and (3.7b).

Figure 5.7 shows the results for series B1, B2 and B3, which correspond to the coarsest grade of riprap tested. In series B1 and B3 the cover ratio  $c/D$  is 4; in series B2 the pier size has been reduced and the cover ratio increased to 7. Increased cover is seen to affect the settling process very little. At the highest values of  $U/U_c$  the riprap offered virtually no scour protection. In all three cases the scour protection was well into the unacceptable range, i.e. near 20% to 30% by the time the critical condition for the entrainment of the riprap was reached.

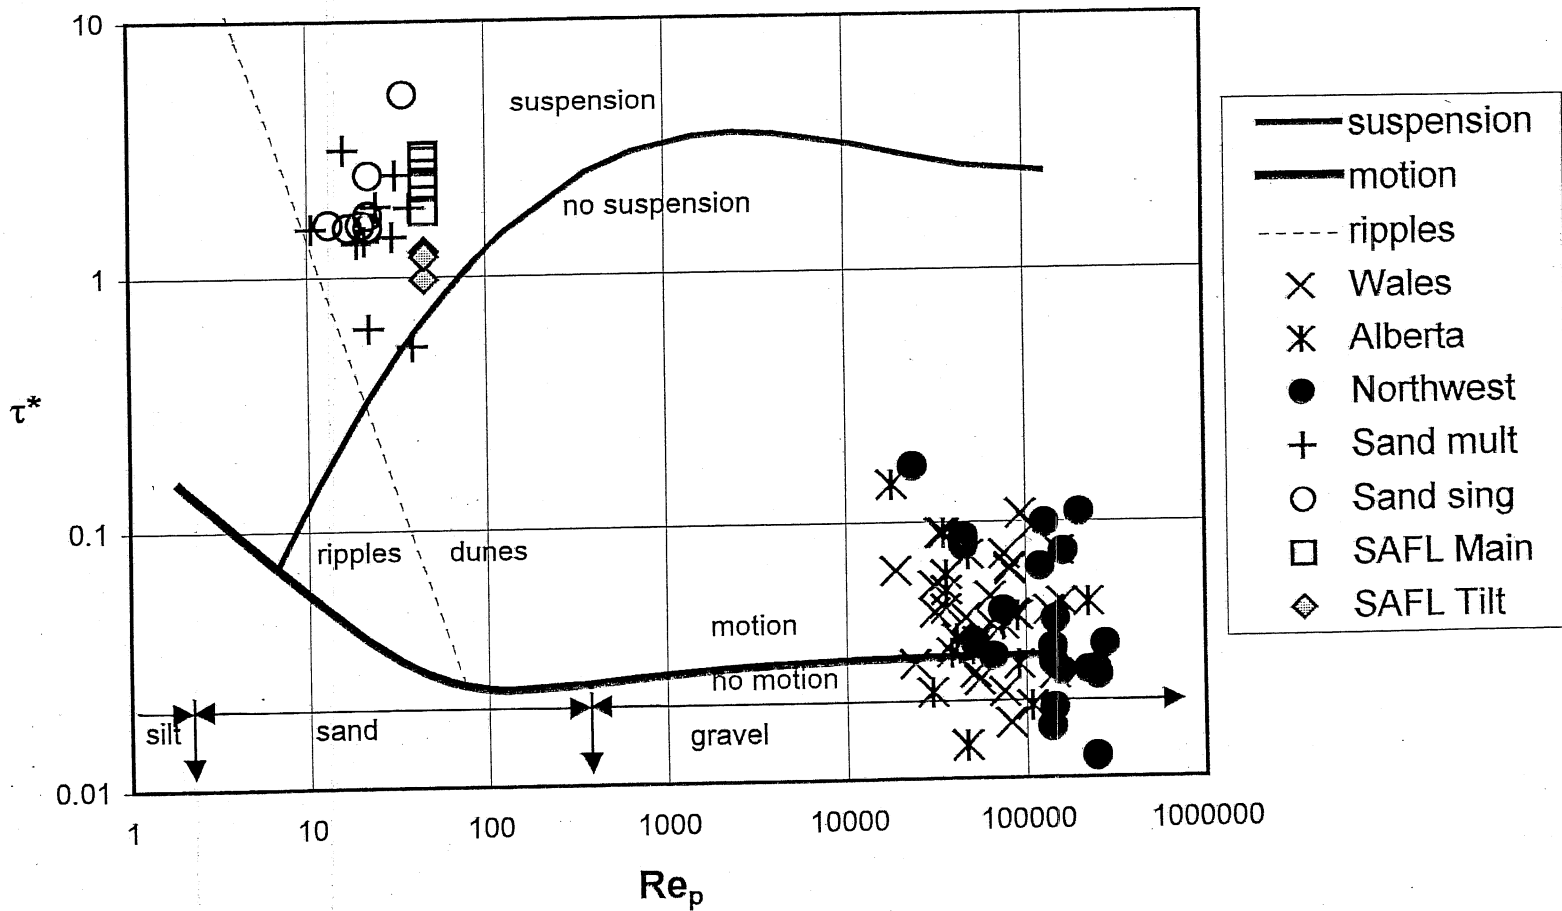
Figure 6.1. Regime diagram for rivers.

Figure 6.1 shows a plot of the values of  $\tau^*$  evaluated at bankfull flow versus  $Re_p$  for five sets of field rivers: a) gravel bed rivers in Wales, U. K. (Wales); b) gravel bed rivers in Alberta, Canada (Alberta); c) gravel bed rivers from the Pacific Northwest, U.S.A. (Pacific NW); d) single-thread sand bed streams (Sand sing); and e) multiple-thread sand-bed streams (Sand mult). Bankfull discharge is chosen as typical of flood flows; in many streams it corresponds to a flood with a return frequency of 1 to 6 years. Also shown in the diagram are lines corresponding to f) the threshold condition for the onset of motion of the median size  $d_{50}$  of the bed material, g) the threshold condition for significant suspension of the median size  $d_{50}$  of the bed material and h) the borderline between the region for ripple formation and the region in which only dunes and antidunes form.

It can be seen from Figure 6.1 that sand bed rivers plot in a very different place from gravel bed rivers. In the case of gravel bed rivers Shields stress  $\tau^*$  at bankfull conditions tends to be low, with typical values that are less than twice the Shields stress for the onset of motion of the  $d_{50}$  size of the surface material. Dunes are often (but not always) poorly developed even at flood flows, with the dominant bedform being bars. Sand bed streams tend to be quite different. Shields stresses at bankfull conditions are typically 20 to 60 times the Shields stress at the onset of motion, so that a) dunes develop prominently for a considerable part of every flood hydrograph and b) sediment transport is intense at flood flows, with a considerable portion of the bed material load in suspension.

Also plotted in Figure 6.1 are the Shields stresses for the highest flows (conditions of Run 4) studied in the Main Channel (SAFL Main) and the Tilting Flume (SAFL Tilt) in the present study. The data pertain to series MC-NP0, MC-NP1, MC-NP2, TF-NP1 and TF-NP2. It is readily seen from the diagram that the experimental conditions of the SAFL experiments include the range corresponding to severe flood flows in sand-bed streams.

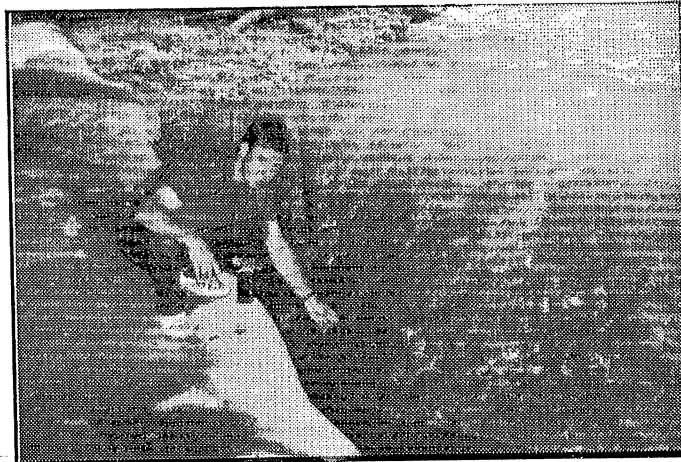
**Figure 7.6.** Shows grout mass undercut and cantilevered from the adjacent abutment.

A number of grout bag installations were evaluated at generally small bridges in Maryland. These appeared to be relatively successful as shown in Figure 7.4 of a typical installation. The primary problems noted concern the bag's size and its rigid nature vs. its ability to resist scour. As seen in Figure 7.5, some undercutting effects were noted at the sides and ends of bags when the bag was unable to settle effectively. The worst case noted was an installation where the contractor had, in an effort to make the finished product look good and use up available concrete, placed a thin coating of concrete on top of the bags and along the joints. Unfortunately, this layer effectively grouted the bags in place. At the time of the team's inspection, the grouted mass had been undercut by approximately 3 feet and was cantilevered from the adjacent abutment Figure 7.6.
