University of Minnesota
ST. ANTHONY FALLS HYDRAULIC LABORATORY

Project Report No. 160

FURTHER STUDIES OF FRICTION FACTORS FOR HELICAL CORRUGATED ALUMINUM PIPES
WITH RE-CORRUGATED ANNULAR RINGS ON EACH END

March 1976

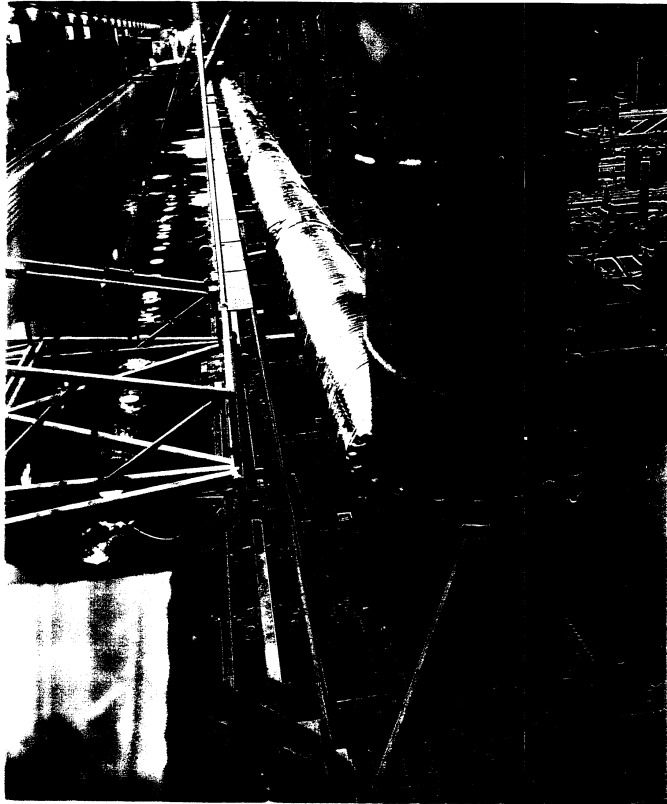
Fig. 8 - Looking Downstream at the Experimental Arrangement with 24 in. Pipe Installed

The pipes were installed in the laboratory flow system as outlined in Fig. 7 and shown in Figs. 8 and 9. Mississippi River water from the laboratory supply channel entered the test pipe through a shut-off valve and three right-angled guide vane bends. As the inlet pipe was also 24 in., the 24 in. helical pipe could be bolted on directly. To connect the 12 in. helical pipe, a plate with a 12 in. hole in it was bolted to the lower 24 in. elbow. The pipe was then bolted to the plate. On the 24 in. test pipe taps were located on the four downstream pipe sections; these were preceded by two pipe sections (20 diameters) to provide entry length to produce fully developed flow. On the 12 in. test pipe, taps were located on the last three pipe sections with two upstream pipe sections (40 diameters) for proper flow development. This resulted in test pipe lengths of about 120 ft and 100 ft respectively, (Fig. 7).
