University of Minnesota
St. Anthony Falls Hydraulic Laboratory

Project Report No. 199

MODEL STUDIES OF A COOLING WATER
DISCHARGE OUTLET MODIFICATION
PRAIRIE ISLAND NUCLEAR GENERATING PLANT

NORTHERN STATES POWER COMPANY

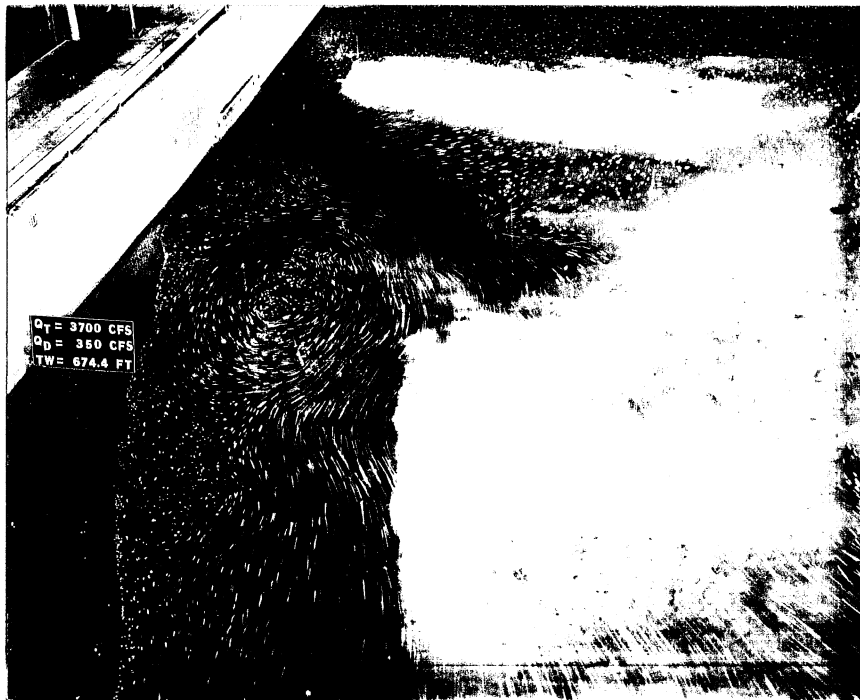
Photo 18 - Discharge Outlet Modification. Flow Condition 5,
 $Q_T = 3700$ cfs, $Q_D = 350$ cfs, T.W. = 674.4 ft,
Pipe Open = 7; flow pattern.

Photos 18 and 19 show the flow pattern in the outlet area and Figs. 21 and 22 present the flow pattern and velocities. Figure 22 was based on Photo 19. With the increase plant discharge, the velocities along the right bank also increased as indicated in a comparison of Figs. 21 and 22 (flow condition 5) with Figs. 19 and 20 (flow condition 4). The flow directions as well as velocities were indeterminate along the left side of the model as indicated by the absence of data on Fig. 21. By adjusting the shutter speed on the camera to obtain the most distinguishable confetti traces as shown in Photo 19, the flow pattern and velocities at the water surface were determined and presented in Fig. 22. The flow
