2009-40

Development of Flexural Vibration Inspection Techniques to Rapidly Assess the Structural Health of Rural Bridge Systems:
Phase II

1. Report No. MN/RC 2009-40	2.	3. Recipients Accession No.	
4. Title and Subtitle Development of Flexural Vibration Inspection Techniques to Rapidly Assess the Structural Health of Rural Bridge Systems: Phase II		5. Report Date December 2009

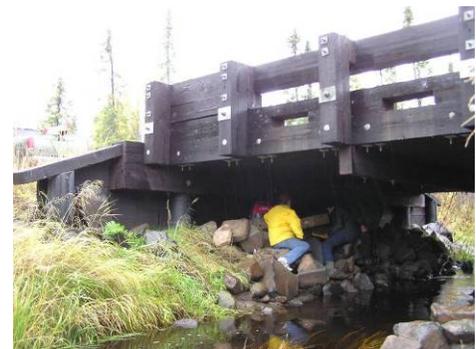
Figure 1.1. Dowel laminated timber bridge near Brimson, Minnesota.

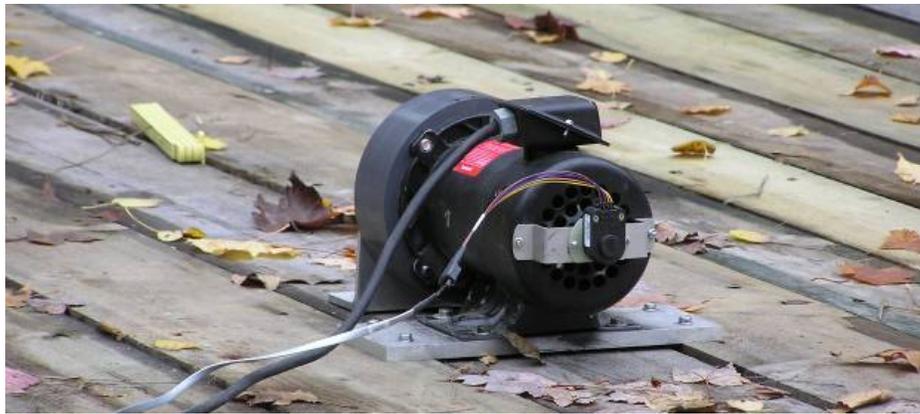
Figure 2.1. Rotating motor used to excite the timber bridge.

In previous USDA Wood in Transportation projects (Brashaw et al 2006) and a Northland Advanced Transportation Research Laboratories project, Development of Flexural Vibration Inspection Techniques to Rapidly Assess the Structural Health of Rural Bridge Systems (Brashaw et al 2008), a forced vibration technique was used to identify the first bending mode frequency of the bridge structures. This method is a purely time domain method and was used because it eliminates the need for expensive and complicated modal analysis. An electric motor with a rotating unbalanced wheel was used to excite the structure (Fig. 2.1), which creates a rotating force vector proportional to the square of the speed of the motor. Placing the motor at midspan ensured that the simple bending mode of structure vibration was excited. Two piezoelectric accelerometers (PCB 626BO2), also at midspan, were used to record the response in the time domain. To locate the first bending mode frequency, the motor speed was manually increased from rest until the first local maximum response acceleration was located. The period of vibration was then estimated from 10 cycles of this steady-state motion as captured using a Fluke digital scopemeter. Figure 2.2 shows the setup of the signal acquisition and the motor control system that was used in that testing.

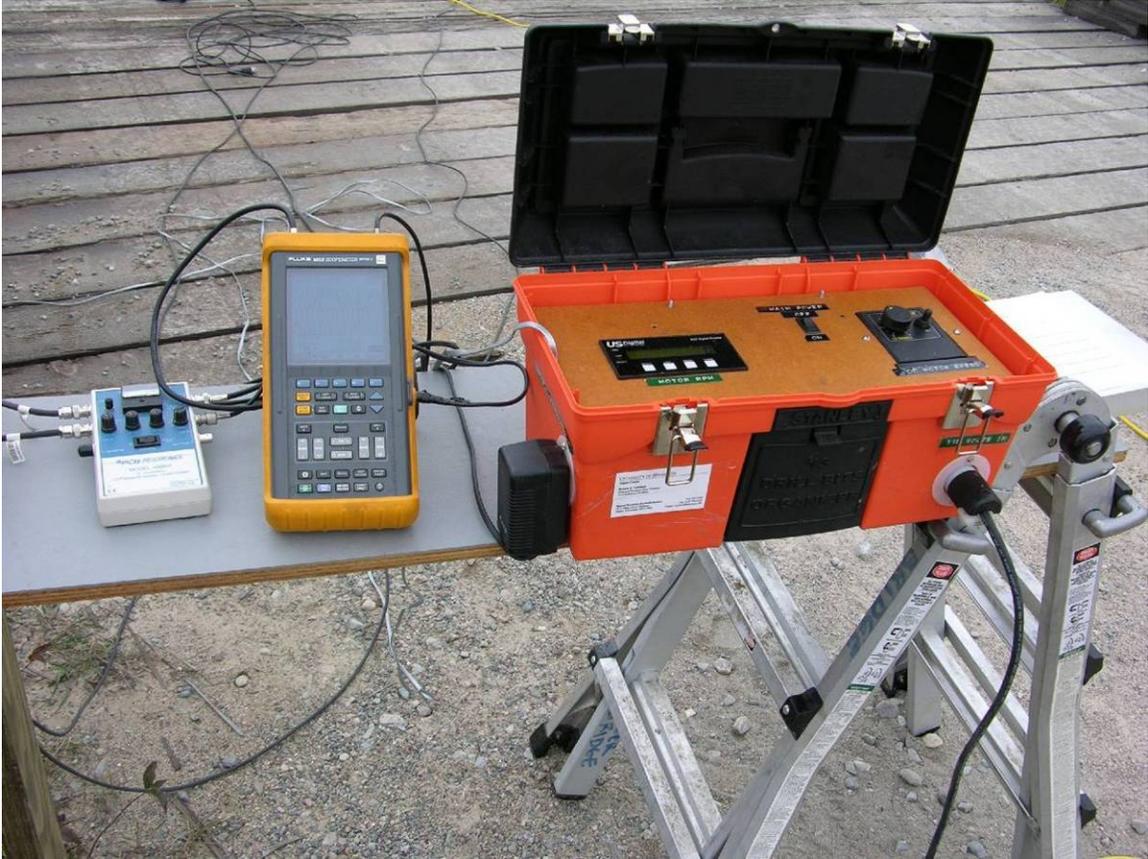
Figure 2.2. Testing system used to control motor and acquire vibration response.

The first step in our process of building a new system was to research the hardware used to control a motor and read the accelerometers. This hardware was then installed within a weather

resistance plastic case for portability and ease. The computer selected was a Toshiba Satellite laptop. This unit had more computing power and speed than other systems evaluated. The proposal had suggested purchase of a “ruggedized” laptop. Several manufacturers of “ruggedized” laptops were evaluated, however, the computer processing speed was very limiting and the costs excessive. As an alternative, a 3 year extended warranty was purchased for the Toshiba, which would cover any damage from weather, impact or other on-site problems.

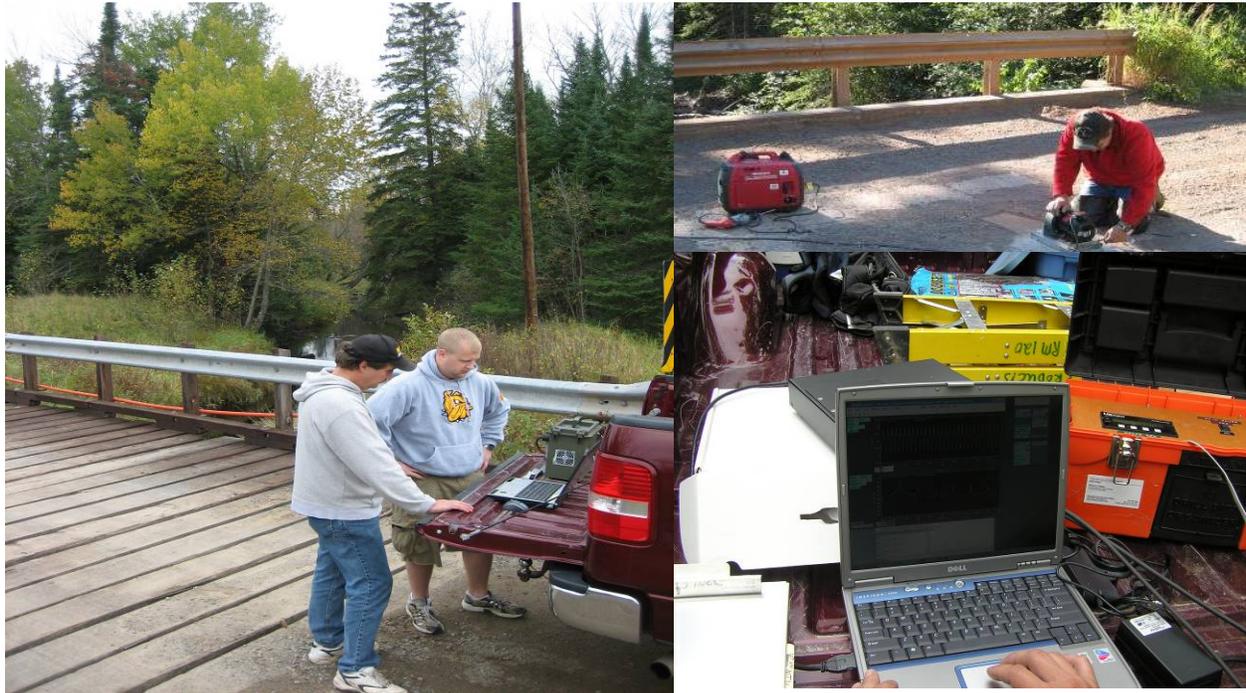
Figure 2.3. Images from the automated bridge vibration system developed in this project.

National Instruments LabVIEW was chosen as the control software package. This automated testing procedure using LabView has improved the testing and data consistency of testing. When the program has finished the test, a graph is displayed identifying the peak frequencies over time from each accelerometer during the test. A subprogram was developed to replay the signal response as desired.

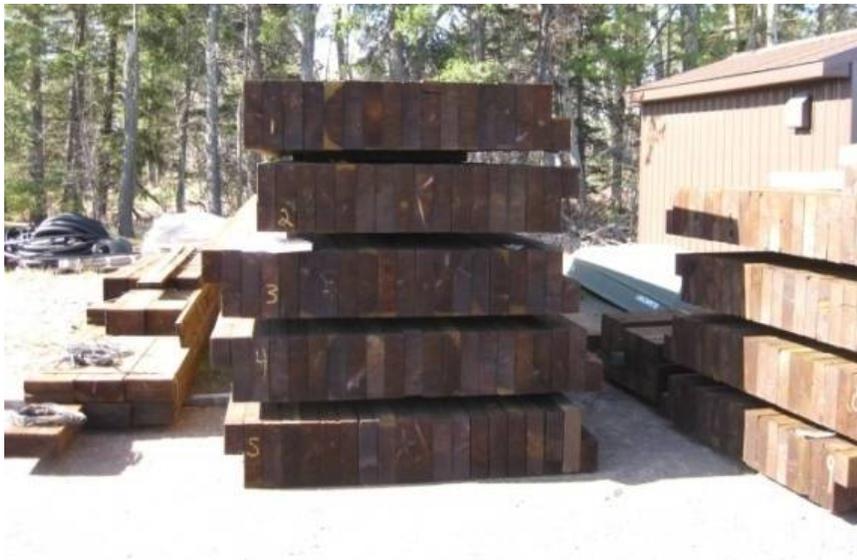
Figure 3.1. Bridge sections to be used as the new superstructure for St. Louis County Bridge 53.

The bridge sections that were to be used for the new Bridge 53 were numbered so the data collected during testing would be clearly identified and to minimize potential testing error through misidentification. There were two different types of cross sections for the bridge members. Sections 1 and 2 had a shiplap type joint on one edge on their cross section and were the outside sections of the bridge deck. Sections 2, 3 and 4 had a shiplap joint on each outer edge and would be the inner sections of the bridge. The numbered sections and their different cross sections can be seen in Figure 3.1. Dimension measurements for the length, width, and depth of each section were collected.

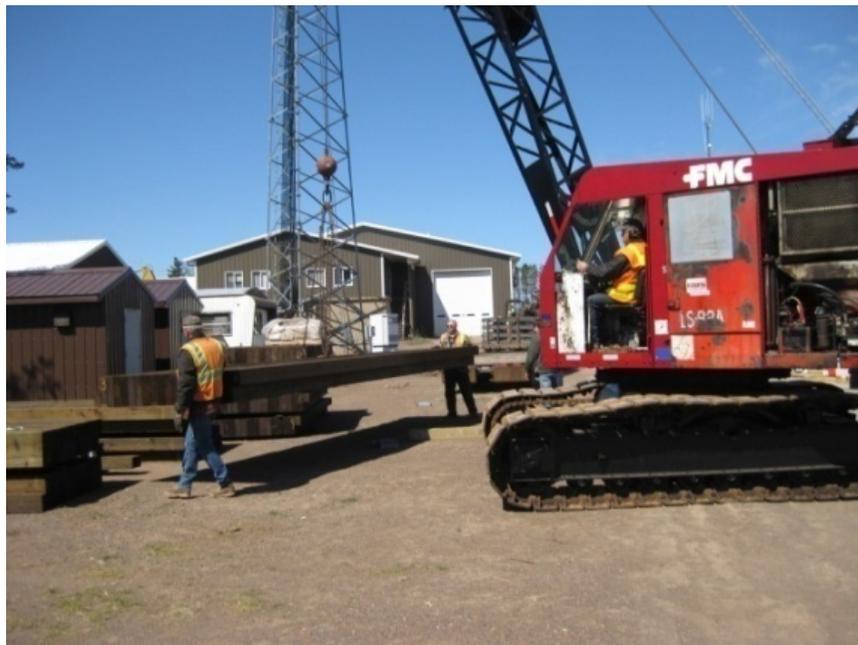
Figure 3.2. A crane was used to transport sections for weighing and vibration testing.

Each bridge section was weighed. As known from the theoretical model shown in Equation (3), bridge weight is needed in predicting the structure stiffness when using the vibration response method, which was used in this research and is outlined later in this chapter. In order for the sections to be weighed, a crane was used to transport the sections from their original position onto two wooden beams. This process can be seen in Figure 3.2. The purpose of the beams was to elevate the sections so they were only in contact with the beams and not the ground. They were spaced apart so that when the sections were set on them there was little to no overhang of the section over the beam. Scales were placed on each corner of both beams for a total of four scales as seen in Figure 3.3. When the section was set onto the beams, the weight measurement for each scale was recorded and the four measurements were then added together to get an estimate of the overall weight of the section.

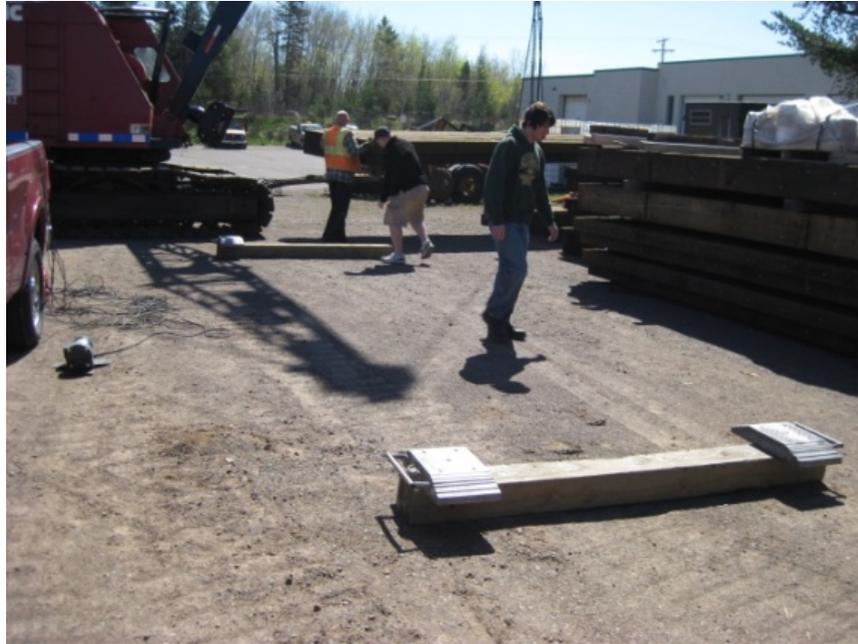
Figure 3.3. Scales were placed on each corner of two beams. The sections were then set on the scales using a crane to get a weight estimate.

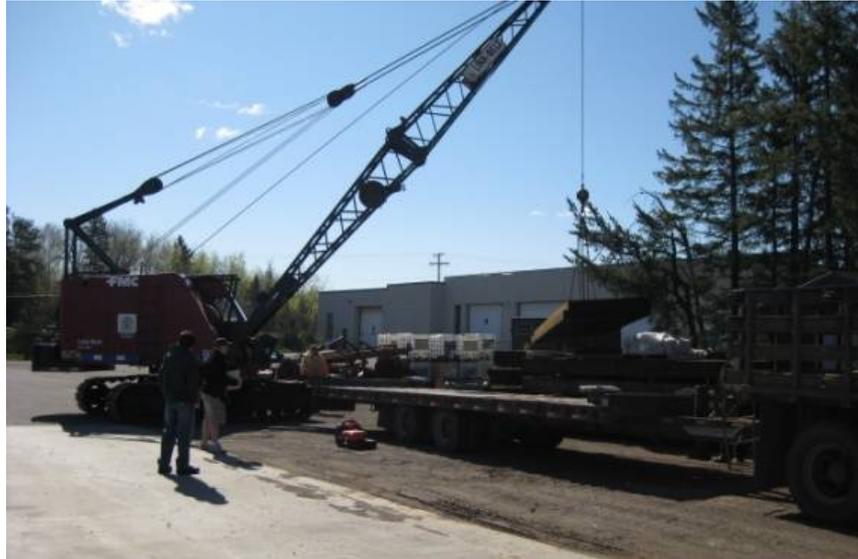
Figure 3.4. The first two tests of the first section were conducted on a trailer. Due to poor signal quality, this technique was abandoned for the remaining testing.

After the weight measurements were recorded, the crane lifted the section and the scales were removed. The section was then set down on two beams for vibration testing. For the first two tests of the first section, the beams were placed on a flatbed trailer seen in Figure 3.4. A review of the vibration data showed substantial damping and poor signal quality. It was concluded that placement of the deck sections on a flatbed trailer would yield inaccurate results because of the springs and tires on the trailer. Because of this, the remainder of the tests occurred with the two beams placed on the ground, which was a gravel surface. This setup can be seen in Figure 3.5.

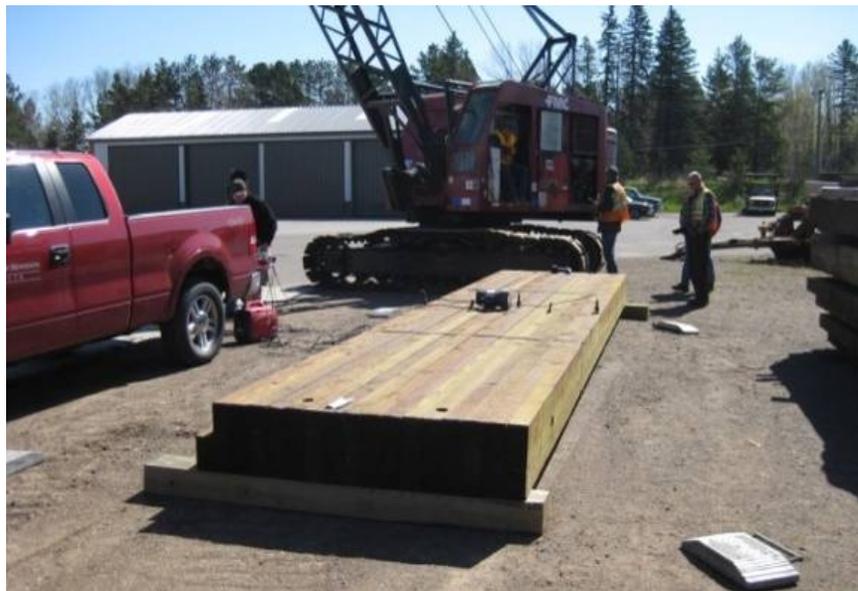
Figure 3.5. The sections were placed on two beams so that they were elevated above the ground for vibration testing.

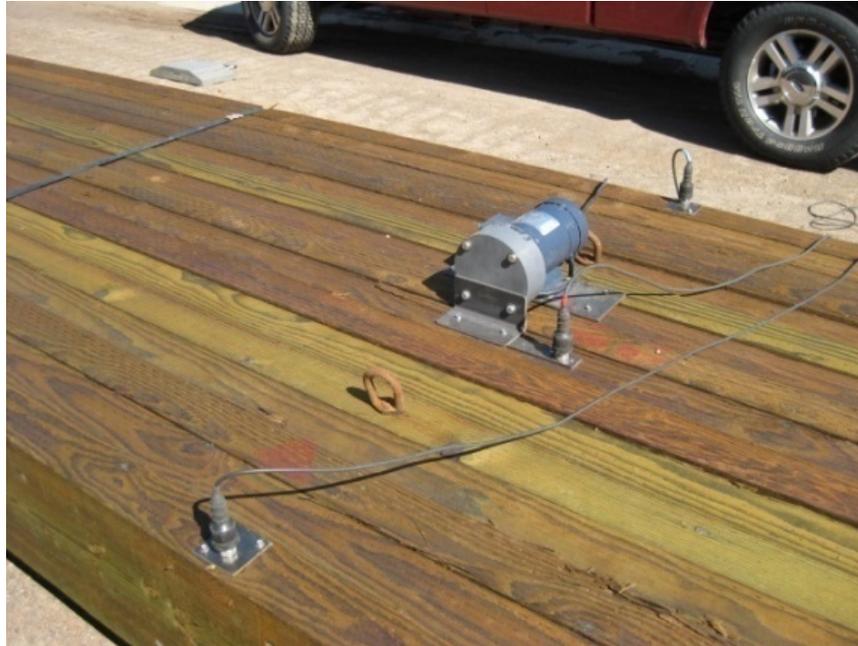
Figure 3.6. General test setup used for vibration testing of each section.

Vibration testing of the section was then conducted. The general setup can be seen in Figure 3.6. A ½ hp electric motor with a rotating unbalanced disc was attached to the mid-point of the structure. Three piezoelectric accelerometers (PCB 626BO2), also at midspan, were magnetically attached to steel plates attached using lag screws to the outer edges and the midpoint. The motor was controlled and the data collected using a laptop notebook with a customized program developed using Labview Windows. The motor slowly increases in RPM and the resulting vibrational frequency is collected. The amplitude of the frequency response is plotted to identify frequency peaks that occur during testing.

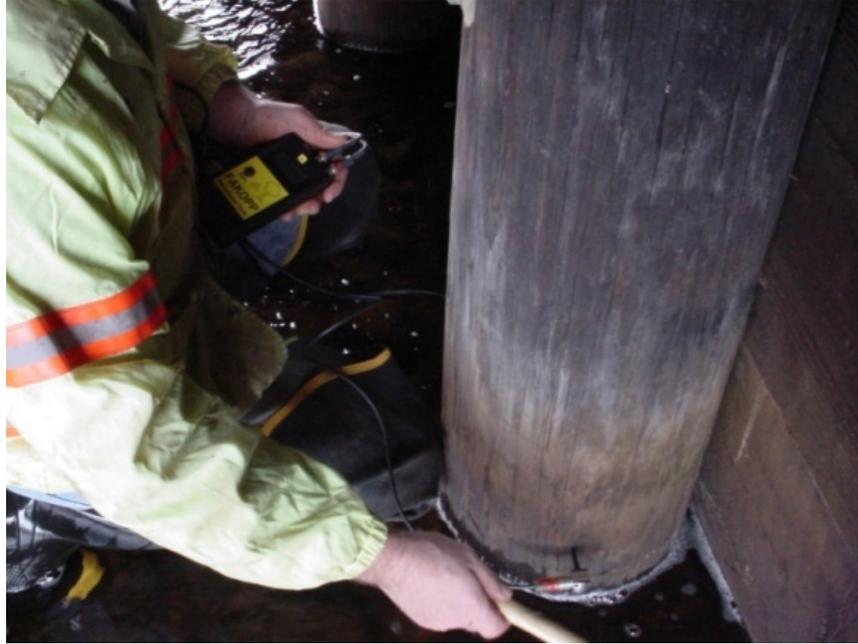
Figure 3.8. Fakopp microsecond timer being used on a timber pile.

An example of the stress wave concept for detecting decay for a circular piling is shown in Figure 3.8. First, a stress wave is induced by striking the specimen with an impact device instrumented with an accelerometer that emits a start signal to a timer. A second accelerometer, which is held in contact with the other side of the specimen, receives the leading edge of the propagating stress wave and sends a stop signal to the timer. The elapsed time for the stress wave to propagate between the accelerometers is displayed on the timer. There are several commercially available stress wave timing units. These units will yield comparable results if they are calibrated and operated according to the manufacturer's recommendations. The use of stress wave velocity to detect wood decay in timber bridges and other structures is limited only by access to the structural members under consideration. It is especially useful on thick timbers 89 mm (3.5 in.) where hammer sounding is not effective. A detailed explanation of the use of stress wave timing and interpretation of the testing is detailed in publications prepared by Brashaw et al (2005).

A commercial Fakopp Microsecond Timer was used to determine the stress wave time across the pile top and 2 feet below the pile top. The Fakopp is very accurate at determining the presence of decay at the testing location and is useful in mapping the decay locations. Table 3.1 shows the stress wave transmission times perpendicular to the grain for several species at various degradation levels for the species present in timber bridges. The substructure species for bridge 53 was determined to be southern yellow pine.

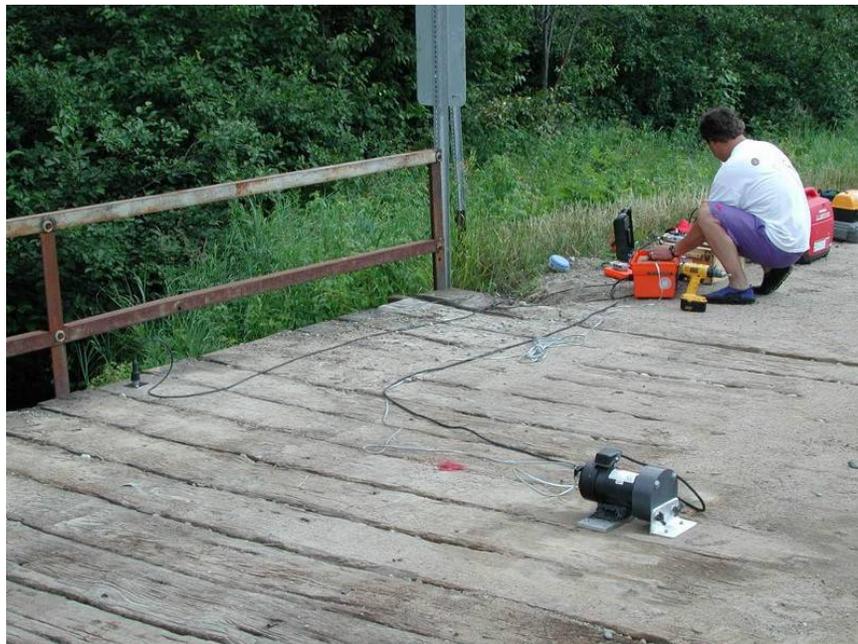
Figure 3.9. General test setup for vibration testing.

Once all of the tests have been completed, the data is reviewed briefly and photographs are taken before leaving the test site. The typical test setup for vibrational testing on a bridge superstructure can be seen in Figure 3.9.

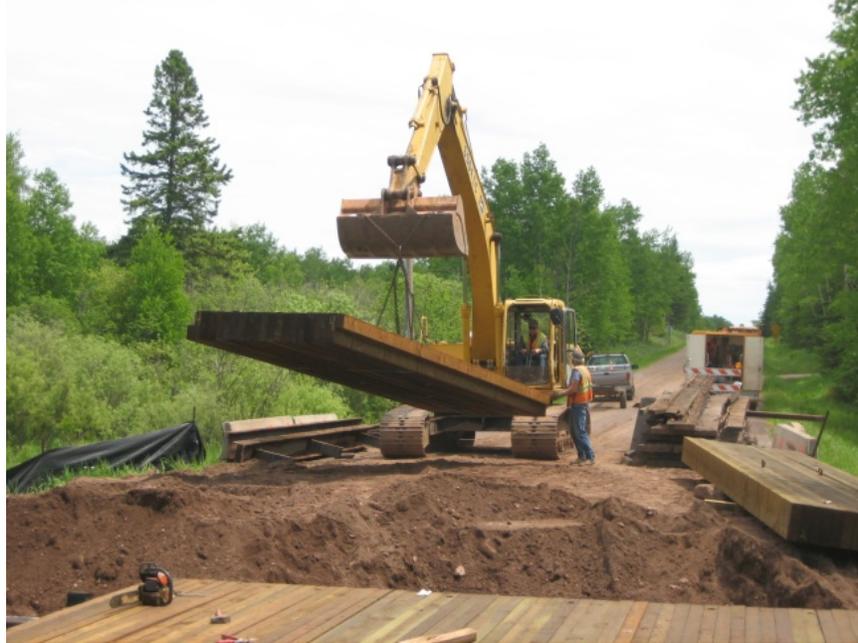
Figure 3.11. Wood sections were set into place using an excavator.

The new superstructure for St. Louis County Bridge 53 consists of the five wood sections previously noted. The placed position of each section can be seen in Figure 3.9. The sections were set into place on the bridge using an excavator. This can be seen in Figure 3.10. All construction was completed by the St. Louis County bridge construction crew.

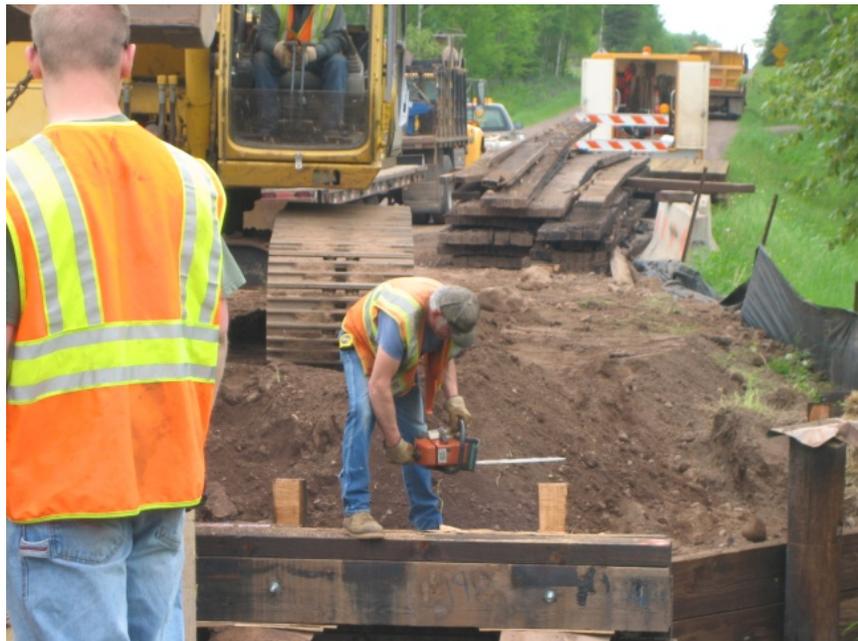
Figure 3.12. Some stays were trimmed with a chainsaw so sections could fit. Copper naphthenate was used to treat the newly exposed surfaces.

Some of the stays that hold the sections in place had to be trimmed with a chainsaw in order for the sections to fit onto the pile cap. Every stay that was cut was treated with copper naphthenate to protect the wood from decay. The procedure can be seen in Figures 3.11 and 3.12.

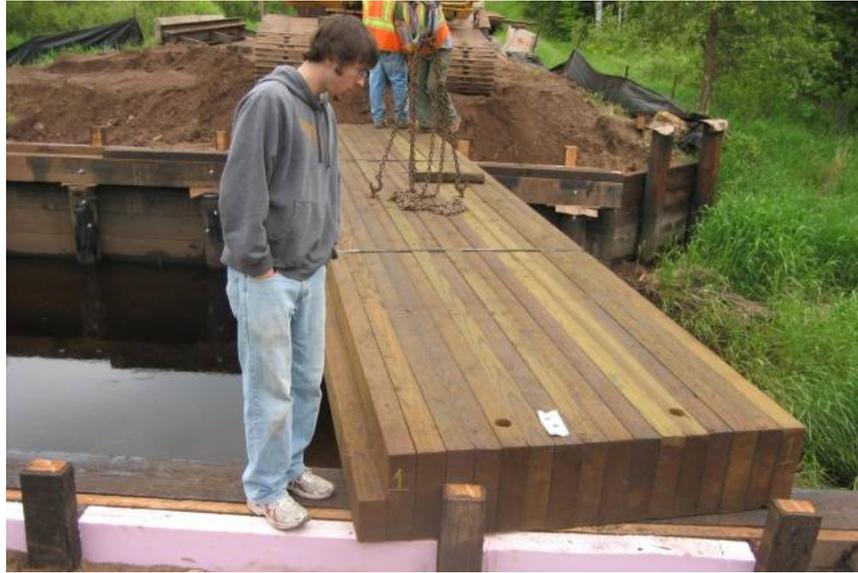
Figure 3.13. Sections were set into place once stays were trimmed and treated.

As soon as the cut stays were treated, the sections could be set into place as seen in Figure 3.13. Once the sections were all in place, the lap joints were pinned with carriage bolts. This can be seen in Figure 3.14. The sections were then bolted to the pile cap and all of the dirt that had been removed was back filled. Figure 3.15 shows the bridge with one side completely back filled and the other side in the process of being back filled.

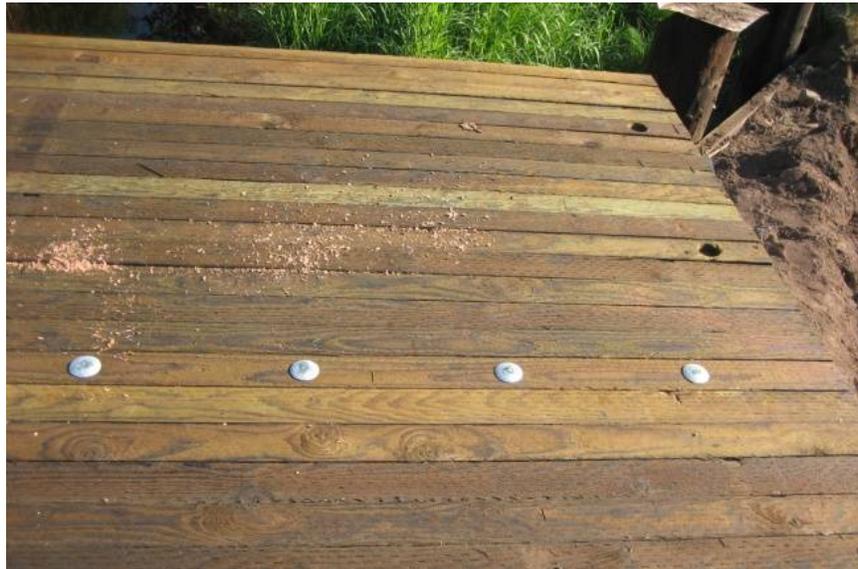
Figure 3.14. Lap joints were pinned together with carriage bolts once sections were set into place.

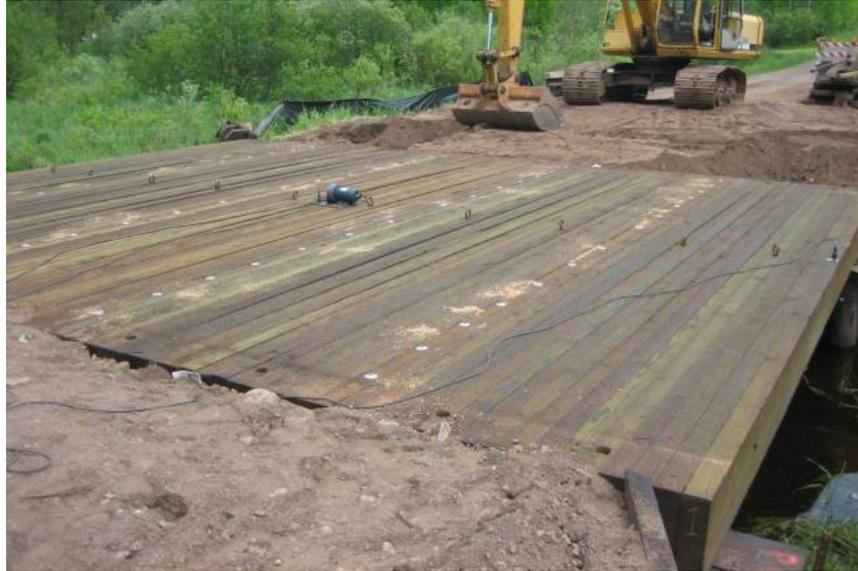
Figure 3.15. Once sections were pinned together and bolted to the pile cap, dirt was back filled.

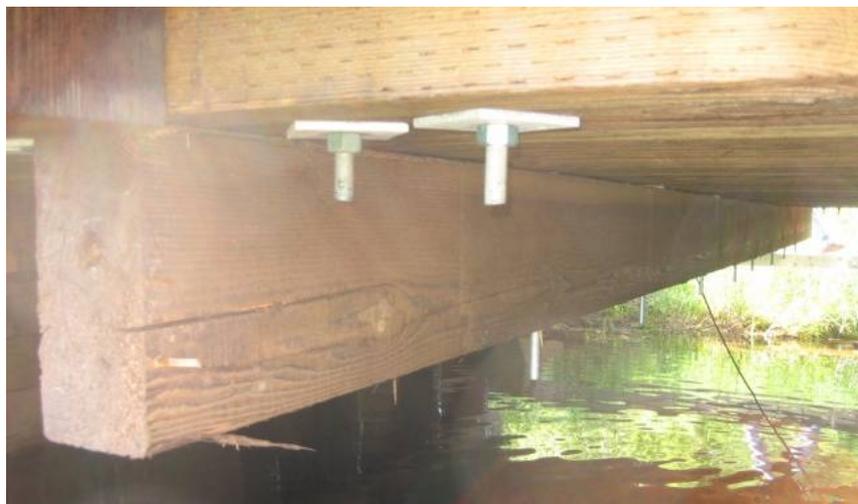
Figure 3.16. Spreader beam mounted below the bridge deck.

Once all of the dirt was back filled, the spreader beam was mounted below the deck, but it was not bolted tight. The curbs and guard rails were then installed. Figure 3.16 shows the spreader beam mounted below the deck and Figures 3.17 and 3.18 show the curb and guard rail being installed on one side of the bridge. After the guard rails were installed, the spreader beam was bolted tight, additional dirt work was completed, and the bridge deck was paved with bituminous asphalt. Construction of the bridge was then complete. Vibration testing was conducted during each phase of bridge construction as noted in the following dated sections.

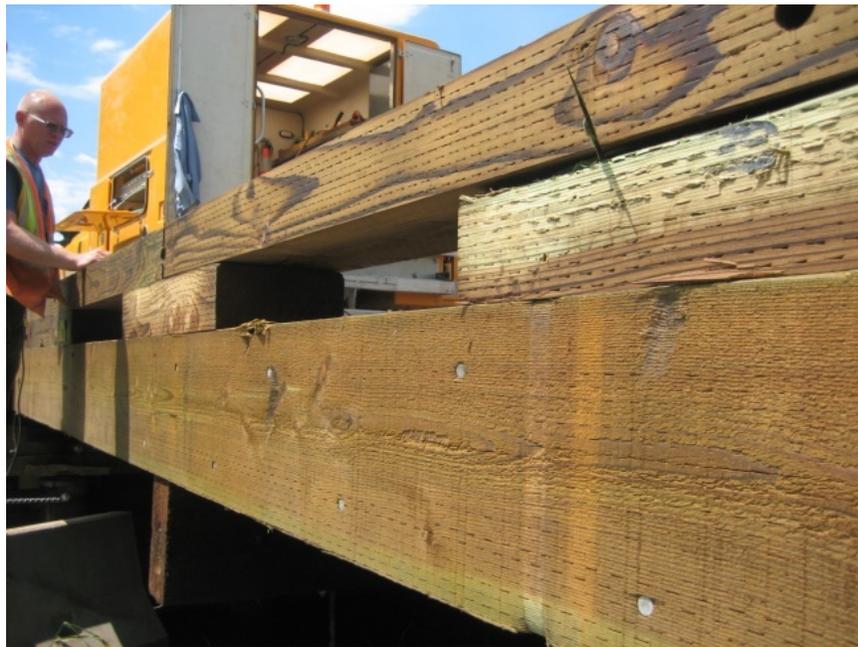
Figure 3.17. Curb being installed on bridge deck.

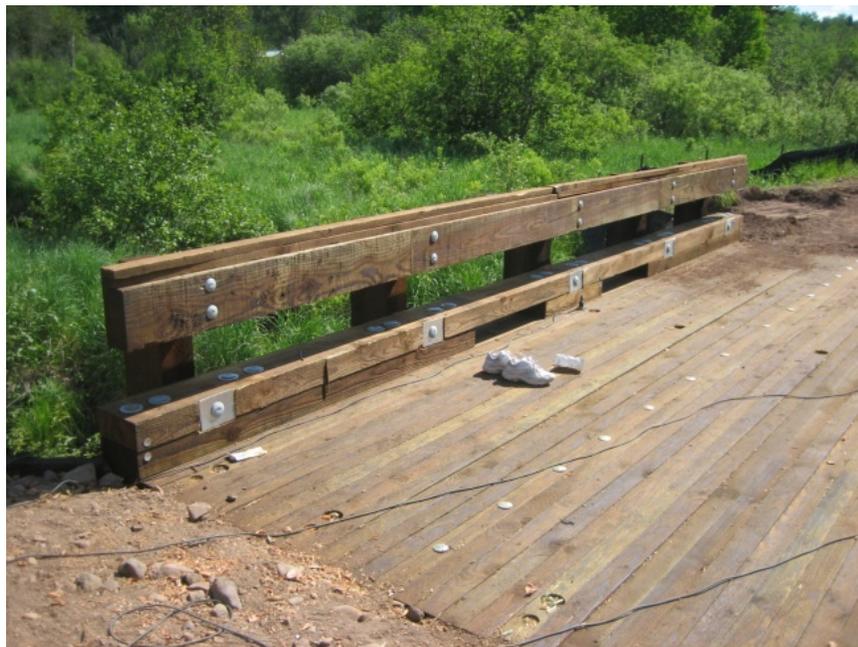
Figure 3.18. Guard rail installed on bridge deck.

6/26/2008 The upstream rail was now secure as seen in Figure 3.18, but the downstream rail was not. The spreader beam was still not bolted. Three tests were conducted with the motor mounted on top of the bridge. Three additional tests were run with the motor mounted underneath the bridge and the accelerometers mounted on top. Figure 3.25 shows the motor mounted underneath the bridge deck. For the tests with the motor mounted on the bottom, the deck was clear of materials and the downstream railing was being installed.

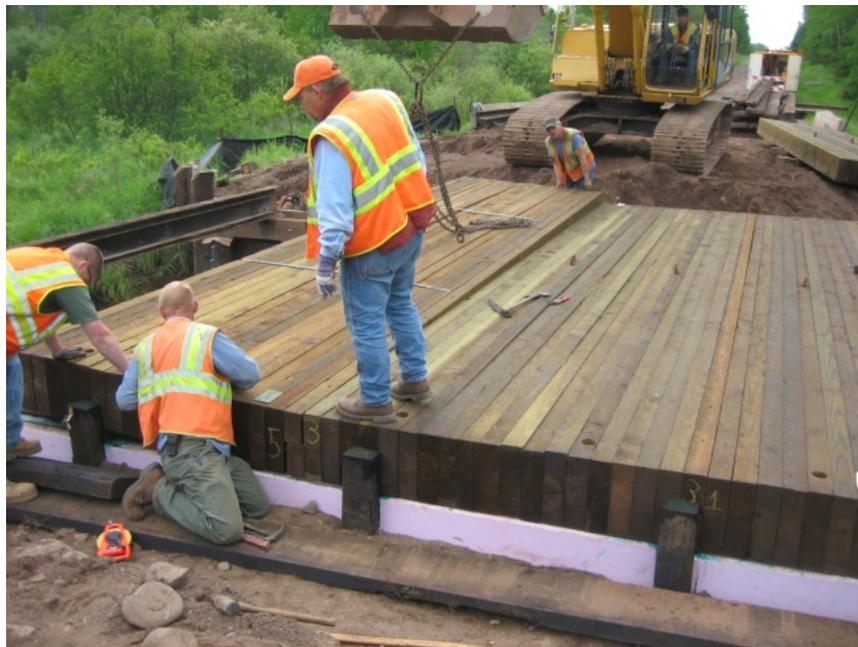
Figure 3.19. The first three sections were set into place and then vibration testing was done.

6/19/2008 Vibration testing was conducted after the first three sections had been set and were only resting on the pile cap as seen in Figure 3.19. The first series of tests were performed with the motor parallel to the laminations at the center of panel 1. The setup is shown in Figure 3.20. Test 9 was conducted with the motor in the center of panels 1 and 3, but perpendicular to the laminations. The lap joints for the three sections were then pinned and test 10 was run with the motor still in the center of panels 1 and 3, but with the motor shaft rotating parallel to the laminations as shown in Figure 3.21.

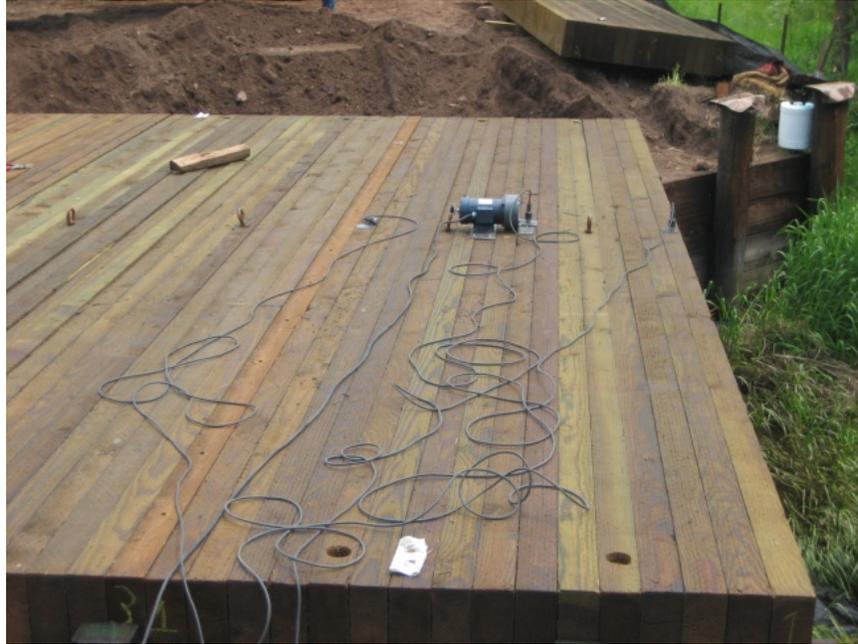
Figure 3.20. The first tests were conducted with the motor in the center of the first section oriented parallel to the laminations.

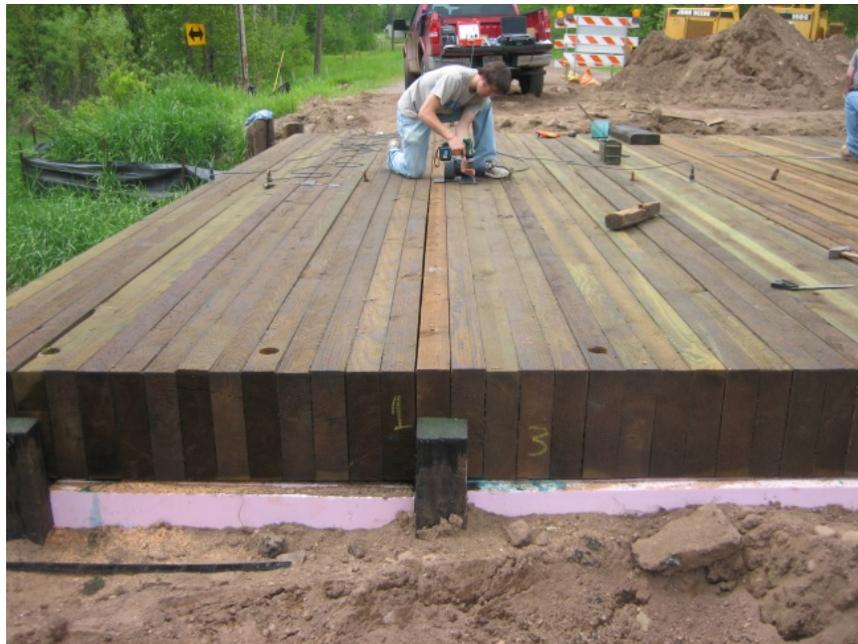
Figure 3.21. Motor being mounted parallel to the laminations in the center of sections 1 and 3.

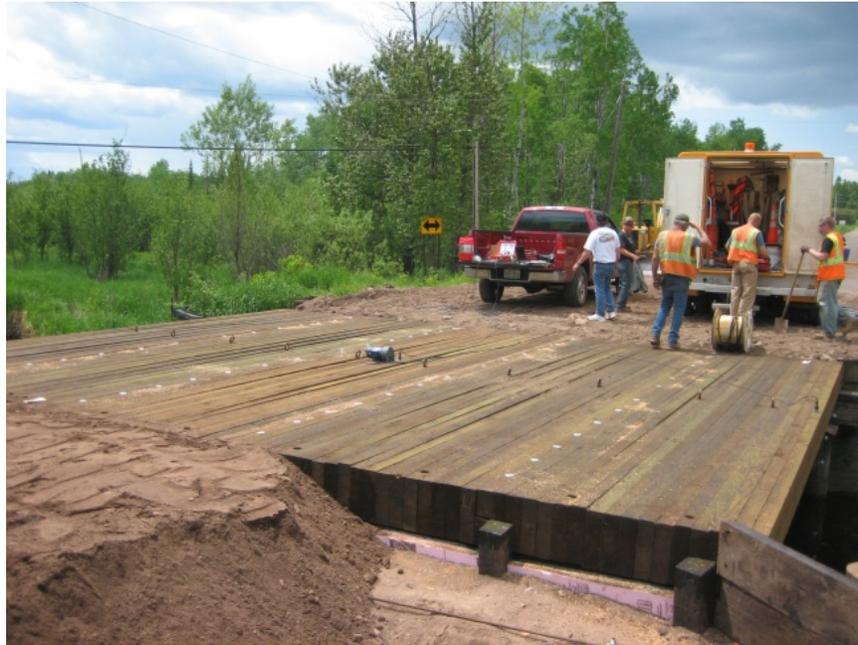
Figure 3.22. Vibration testing conducted with the French River Rd side of the bridge completely back filled and half of the other side of the bridge back filled.

6/20/2008 All five of the sections were now in place and their lap joints pinned together. They were not bolted to the pile cap. The motor was placed in the center of the bridge with the shaft parallel to the laminations for the first three tests. For tests 4 through 6, the motor was rotated so the shaft was perpendicular to the laminations. The French River Road side of the bridge was then back filled with dirt and tests 7 through 9 were conducted with the motor perpendicular to the laminations. Tests 10 through 12 were performed with the motor rotated so it was parallel to the laminations. Tests that were run with the motor shaft parallel to the laminations were reading clearer signals so at this point the rest of the tests run on this bridge were run with the motor shaft parallel to the laminations. Once test 12 was completed, the other side of the bridge was half back filled with dirt as shown in Figure 3.22 and test 13 was run.

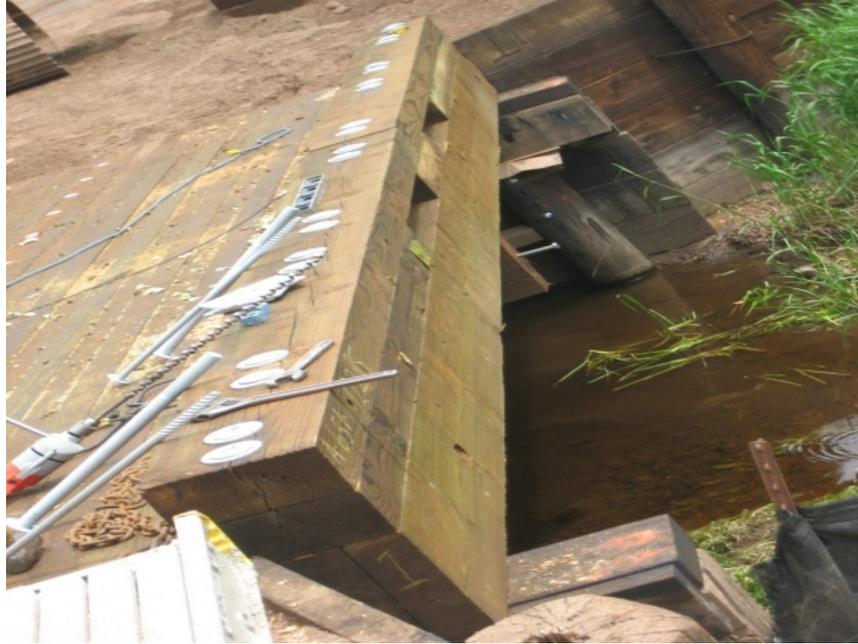
Figure 3.23. Downstream curb completely installed.

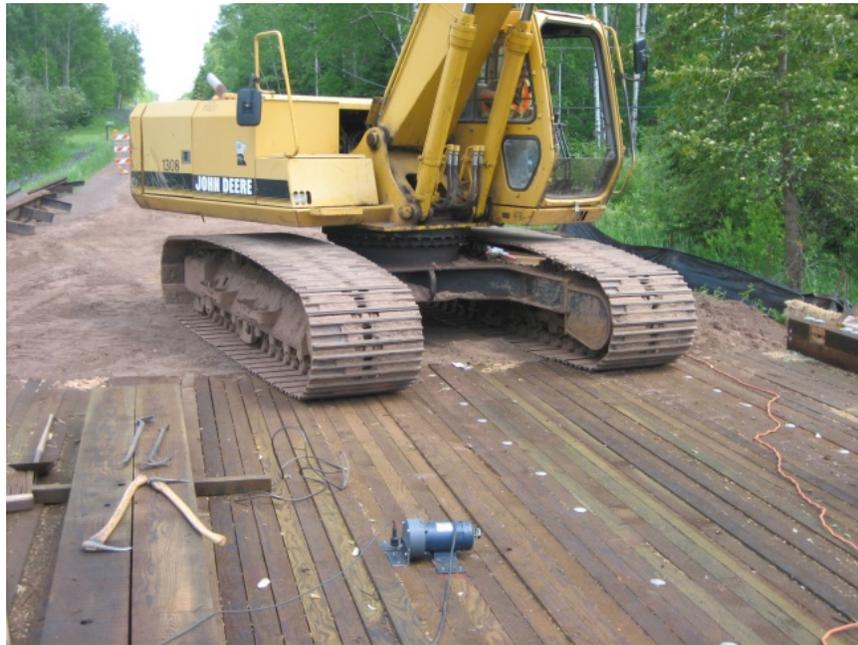
Figure 3.24. Some tests were run with the excavator part way on the bridge deck.

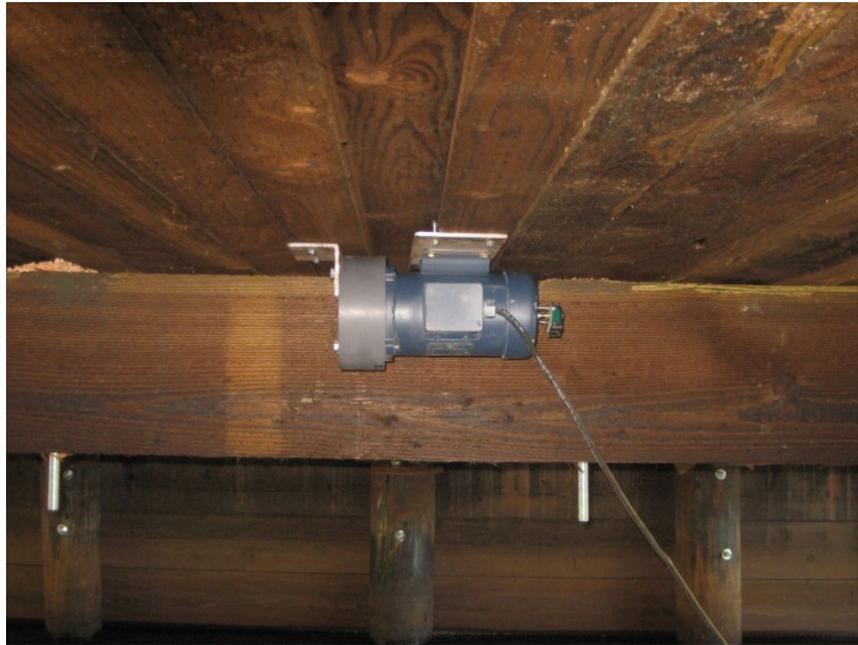
Figure 3.25. Vibration testing with motor mounted below the bridge deck.

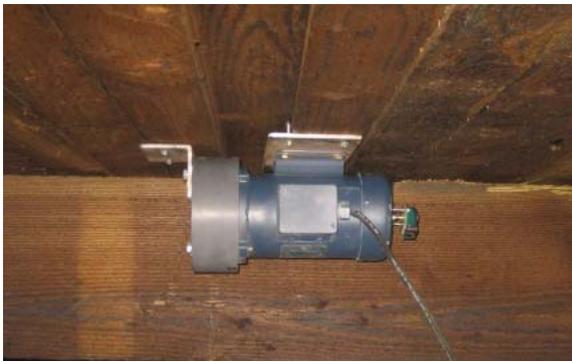
Figure 4.2. General motor attachment on underside of bridge deck for conducting vibration testing.

The typical test setup for the motor attached midspan under the bridge is shown in Figure 4.2. The in testing computer interface that controls the testing and acquires data is shown Figure 4.3 and the data collection accelerometers are shown as attached in Figure 4.4.

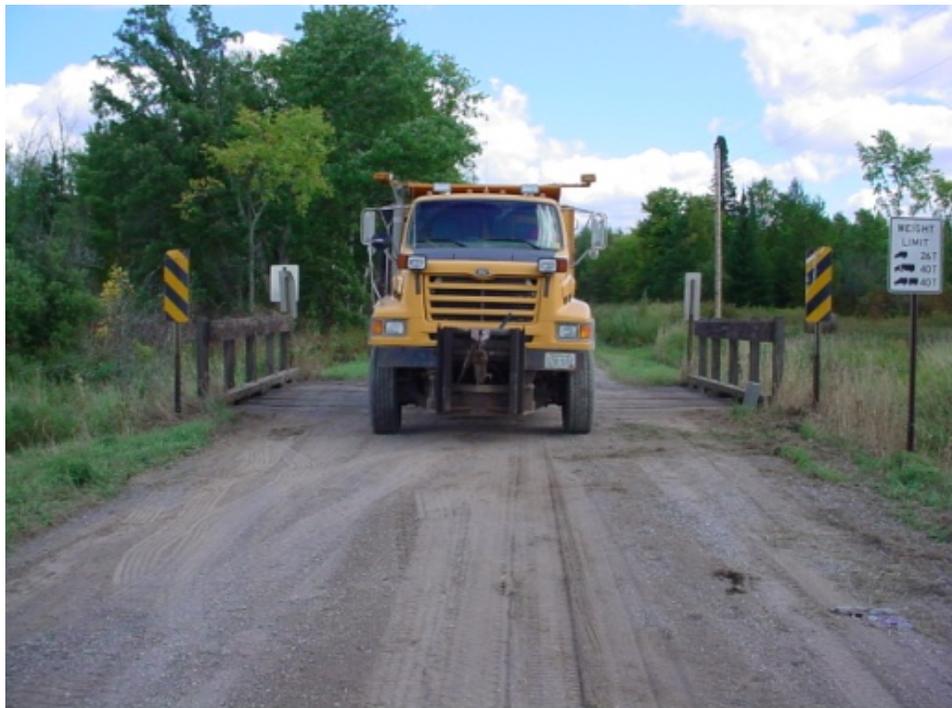
Figure 4.5. Truck positioned on bridge.

Once all of the data has been collected, it is reviewed briefly before the truck leaves the bridge location. Photographs of the bridge, both end and side views, are then taken with no people, vehicles, or anything else on the bridge. The main components of the setup for load testing can be seen in Figures 4.5, 4.6, and 4.7.

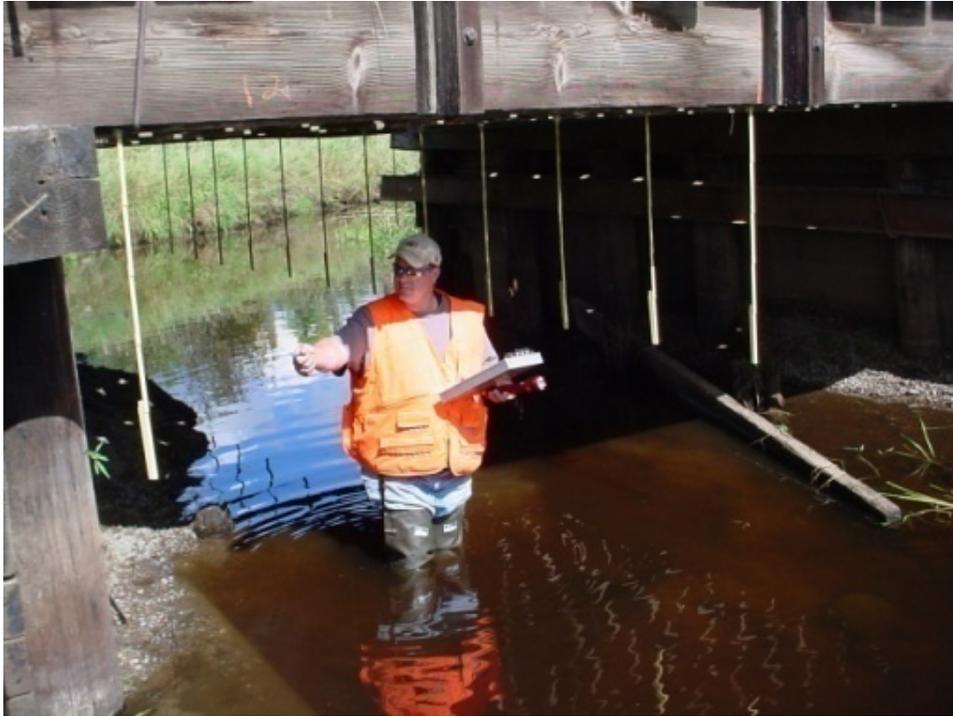
Figure 4.6. Deflection rulers.

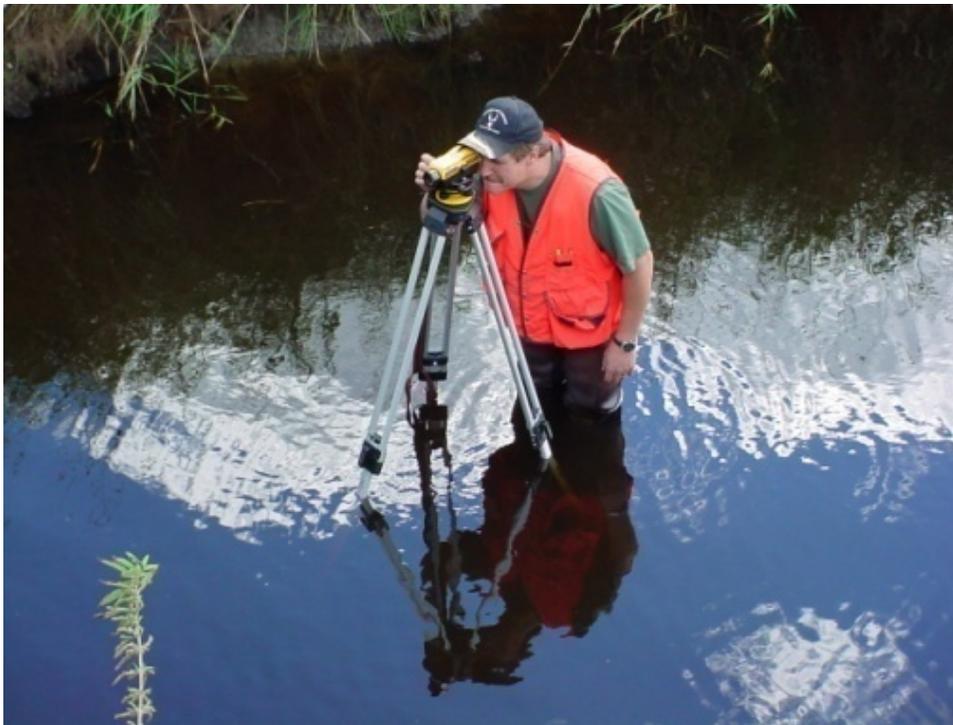
Figure 4.7. Optical surveying level.
