UNIVERSITY OF MINNESOTA  
**ST. ANTHONY FALLS LABORATORY**  
Engineering, Environmental and Geophysical Fluid Dynamics

PROJECT REPORT 512

# The Physical Model Study of the Bond Falls Emergency Spillway

Prepared for  
**Upper Peninsula Power Company**

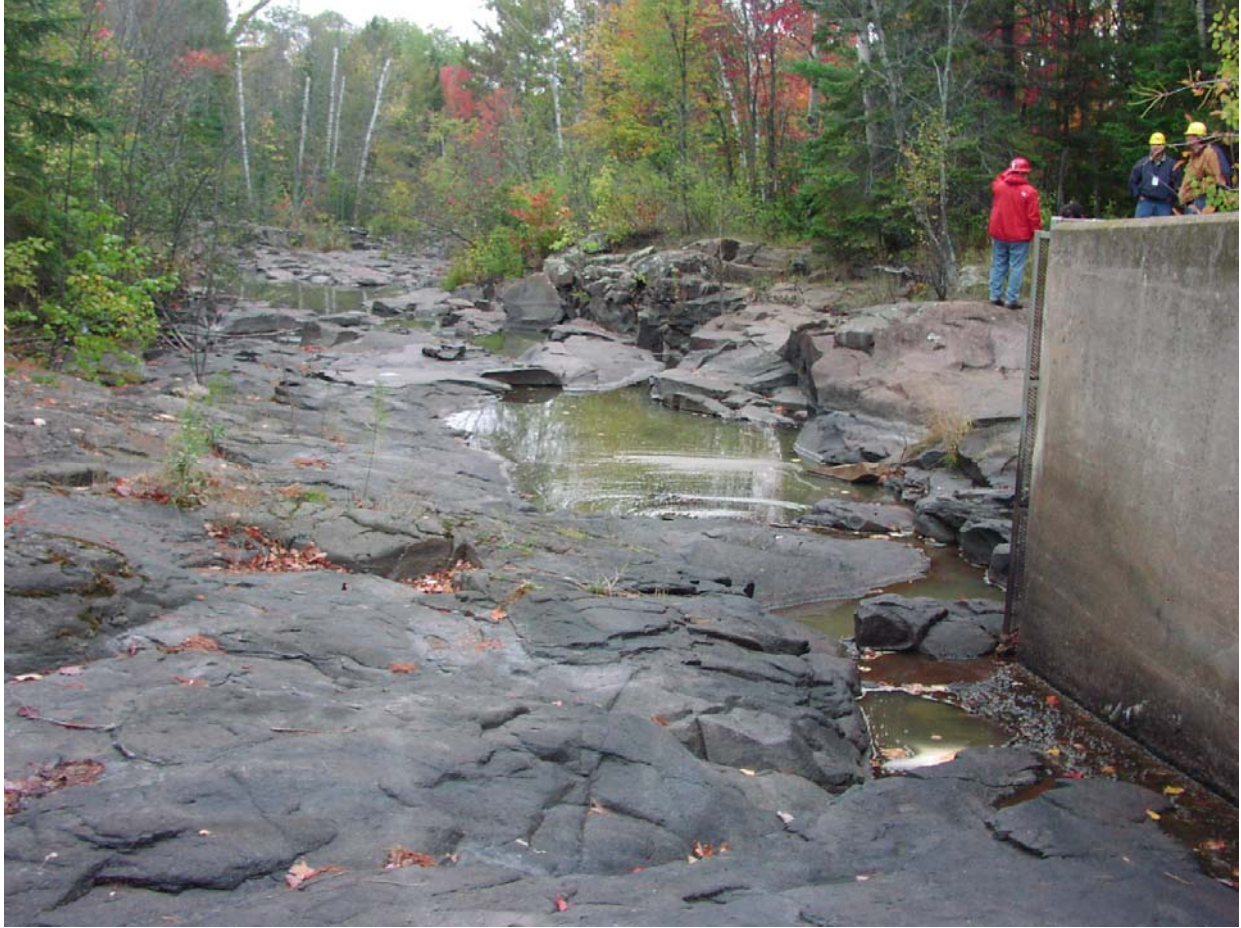
**Figure 2.2.** A photo of the channel bed rock and the wooded area of the floodplain downstream of the retaining concrete wall, looking downstream.

RAS model was developed using the data shown in Figure 2.1 and the observations made during the site visit in October 2007. The channel bed was all bed rock with a very steep slope, while the floodplain was a densely wooded area (Figure 2.2). The downstream boundary condition was set at the critical depth because of the free fall at the downstream end of the stream. The upstream boundary condition was set at the normal depth because the upstream end of the surveyed area was relatively flat, and a normal depth at the upstream could potentially pronounce the effect of tailwater on the flow patterns at the bridge and upstream of the bridge. Assuming a Manning's n-value<sup>2</sup> of 0.15 for the floodplains and 0.03 for the channel, the HEC-RAS model was run under the 13,500 flow condition, i.e. the PMF. The model was run under "mixed flow conditions" to allow both subcritical and supercritical regimes in the stream.

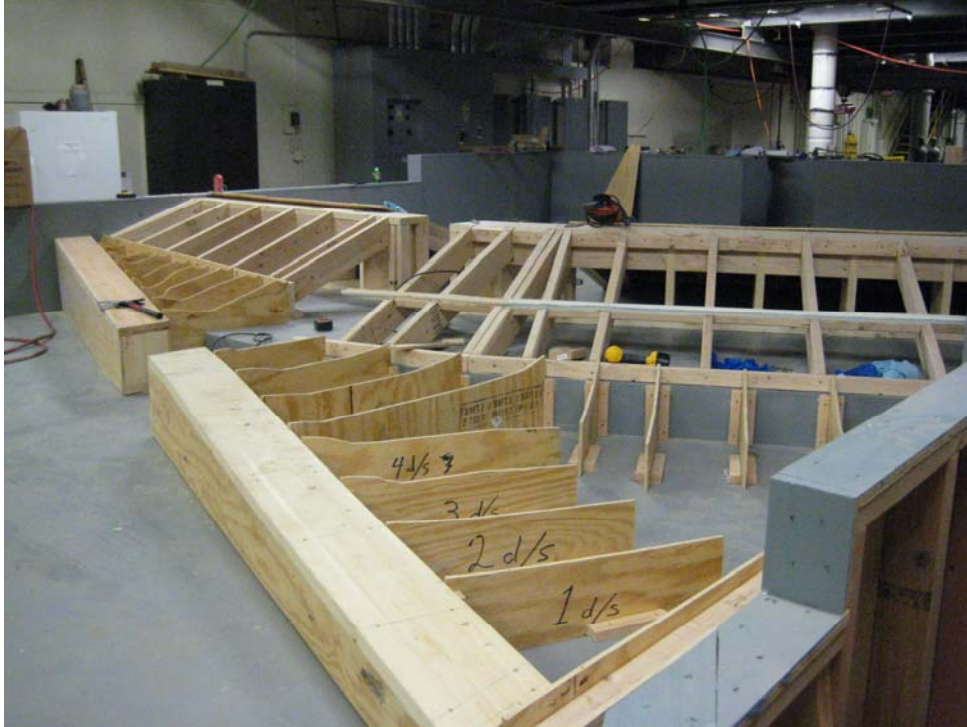
**Figure 2.9.** The physical model of the Bond Falls spillway system under construction. The embankment, road, topographic templates and structural elements were built from lumber and plywood.

The model was constructed using three different types of materials. The structural components, reservoir, dam or embankment, roadway and the portion of the channel chute at the downstream end of the spillway were all built from wood (Figures 2.6, 2.7, 2.8 and 2.9). The rest of the model was built using topographic templates, packed with filler materials and finished with a thin layer of concrete (Figure 2.10). The spillway, gates, and the bridge deck and pier were constructed out of acrylic and sheet metal (Figures 2.8 and 2.11). The gate actuators were fabricated using ACME threads and nuts because the model gates required a high degree of adjustability for opening and closing of the gates. The entire structure was painted and sealed to create a water tight basin.

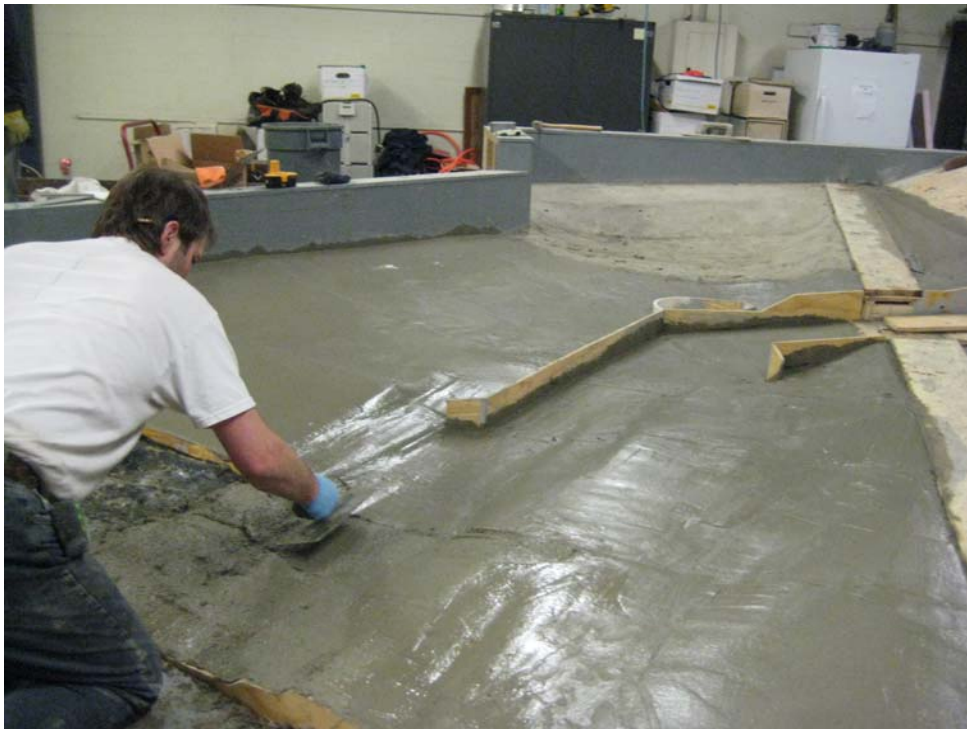
**Figure 2.10.** The topography of the stream channel and its floodplain was built using formed concrete.

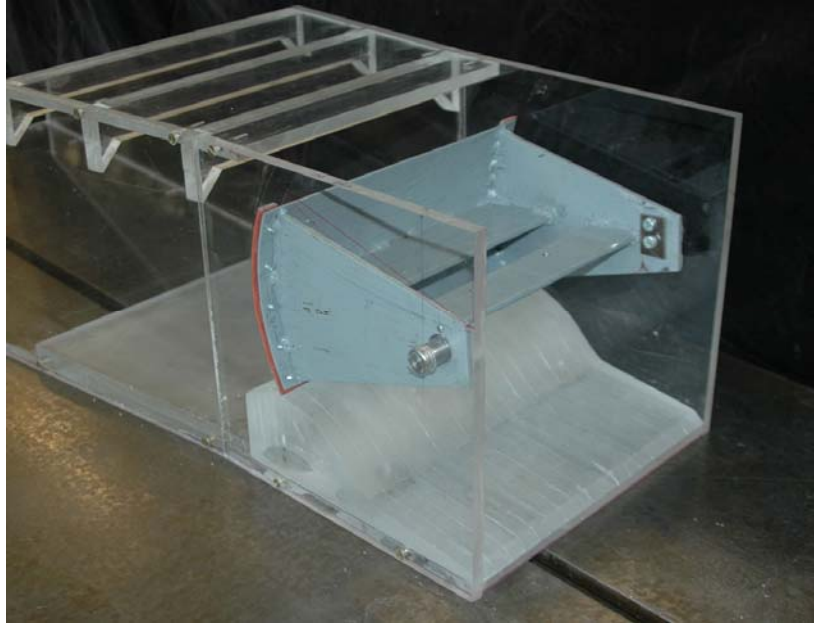
**Figure 2.11.** The original geometry of the existing spillway and the tainter gate which were made of acrylics and sheet metal, respectively.

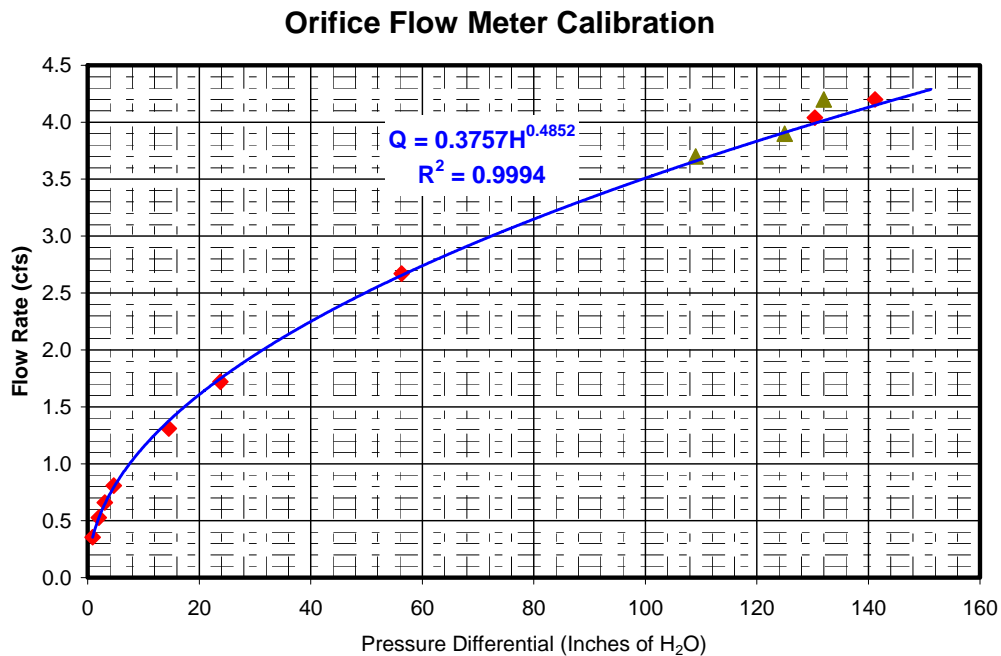
**Figure 2.12.** Measured flows versus measured pressure differentials across the orifice plate and the function fitted to the data for the orifice flow meter calibration. The red diamonds were the initial data collected for calibration, and the green triangles were collected later to verify the calibration function for high flows.

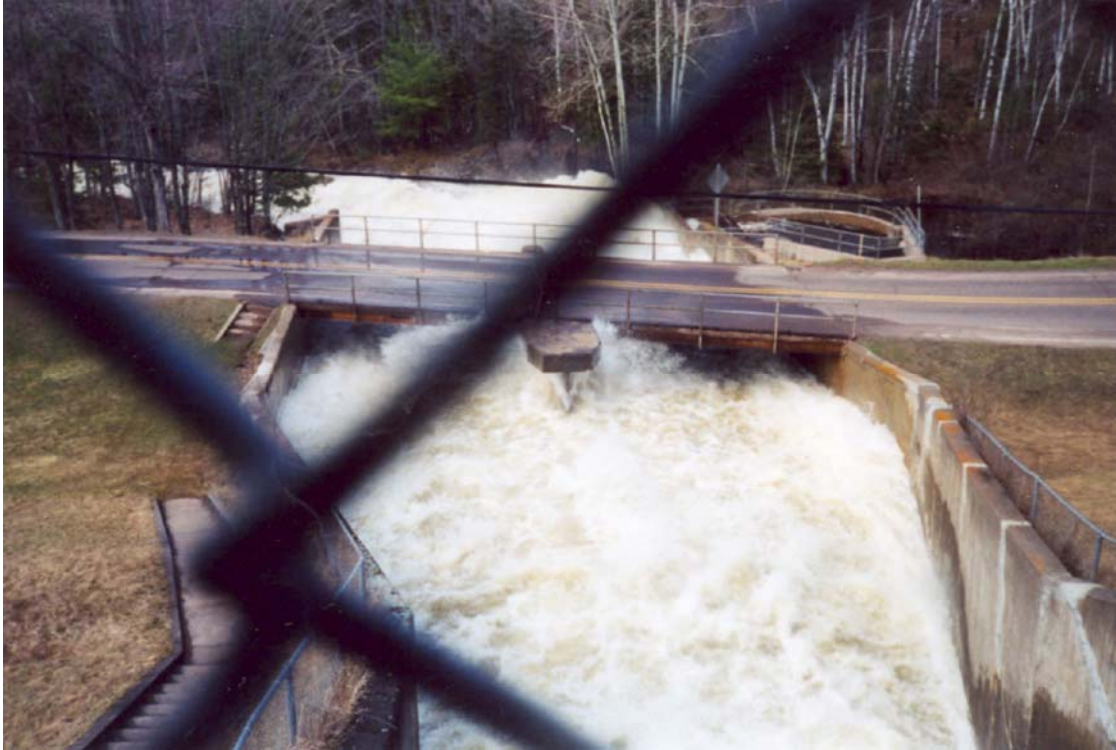
**Figure 3.1.** A photo of the flood of April 19, 2002 through the channel downstream of the spillway and the bridge.

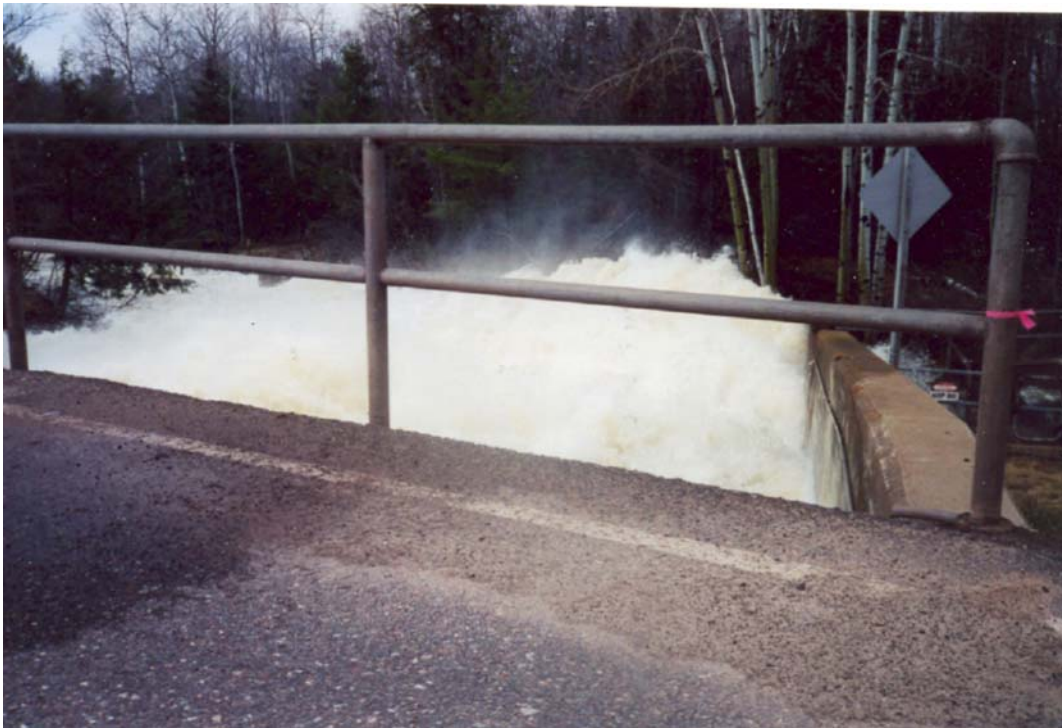
**Figure 3.2.** A photo of the flood of April 19, 2002 near the concrete retaining wall downstream of the bridge.

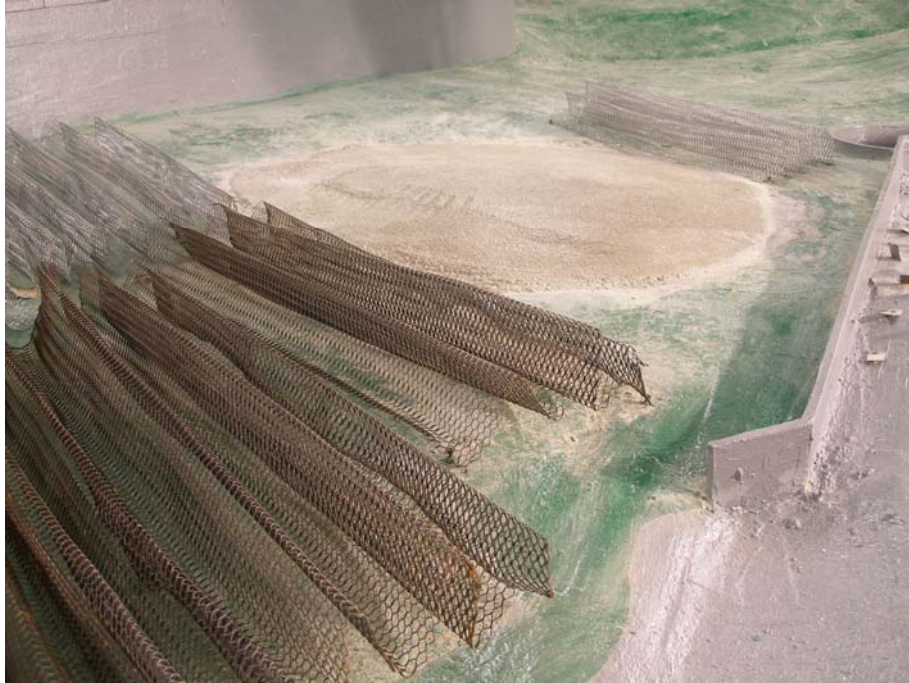
**Figure 3.5.** The elevation of the area behind the retaining wall was increased to more accurately reflect the topography of that area. In addition, chicken wire was added to the channel floodplain to model the roughness of the wooded areas in the prototype.

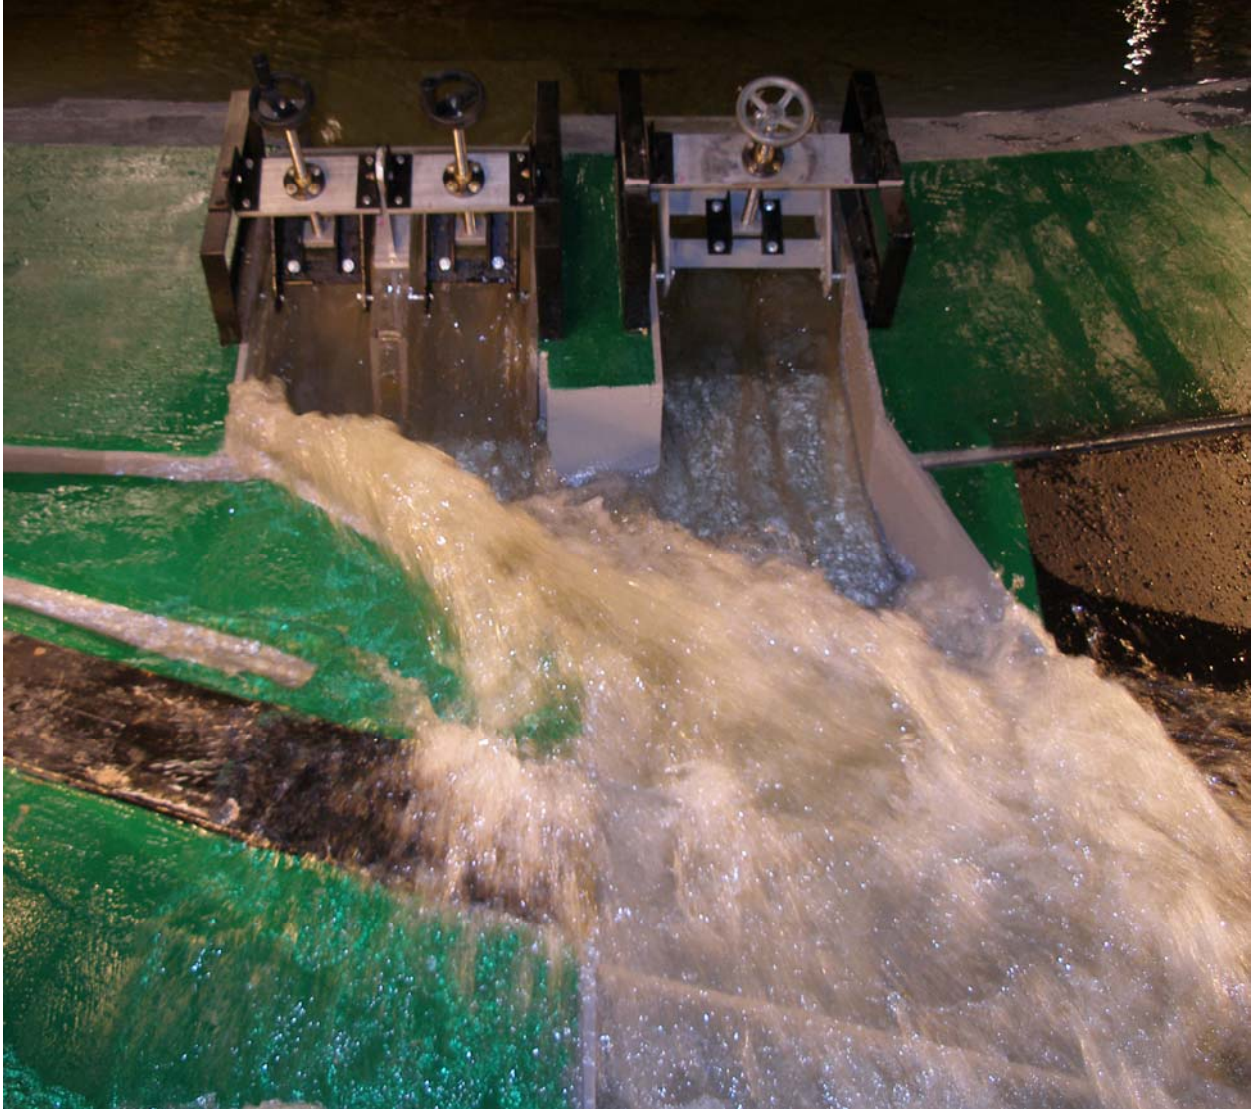
**Figure 3.9.** Water flowing through the spillway Design-1 under the PMF (flow). All three gates are fully open and the reservoir is at the maximum pool level (1480.9'). Under this condition, flow overtopped the 50° wall downstream of the new gates (on the left side of the picture) by 16 ft and the west side wall upstream of the bridge (on the right side of the picture) by 8 ft.

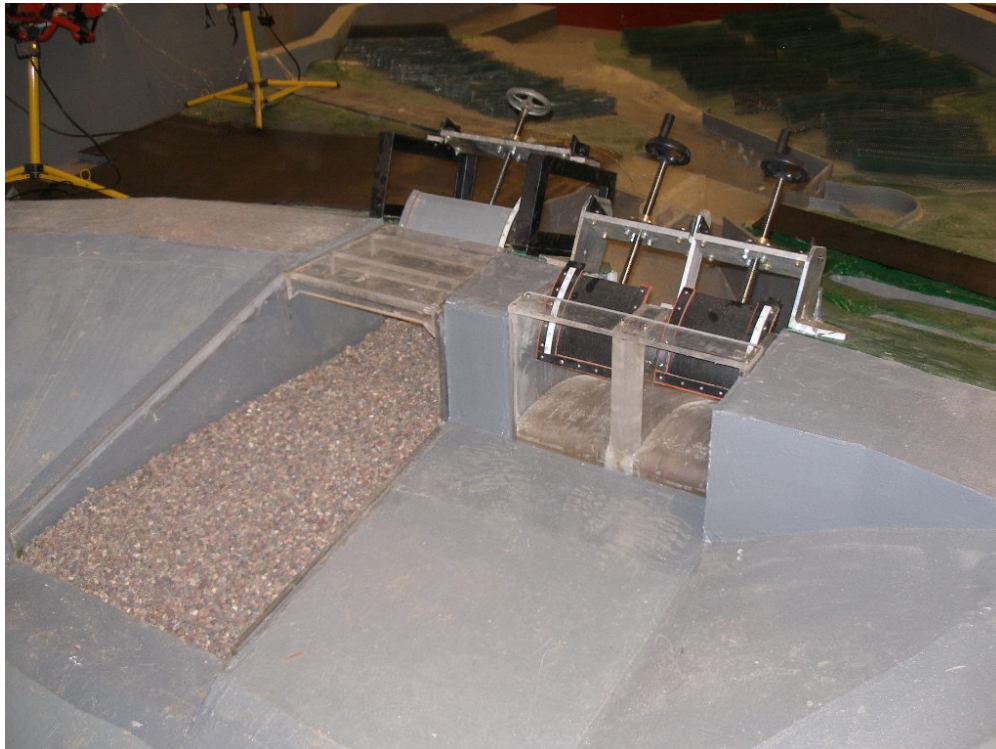
**Figure 3.12.** Upstream view of the spillway Design-1 Modified-1.

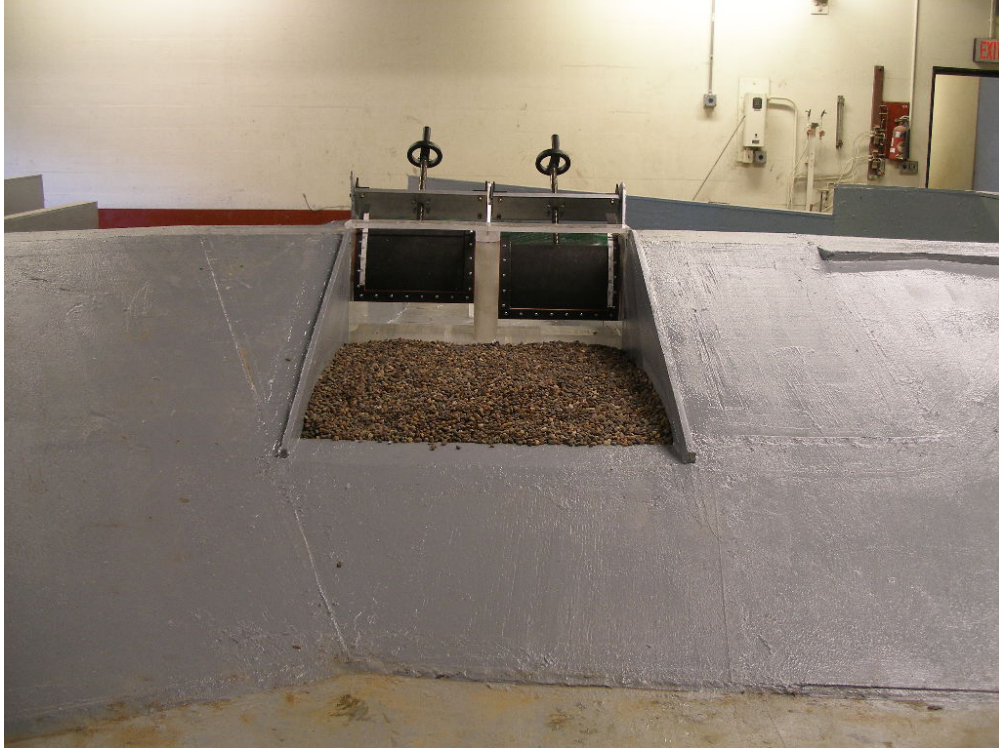
**Figure 3.17.** Upstream view of the spillway Design 2

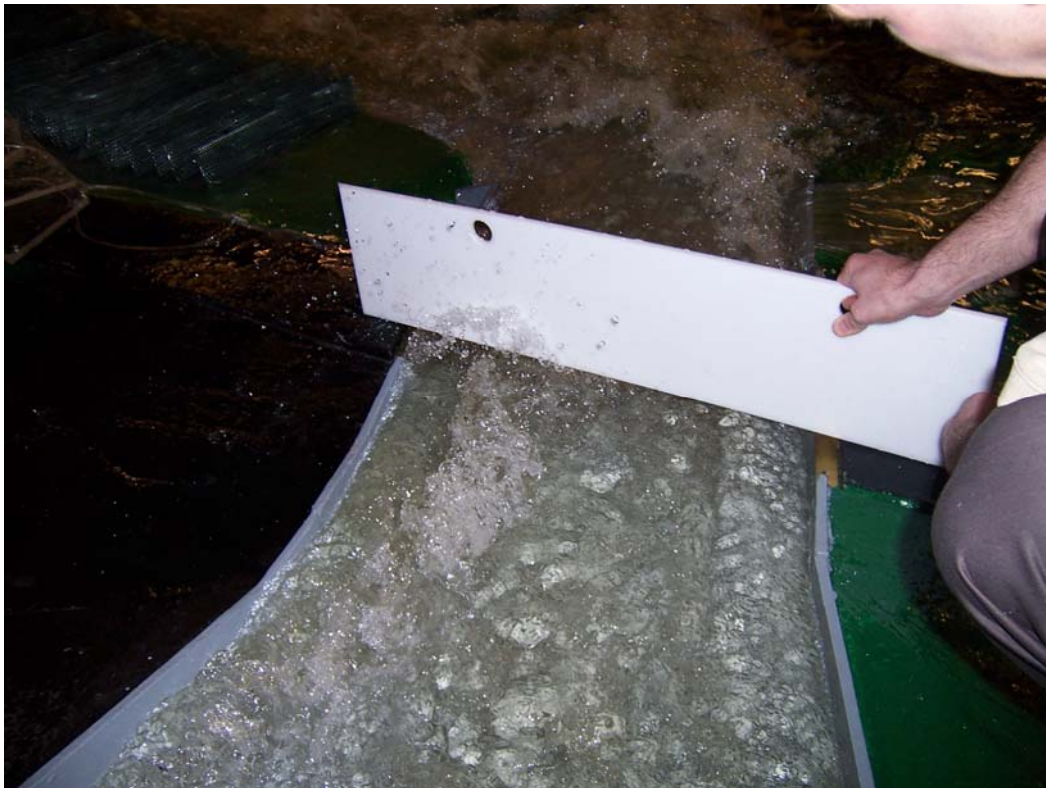
**Figure 3.20.** Under the spillway Design-2, but with no bridge in, water flowed through the channel without overtopping the side walls. By placing a plastic board over the channel walls the standing wave hit the board and splashed over the west side wall
