A Research Plan and Report on Factors Affecting Culvert Pipe Service Life in Minnesota

Jeff Marr, Principal Investigator
St. Anthony Falls Laboratory
University of Minnesota

September 2012

Research Project
Final Report 2012-27

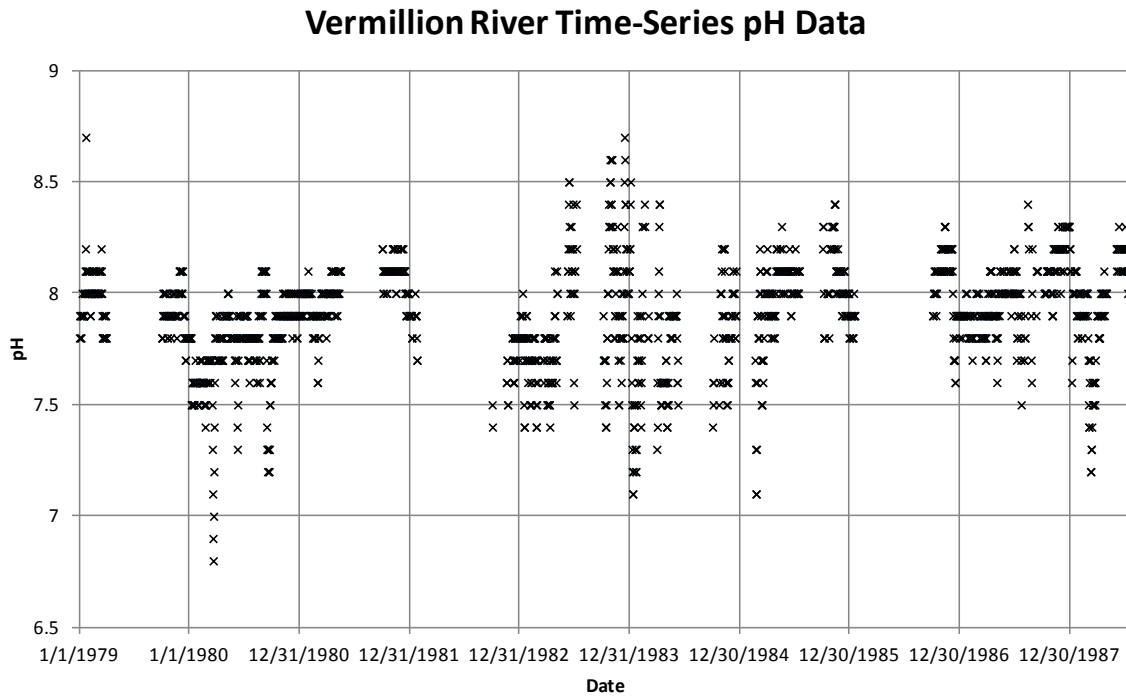
Figure 3 – Time-series pH data for the Vermillion River

The California Method is silent about the best time of year to take pH samples and does not specify if samples are for extreme values or for average values. Non-continuous sampling conducted in the California study implies an average pH assumption. USGS pH time-series data for the Minnesota River and Vermillion River are provided in Figure 3. On the Vermillion River there is no discernible seasonal trends in pH. On the Minnesota River the pH appears to be lowest during the winter months. This trend is most likely due to lower flows and less biologic activity in the watershed during the winter. Based on these results, summer pH samples are more likely to yield an average pH seen at a pipe than winter samples.

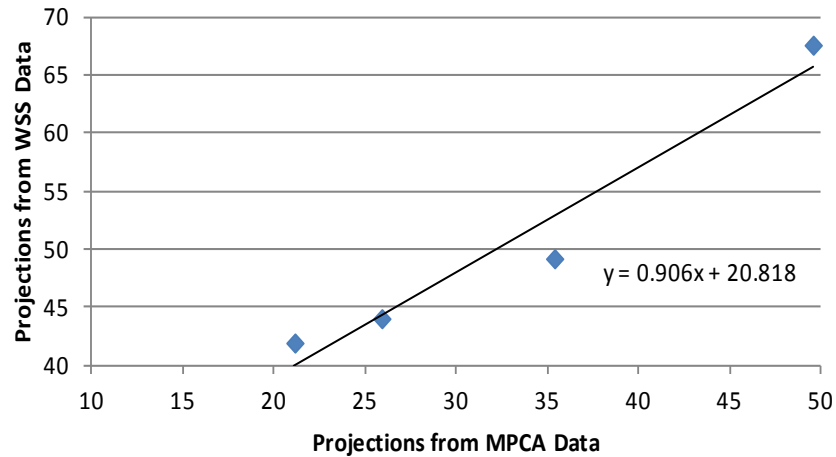
Figure 6 – 16G galvanized pipe service life as estimated by the California Method comparison plot (Tabular data available in Appendix C)

The MPCA has shallow groundwater data available around the state. Most of the sites have groundwater tables greater than 20 feet below the surface. For the sites less than 20 feet deep, 16-gage, galvanized pipe life was estimated using both the MPCA groundwater data and the WSS data. An image of the well locations that are less than 20 feet deep is provided in Figure 4. Figure 5 is a comparison plot of the pH data and Figure 6 is a comparison plot of the projected pipe life. Figure 5 shows that there is a weak correlation between MPCA pH data and WSS pH data. Figure 6 shows that the WSS will project 16-gage, galvanized pipe service life about 20 years longer than MPCA groundwater data will. The differences in the service life projection can be attributed to the WSS predicting higher resistivity than observed in MPCA data.

16G Galvanized Pipe Life Comparison

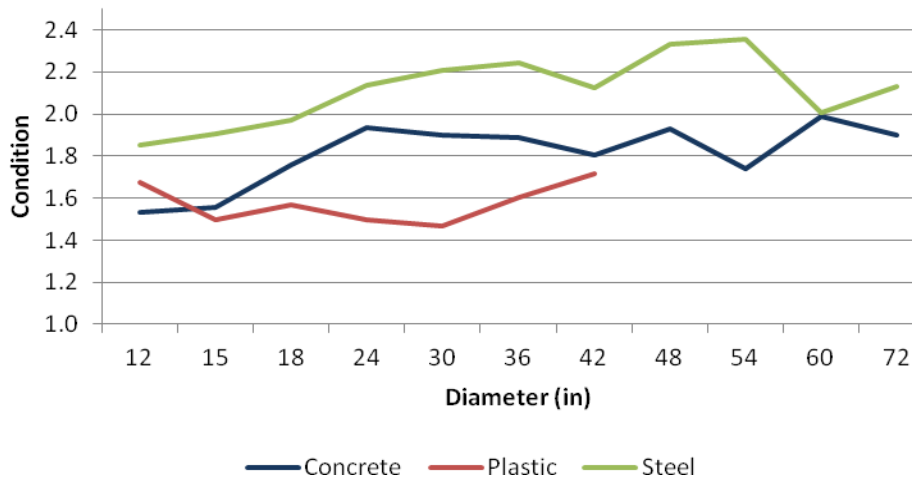
Figure 10 – Average condition by pipe diameter for all pipes excluding pipes with a condition 0 rating.

Tables 5 and 6 and Figure 10 explore the influence of pipe shape and size on condition. The average size and length for each pipe type does not vary much; although, concrete pipe seems slightly favored for larger installations. This is consistent with the finding of Task 2. Figure 10 shows a trend of poorer condition for larger diameter pipes of all material types. This could be because large diameter pipes are more difficult to install, or larger diameter pipes are more difficult to replace and therefore older. The condition does not vary much for the different

concrete pipe shapes. Elliptical concrete pipes are the exception. The lower condition for elliptical concrete is most likely due to a much smaller sampling size. It should be noted that shape is reflective of the current installed shape and the not designed shape. For example, there has not been elliptic or arch plastic pipe specified in any MnDOT plans. Plastic pipe listed as elliptic and arch plastic pipe are likely actually deformed pipes or liners that have been molded to elliptic or arch pipes.

Average Condition by Pipe Diameter

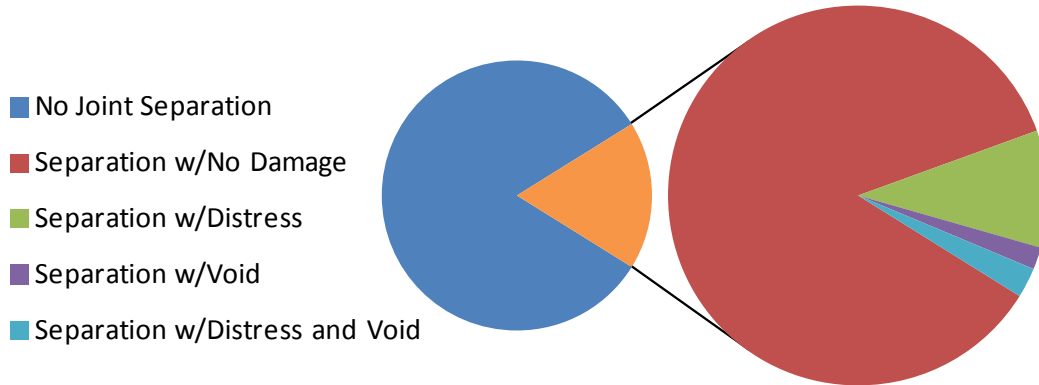
Figure 11 –Road damage where concrete pipes (both centerline and entrance) have joint separation

Joint separation is a common problem with concrete pipe. Table 9 and Figure 11 investigate the instances of joint separation and road damage. The Metro District has the lowest rate of joint separation and District 8 has the highest rate of joint separation. Although it is expected that joint separations cause road damage there are likely mitigating factors. For example, District 8 has the highest incidence of joint separation, but do not lead to a higher rate of road damage. Metro has a higher percentage of pipes that are storm drain systems and has been installing gasketed RCP in recent years both of which may be less susceptible to joint separations. Soil types, joint treatments, and different pavement types may bridge joint separations to prevent road distress.

Concrete Pipe Joint Separation & Road Damage

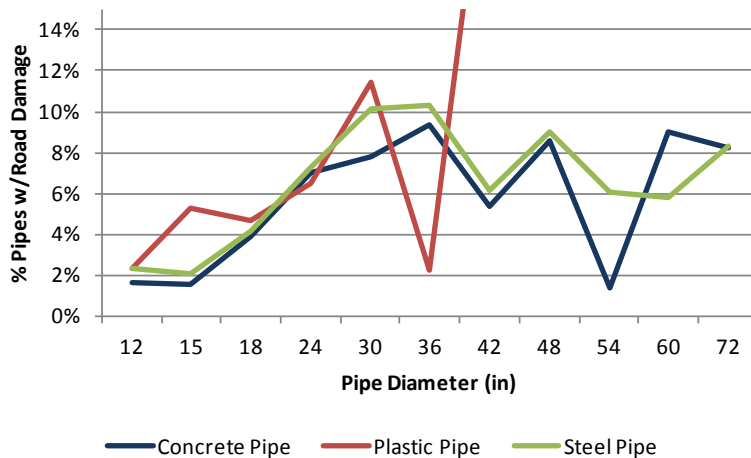
Figure 12 – Tendencies of road damage for various pipe sizes (both centerline and entrance)

Incidences of road damage do seem to depend on pipe diameter (Figure 12). Large spikes up and down in Figure 12 are due to small sample sizes. Medium sized pipe have highest probability of road damage. One possible explanation is that the larger pipe size the more material is displaced and the higher the risk is of soil shifting causing road damage; however larger pipes also get more vigorous testing and inspection. Medium pipes displace a significant amount of material, but their common use (Table 5) reduces the amount of inspection and testing they receive.

Trends in Pipe Size and Road Damage
