Crack and Concrete Deck Sealant Performance

1. Report No. MN/RC 2009-13	2.	3. Recipients Accession No.	
4. Title and Subtitle Crack and Concrete Deck Sealant Performance		5. Report Date March 2009

Final Report

March 2009

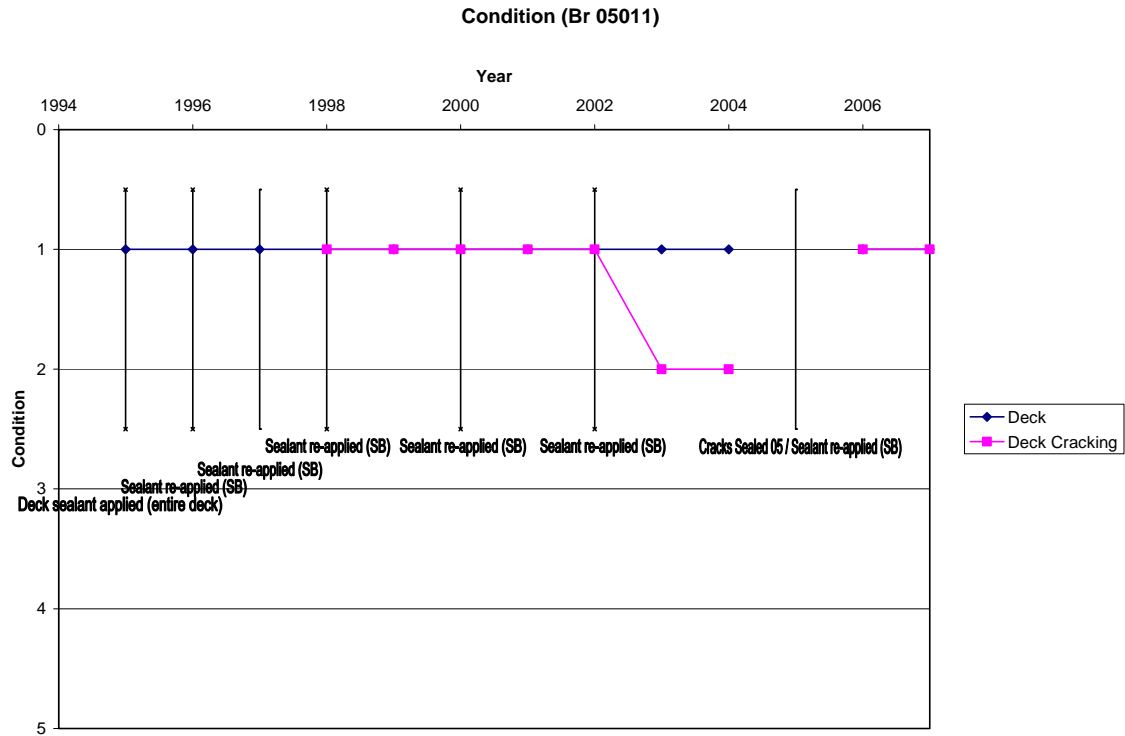
Figure 1. Bridge of Hope Deck Inspection Condition

Multiple bridge inspection reports were reviewed in order to determine the effect sealing had on bridge condition. The condition rating versus time was graphed for three bridge decks with known deck and crack sealing activity. Little information became evident after reviewing the plots. The plot for Bridge of Hope (bridge from Nancy Whiting's study seen in Figure 1) shows that the deck wearing surface rating stayed constant from 1995 to 2007. However, it is not possible to determine if these results would be similar if the seven applications of water-based silane had not been applied to the south-bound section of the bridge deck. The deck is rated with a scale of one through five. A score of one indicates the best condition while a score of five indicates the worst condition.

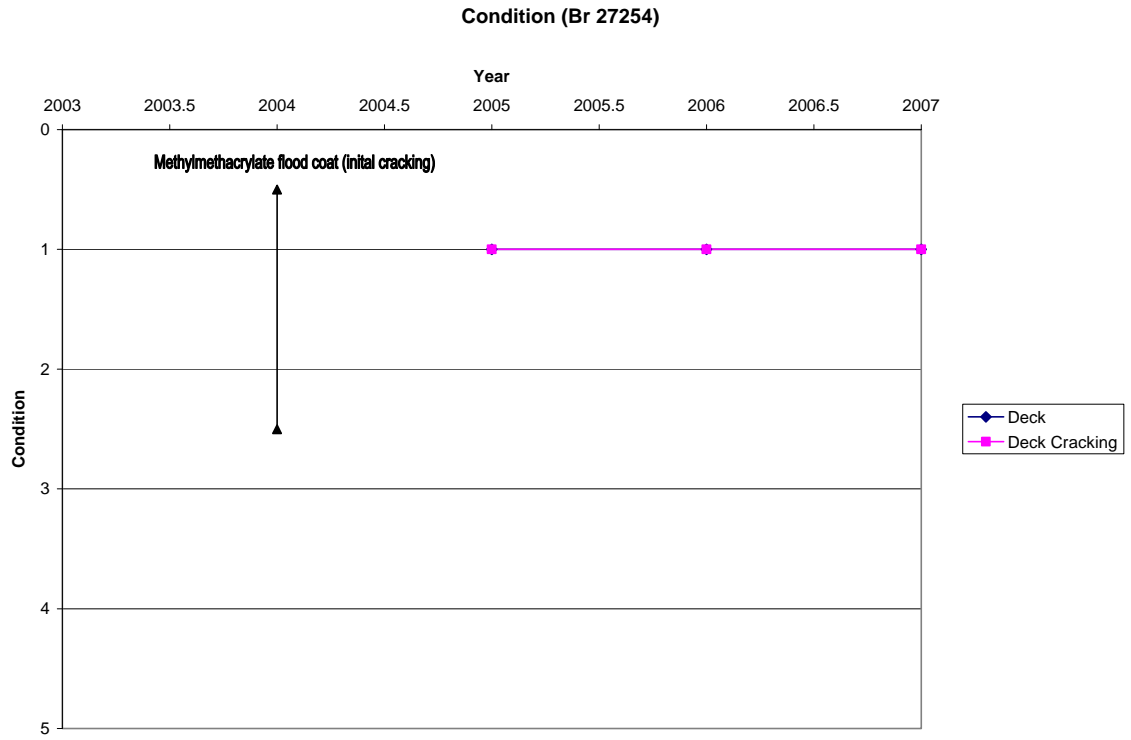
Bridge number 27254 sustained a large amount of early age cracking after construction in 2004. Because of this, the deck was sealed with a methyl-methacrylate flood coat to repair the cracks. Bridge inspections indicate a perfect rating for deck cracking in the three subsequent years after sealing (seen in Figure 2). However, it cannot be determined if the bridge inspector verified whether debonding or cracking occurred in the previously sealed crack. Because of this limitation, one cannot determine if the sealer did an adequate job of sealing the cracks without some other form of testing (depth of penetration, chloride content, coring, etc.).
