Advanced LED Warning System for Rural Intersections: Phase 2 (ALERT-2)

Minnesota
Department of
Transportation

Taek M. Kwon, Principal Investigator
Department of Electrical Engineering
University of Minnesota, Duluth

Research Project
Final Report 2014-10

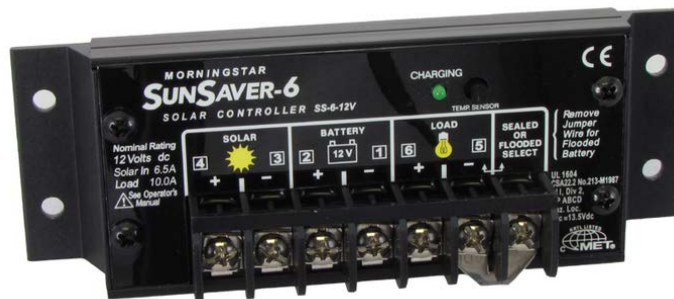
Figure 10: Morningstar SunSaver-6 solar charge controller.

The charge controller used in this project is Morningstar SunSaver SS-6-12V (Figure 10). This charge controller is used for charging AGM batteries. The SunSaver-6 is rated for 12 V systems and uses an advanced series Pulse Width Modulation (PWM) charge control for constant voltage battery charging. The maximum solar array open circuit voltage is 30 V. The operating power consumption is 8 mA. Use of cooper wires between 10 AWG and 14 AWG are recommended. Therefore, 12-AWG wires are used to connect the charge controller with the solar panel and battery.

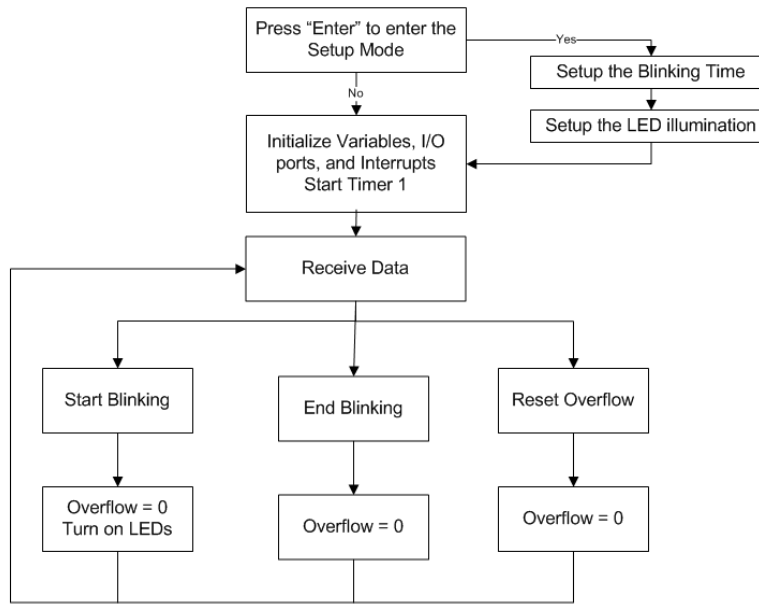
Figure 22: Blinker 1 firmware flow diagram.

Blinker sign S1 is responsible for processing the wireless signals received from both of the radar detectors (D3 and D4). A software flow diagram for blinker sign S1 is illustrated in Figure 25. First, the user will be asked to press “Enter” to enter the setup mode or wait for 2 seconds to start the main routine. Two parameters can be set by the user through the HyperTerminal interface: the blinking time and the LED illumination. After insertion of the required parameter, the main routine starts with defining variables and initializing Ports A, B, C, and the Timer 1 interrupt. Then, the program waits for incoming data. Three types of signals can be received from either of the FMCW radar detectors: The first signal is a “START” blinking signal. When this signal is received, a vehicle has entered either one of the detection zones at the intersection. Here, the overflow counter is reset and the blinking LEDs are turned on. The second signal is an “END” blinking signal. When this signal is received, a vehicle has exited either one of the detection zones at the intersection. Here, the overflow counter is reset and the LEDs are turned off. The third signal is an “ALIVE” signal. When this signal is received, the overflow counter is reset. If a “START”, “END”, or “ALIVE” signal is not received from a Radar detector for more than 12 minutes, the blinker sign will enter fail safe mode and the LEDs will blink continuously, until receiving any new signal.

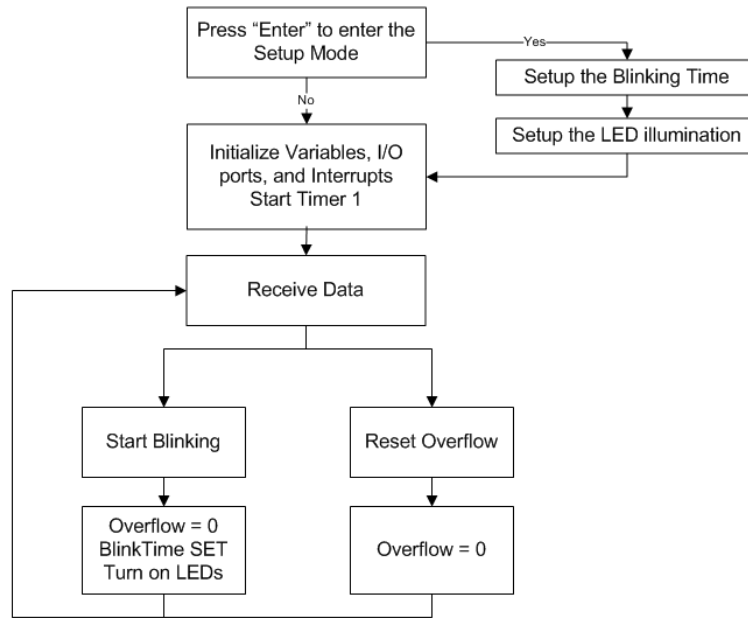
Figure 23: S2, S3, S4 and S6 firmware flow diagram.

Blinker warning signs S2 and S3 are responsible for processing the wireless signals received from the Doppler radars D1 and D2, while the STOP Blinker signs S5 and S6 are responsible for processing the wireless signals received from the Doppler radars D5 and D6. The software flow diagram is illustrated in Figure 26. First, the user is asked to press “Enter” to enter the setup mode or wait for 2 seconds to automatically start the main routine. Two parameters can be set by the user through the HyperTerminal interface: the blinking time and the LED illumination. In the main routine, variables, Port A, Port B, Port C, and Timer 1 and its interrupt routine are initialized. Then, the program waits for incoming data from the Doppler detectors. Two types of signals can be received from a Doppler detector. The first signal is a “START” blinking signal. When this signal is received, it indicates that a vehicle has been detected. Here, the overflow counter is reset, the “BLINKTIME” variable is set to 9.5 seconds for S2 and S3, and 10 seconds for S4 and S6, and the blinking cycles of LEDs are turned on. The blinking LEDs are turned off when the “BLINKTIME” variable reaches zero. If another “START” signal has been received before the “BLINKTIME” variable reaches zero, the “BLINKTIME” variable is reset. The second signal is an “ALIVE” signal. When this signal is received, the overflow counter is reset. If either a “START” or “ALIVE” signal is not received from the Doppler detector for more than ten minutes, the blinker sign will enter the default mode, and the LEDs will blink continuously until a new signal is received.

When a detector unit completely fails such as out of battery, it will be unable to send an “ALIVE” signal to its respective blinker sign. A fail-safe mode has been implemented into each blinker sign based on a timeout. If a blinker sign has not received any type of wireless signals for more than twelve minutes, it will enter into the fail safe mode and the LEDs will continuously blink until a new data is received. This assures that if a vehicle detector is not working but sign is working, the blinker sign is automatically switched into a traditional blinker sign which continuously blinks.

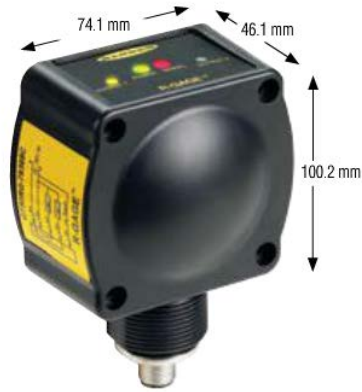
Figure 25: Banner R-Gage QT50RAF radar [19].

The FMCW Radar detector tested is the Banner R-Gage QT50RAF Sensor (Figure 28). This radar is the same radar used in the first phase, ALERT-1, with the same configuration. This radar sensor uses Frequency Modulated Continuous-Wave (FMCW) radar. It transmits a frequency sweep, often called a chirp which is reflected from distant targets and detected by the receiver. By measuring the frequency of the return signal, the time delay between transmission and reception can be measured, and thus the range is determined. Advantages of this sensor are that it can detect both moving and stationary objects. Also, using the R-Gage Radar sensor allows to set a detection zone near each stop sign. Vehicles are detected as they enter the detection zone and remain detected until they leave the detection zone. The sensor can be configured (via DIP switch) to sense objects up to a specific distance, ignoring objects beyond this distance. The detection zone is typically set between 3m – 15m from the sensor. Also, the sensitivity, output configuration, and response speed can be adjusted. Figure 29 describes the radar LED indicators. Figure 28 shows the Banner R-Gage Radar sensor.

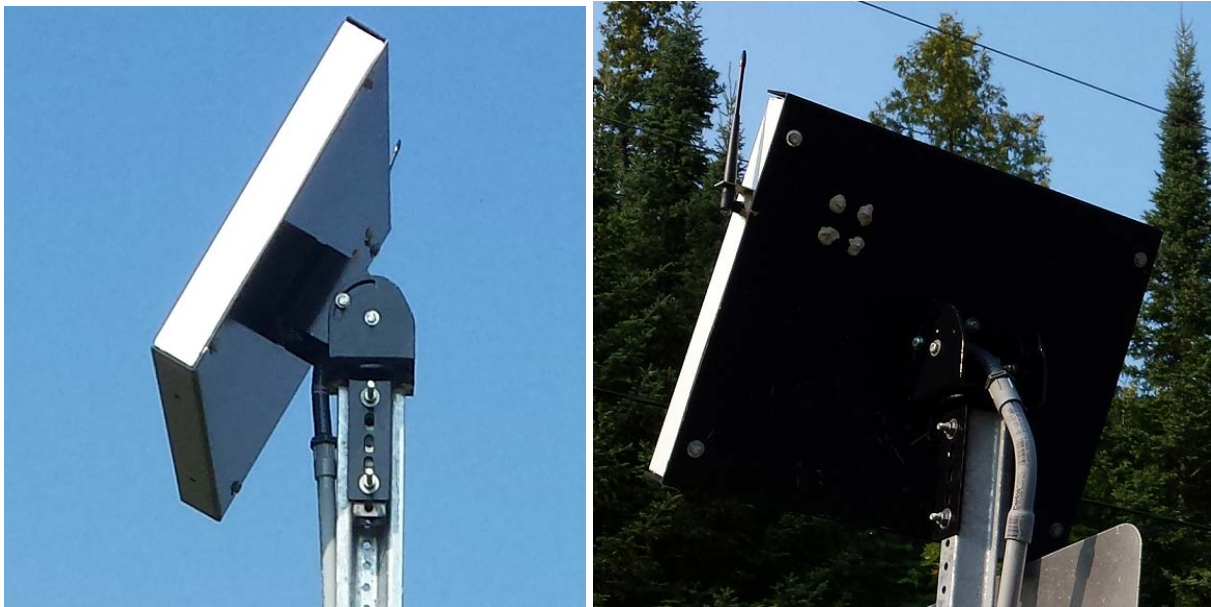
Figure 38: Solar panel housing and its mounting bracket.

The solar panel used in the ALERT-2 system is the bp Solar SX 420J. A custom designed enclosure was used to mount the solar panel. It allows the wireless module to be mounted inside the solar panel housing using four small attaching screws. The solar panel is attached to its enclosure via four self-tapping screws. Rubber weather strips along with the edges of the solar panel housing creates a seal when the two units are screwed together. This protects the wireless module inside from rain and snow. The antenna is mounted on the outside of the solar panel in either left or right upper corner and connected to the wireless module. All screw holes are sealed with white DAP Adhesive Caulk Seal. Each assembled solar panel and housing is attached to a solar panel mounting bracket. This bracket is designed to mount the solar panel to a u-channel sign post. It also allows the solar panel to be adjusted both horizontally and vertically. Figure 41 shows pictures of the solar panel housing and its mounting bracket. Each solar panel has seven connection wires, each wire with 12ft length to make the connection from the solar panel to the battery cabinet. Table 16 summarizes the solar panel wiring details.

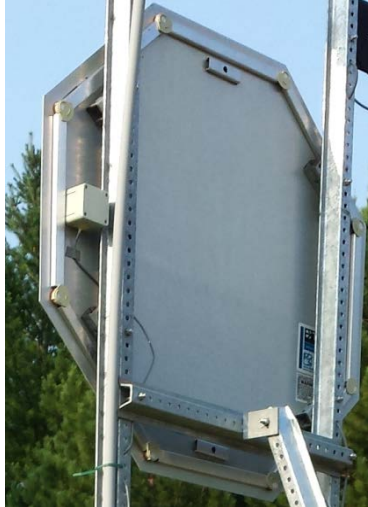
Figure 39: Back side of a blinker sign.

Typical blinker signs commercially available contain electronic control circuits and battery on the back of the sign. The blinker signs purchased for this project contains no electronic circuits and batteries, except LEDs on the perimeter of the sign. A small junction box was attached on the back side of the blinker sign to connect wires from the control cabinet which contains battery and the control circuit. Figure 42 shows the back side of a blinker sign.

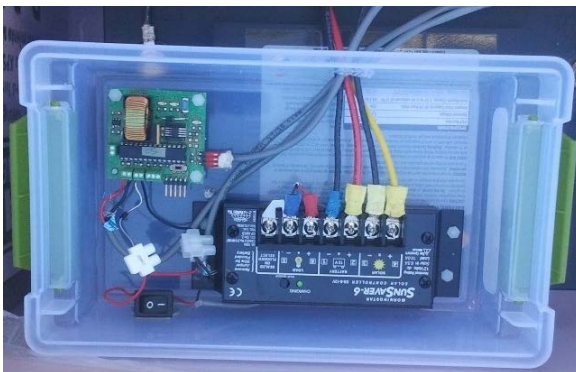
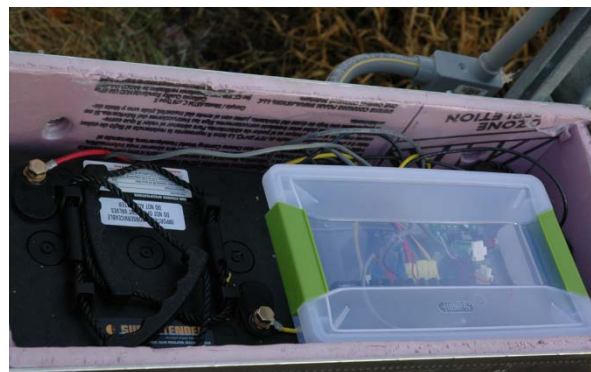
Figure 40: A clear plastic box is used to house controller circuits and placed inside the battery enclosure.
