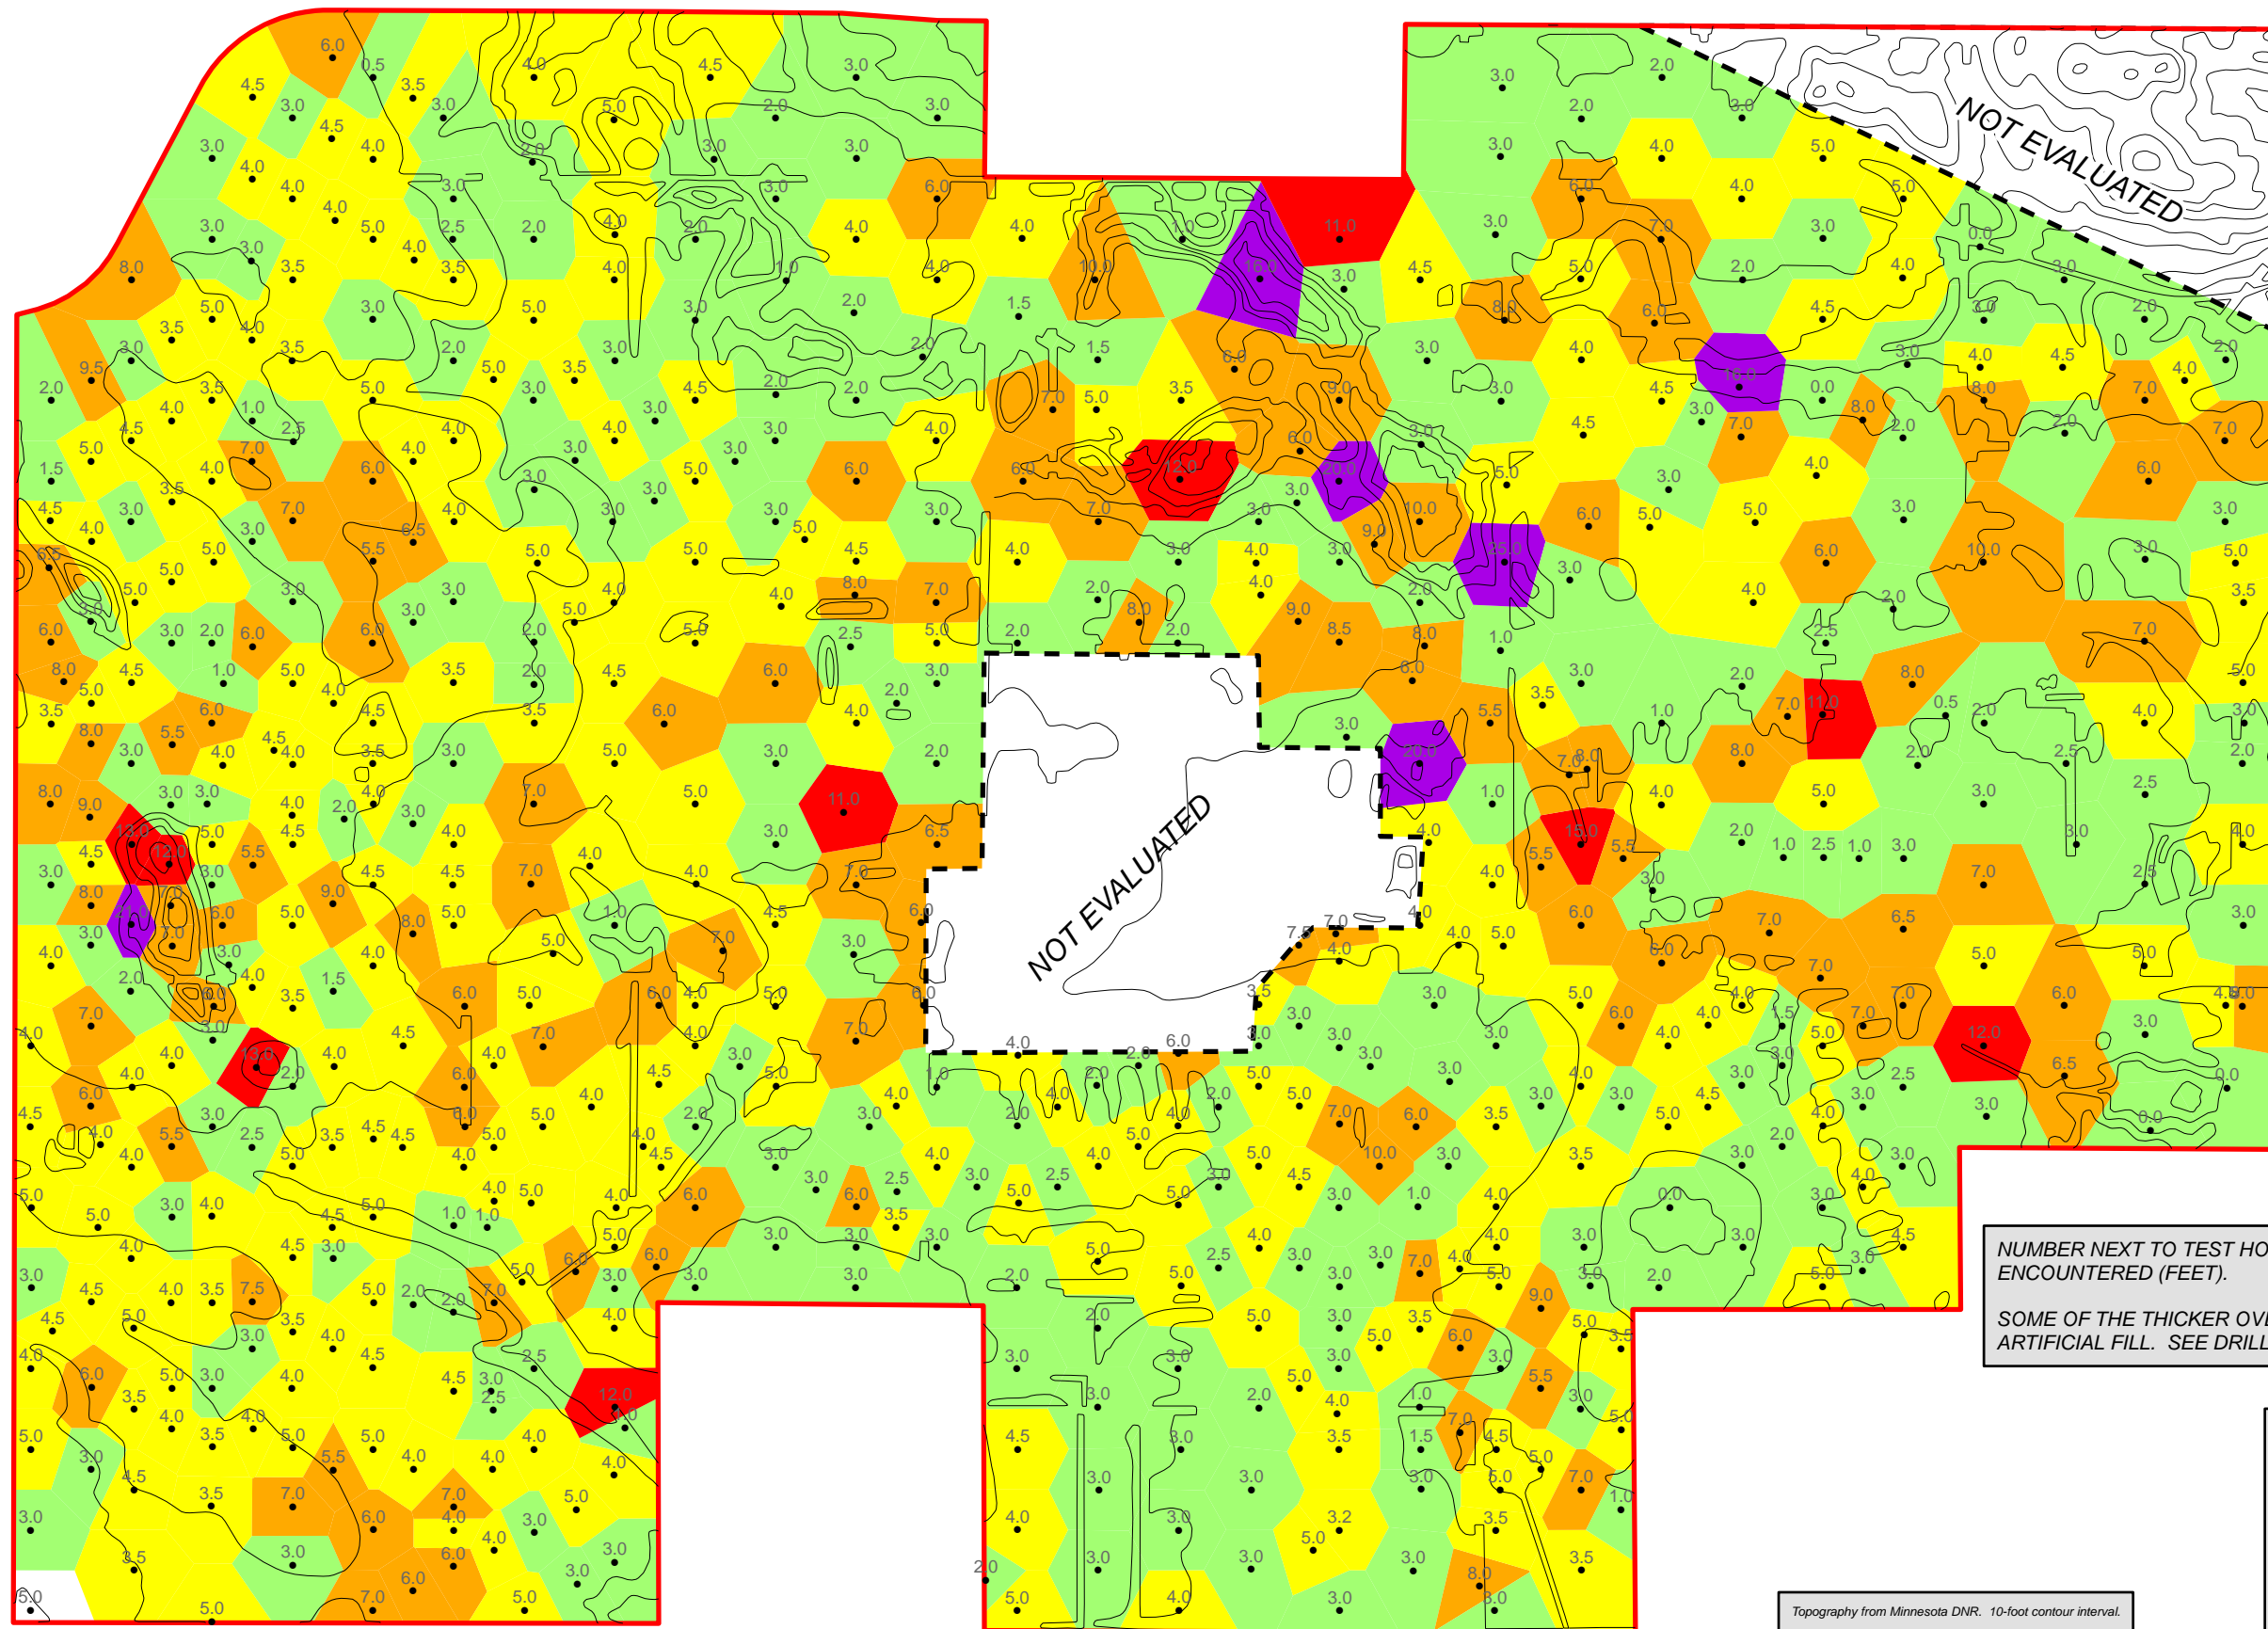
Overburden Thickness (ft.)

NUMBER NEXT TO TEST HOLE INDICATES THICKNESS OF OVERBURDEN ENCOUNTERED (FEET).
 SOME OF THE THICKER OVERBURDEN ENCOUNTERED WAS IN AREAS CONTAINING ARTIFICIAL FILL. SEE DRILLING LOGS FOR DETAIL

Topography from Minnesota DNR. 10-foot contour interval.
