Restoring Our Edge: Rehabilitating the Mississippi Shoreline in Ramsey

Students in PA 5211 Land Use Planning

RESTORING OUR EDGE

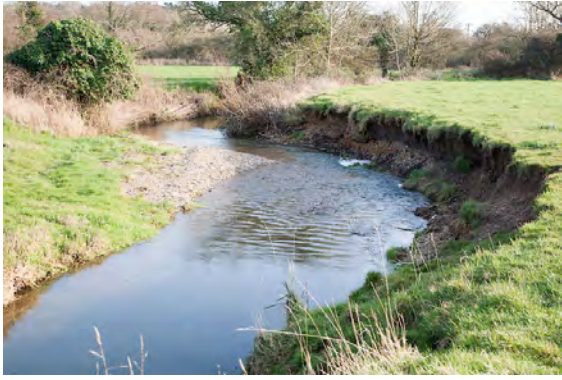
Slight to Moderate Erosion

Shoreline erosion is caused by natural factors and land use practices. To prevent erosion, avoid excessive mowing and removing vegetation along your property's edge. If erosion already exists on your property, effective restoration techniques can be implemented. Below are illustrations of the three categories the Anoka Conservation District uses to define shoreline erosion severity.

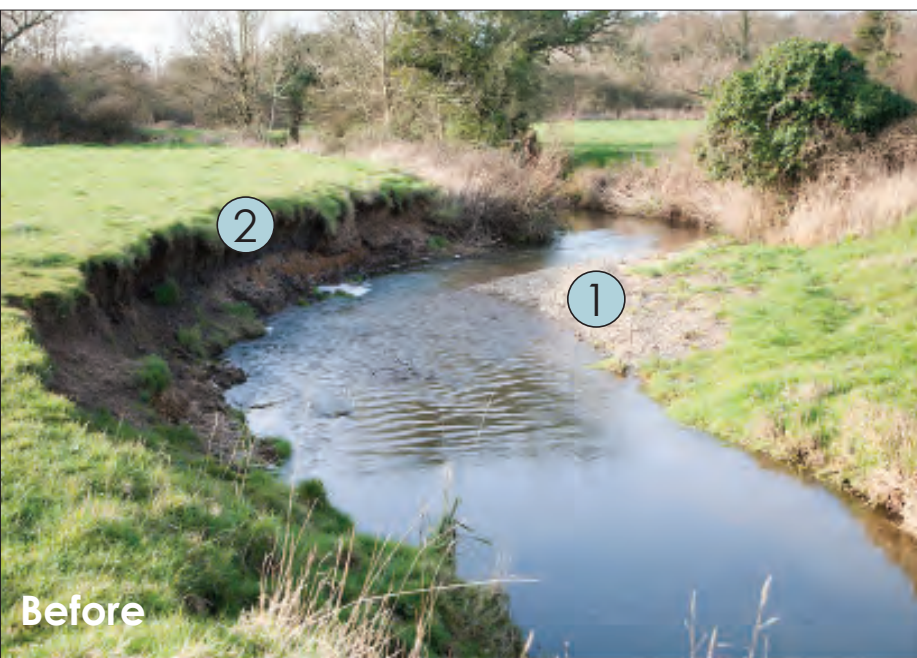
Slight to Moderate Erosion

- 1 Bare bank
- 2 Vegetative overhangs

Bare bank

Vegetative overhangs

Case study cross section, NTS

Slight to moderate erosion includes areas with some bare banks, but where active erosion is not readily apparent. Some vegetative overhang and some exposed tree roots may be present, but no slumps or slips are visible.

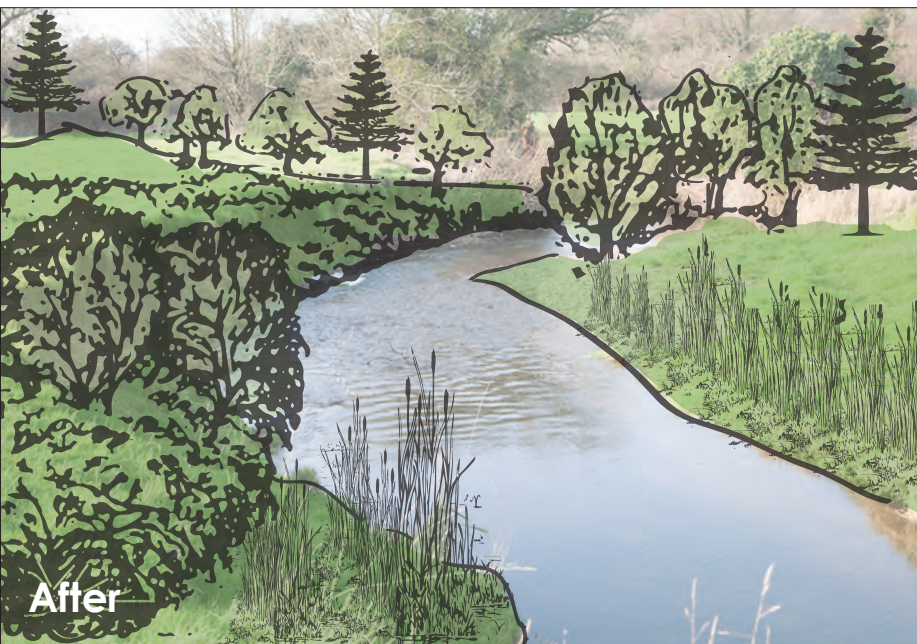
Restored Shoreline

Revegetation, which involves replanting with native vegetation, was used to stabilize the shoreline. The deep roots of these plants bind the earth below tightly, effectively protecting the shoreline from erosion.

Vegetative stabilization

Case study cross section, NTS

This strategy was chosen because it is a relatively easy and cost-effective method of shoreline restoration for areas with slight to moderate erosion. After consultation with an engineer, this method can be completed by the landowner.

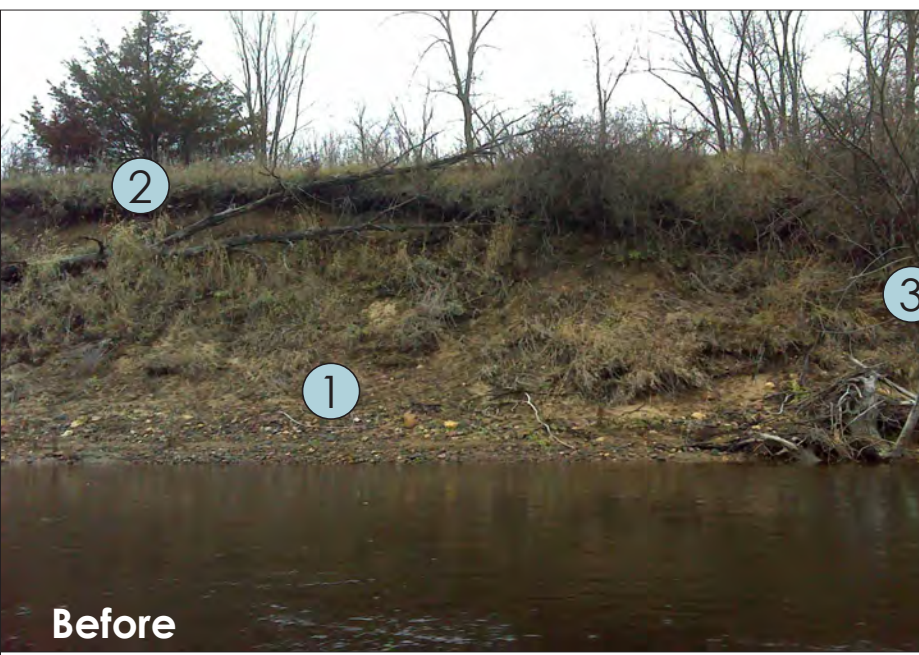
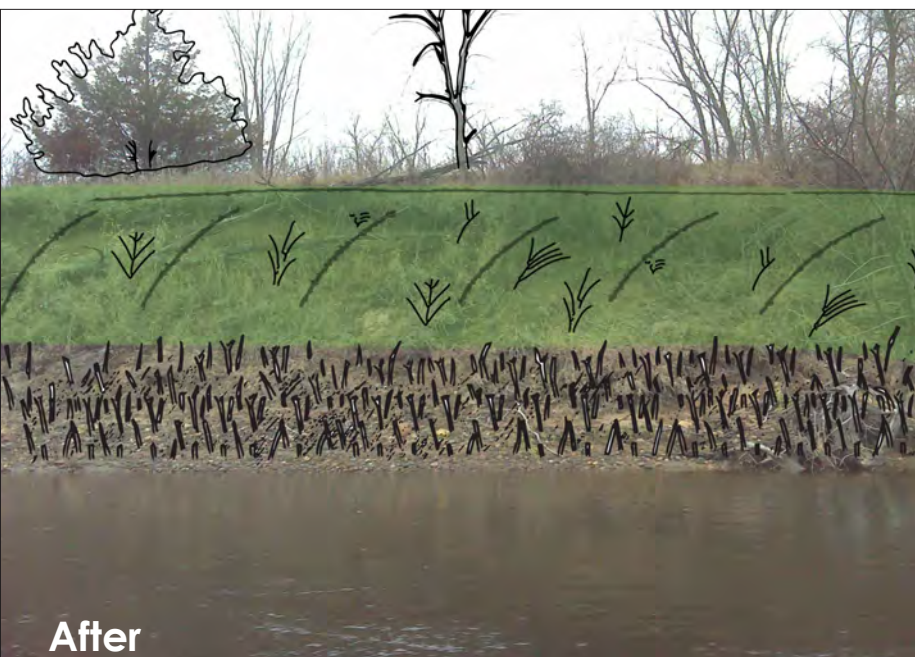
Severe Erosion

- 1 Bare bank
- 2 Vegetative overhang
- 3 U-shaped slope

Severe erosion is identified as a bare bank with visible vegetative overhang and rills. Often there will also be exposed tree roots and even fallen trees. A cross-section view of the river channel would show a U-shaped slope rather than an uneroded V-shape. The Anoka Conservation District considers shorelines that lose 0.3–0.5 feet per year to be experiencing severe erosion.

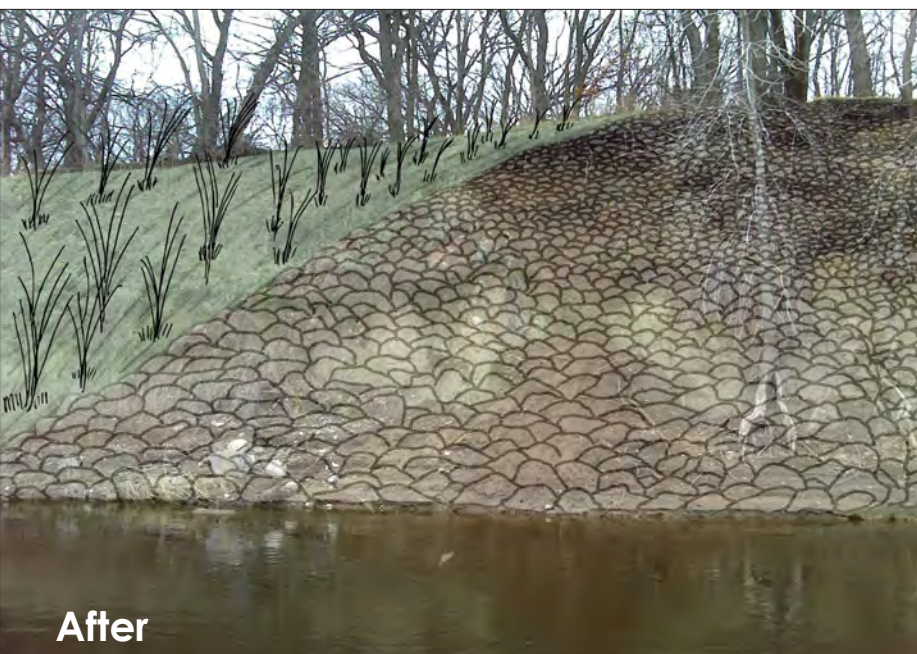
After

The bank was backfilled with soil and graded to reestablish a gradual slope. Riprap (mixed-size rock) was then laid over geotextile fabric to further protect the edge. Native vegetation was also planted.

Hard armoring with riprap is a common restoration technique for severely eroded edges. This strategy was chosen to stabilize the bare soil and prevent erosion caused by wave action. Native vegetation was also added in adjacent areas with less severe erosion to stabilize the edge and provide wildlife habitat.
