FORESTRY FACT SHEET No. 12-1979
LEWIS T. HENDRICKS, HOWARD L. GRANGE,
and LINDA J. CAMP

**Preventing Ice-Dams
on Minnesota Homes**

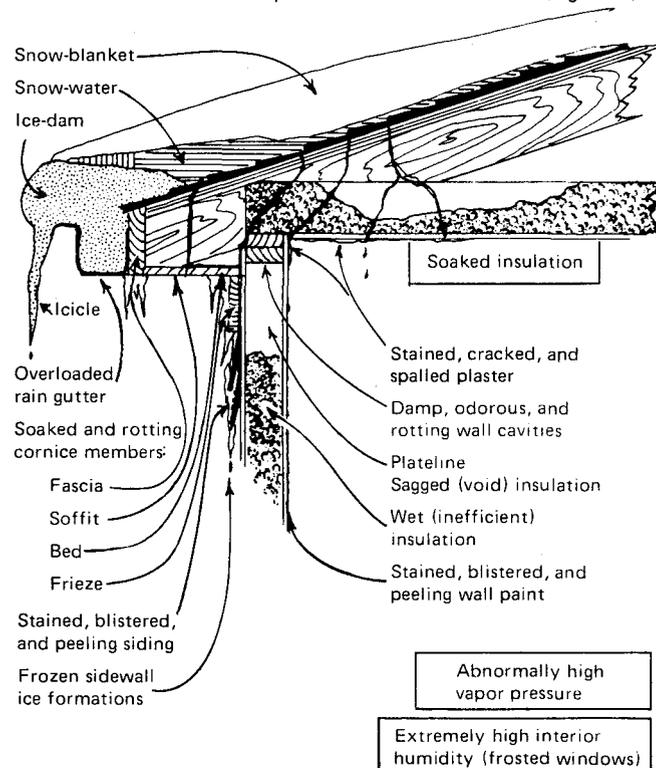
Figure 1. This sketch of the ice-dam problem identifies both the ice-dam and its damages. Of course, all the damages illustrated may or may not occur at any one instance.

In general, ice dams are formed when attic heat moves upward to warm the roof and melts roof-snow at or near ridge areas. Melting of snow occurs at the snow-shingle interface and runs downward (under the snow) as snow-water. At or near the edge of the roof, colder conditions exist that usually result in the freezing of the snow-water, thus forming the ice-dam. Subsequent melting of roof-snow usually accumulates as a pocket of snow-water that eventually backs up under the shingles to cause major damage in the plateline area. This damage can appear in the form of soaked (inefficient) insulation; stained, cracked, and spalled plaster or sheetrock; damp, odorous, and rotting wall cavities; and stained, blistered, and peeling wall paint, both inside and outside the house (figure 1).

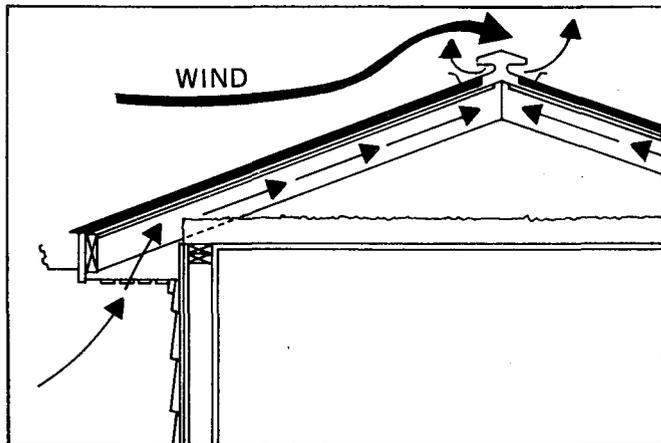
Figure 2. Movement of air when there is adequate insulation and ventilation.

The effectiveness of cold-surface snow behavior to avoid massive ice formations is exhibited everywhere in winterized snow country. There are no massive ice formations on felled timber, rock outcrops, woodpiles, picnic tables, sheds, and unheated buildings. In homes, continuous removal of attic air to maintain the roofdeck at atmospheric air temperatures requires minimizing the amount of heat entering the attic, together with free movement of air from eave inlets to uproof (ridge) outlets. In short, it means insulating room ceilings far more than customary to minimize heat losses and attic temperatures, and ventilating profusely at all eaves and ridge for a natural flow of air to sweep out the warmed attic air (figure 2).

When it comes to preventing ice-dams, it is impossible to have too much ventilation. The Northern States Power Company has recommended that homes have one square inch of ventilation for each square foot of ceiling. Ventilation should be equally distributed between inlet and outlet areas. Overall, the goal is to have a sweep of cooler outside air entering through the soffit which moves along the ridge rafters and exits through a ridge vent near the peak of the house as shown in figure 2.
