I N V E S T I G A T I O N O F A I R F I E L D D R A I N A G E
A R C T I C A N D S U B A R C T I C R E G I O N S

SUPPLEMENT TO PART I
FIELD RECONNAISSANCE AND ANALYSIS

Project Report No. 18

January, 1950

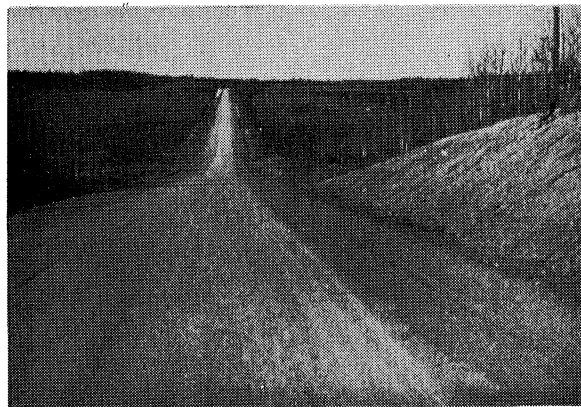
Typical Scenes of Alaska Highway near Blueberry, British Columbia

The cut slopes have been exposed to the weather for about four years
without noticeable damage due to erosion.

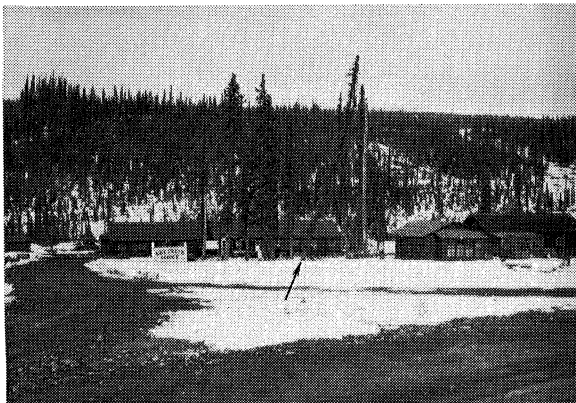
Local residents reported that tilted trees like the one at which the arrow is pointing were common occurrences.

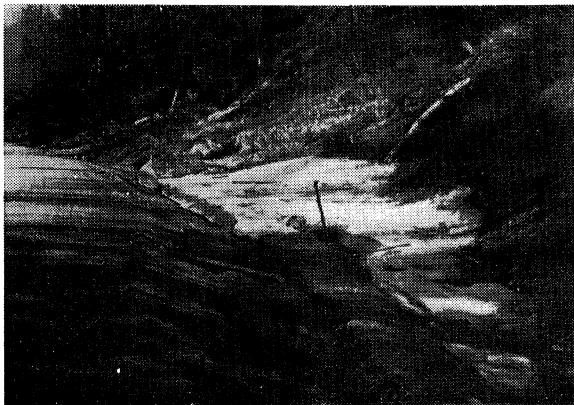
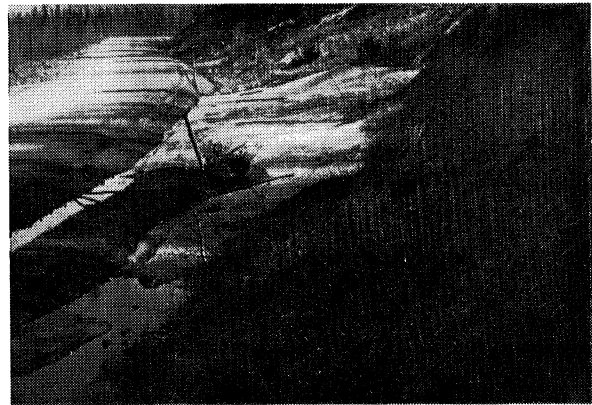
Icing at Muncho Lake

Springtime thaw had nearly melted this icing by May 20, 1949, the time the pictures were taken. The source of water is a spring.

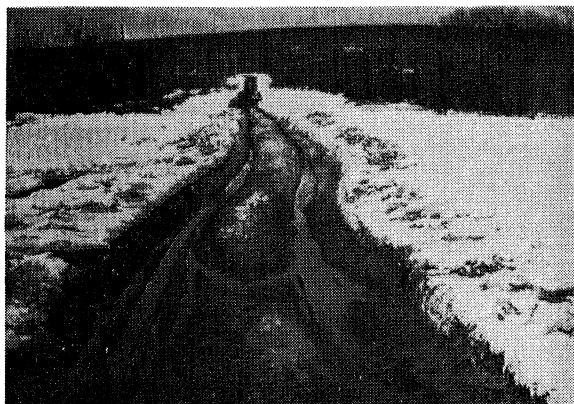
Icing on Elliot Highway at Dome Creek

On May 6, 1949, the blasting operation of April 27 revealed the handrail of a culvert which had been completely covered with ice.

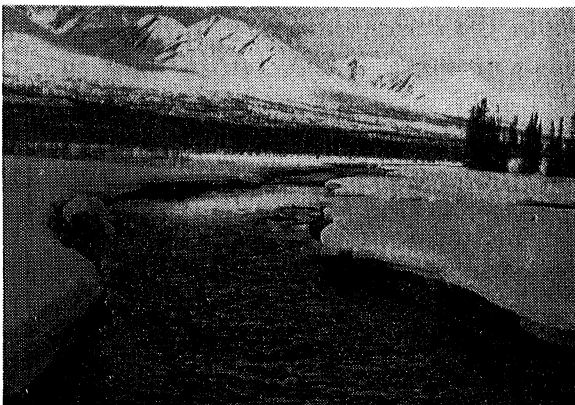
Icing on Johnson River, Alaska

The elevation of the top of the ice is several feet higher than the river stages even though discharges at the time of the pictures were greater than at the time of ice formation.

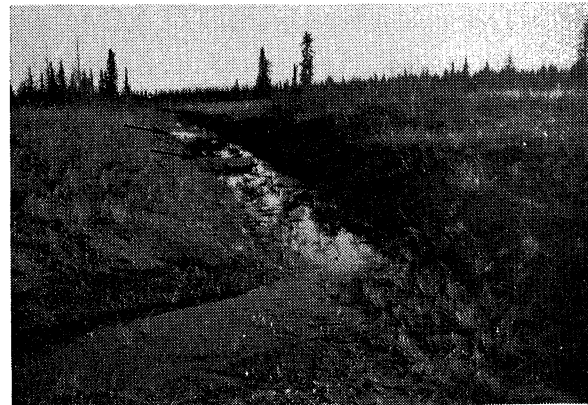
Remnants of icings are indicated by arrows.

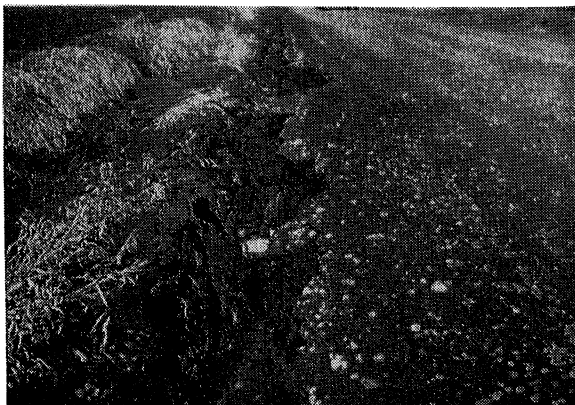
Erosion Resulting from a Thawing Active Layer

At both sites gullies had formed in a matter of a few days even though the active layer was still frozen.
