# Development and Integration of Advanced Timber Bridge Inspection Techniques for NBIS

**January 2015**

Research Project  
Final Report 2015-01

**BRIDGE # 69529  
CSAH 52 over DITCH**

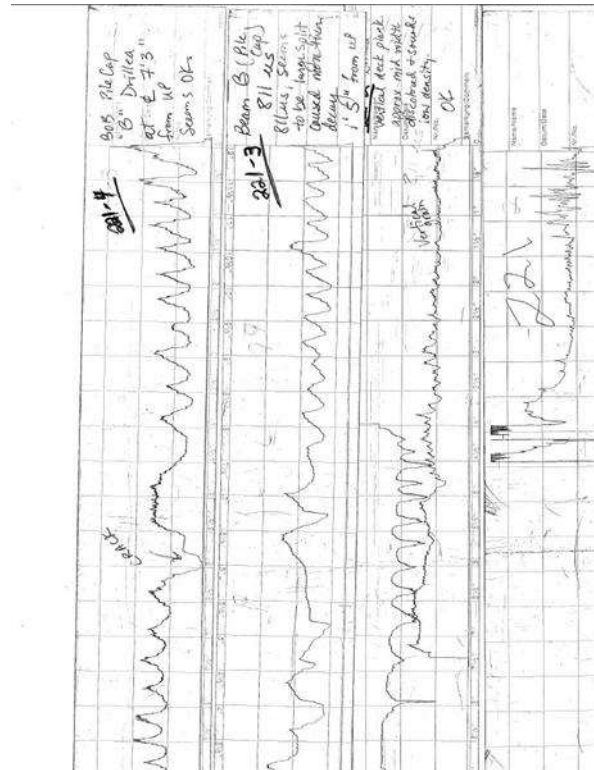
Photo 18 - Resistance drill data

Notes: All pilings CIP. Through splits are present on both the upstream and downstream pier cap. Moisture measures are above 25% MC. Moisture is entering splits from ends and through deteriorated bituminous wear layer. Resistance drill data confirms split, but does not indicate decay.

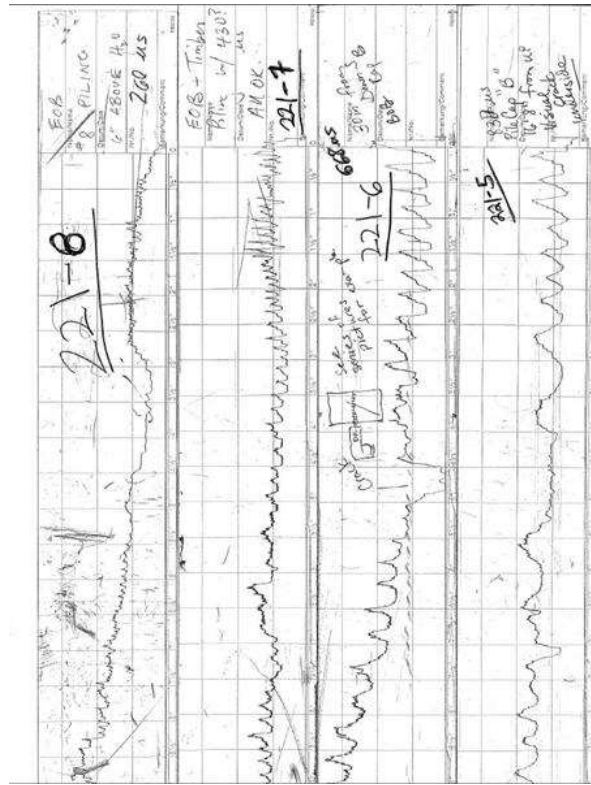
Photo 19 - Resistance drill data

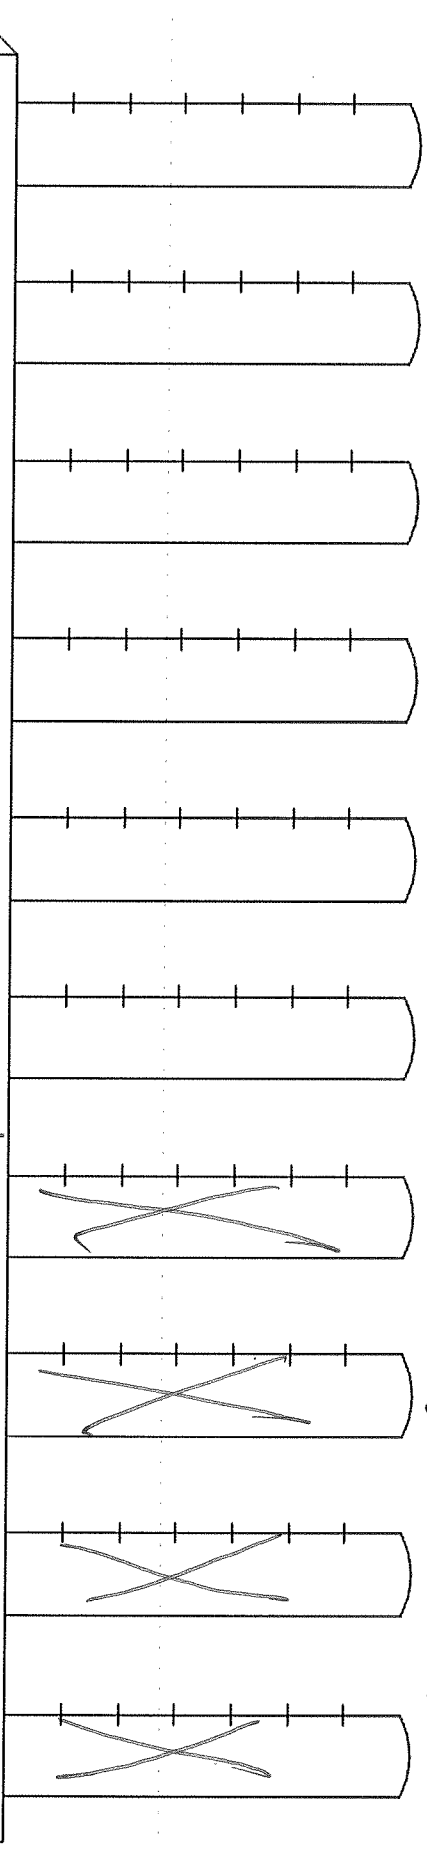
\* Significant rust and deterioration of steel CIP plate. See photos.

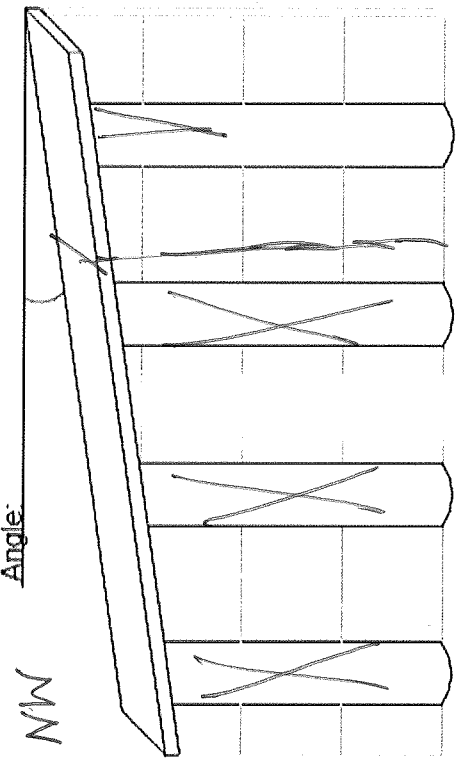
**BOB**

Notes: *Slight visual deterioration in piling.*

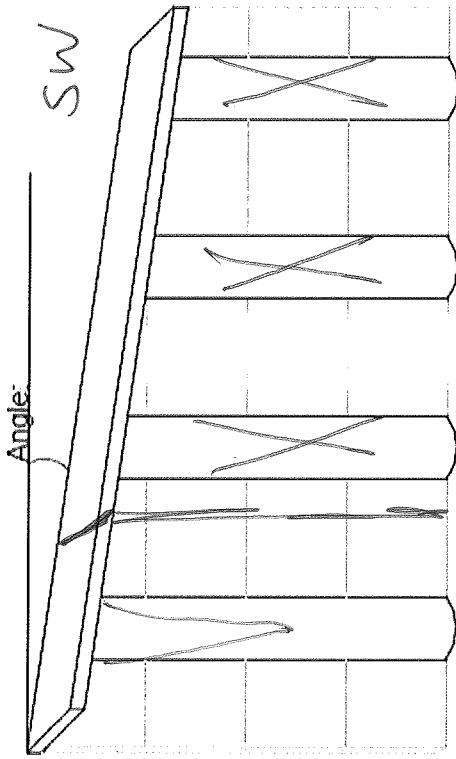
Notes: *Severe decay in piling. Visual.*

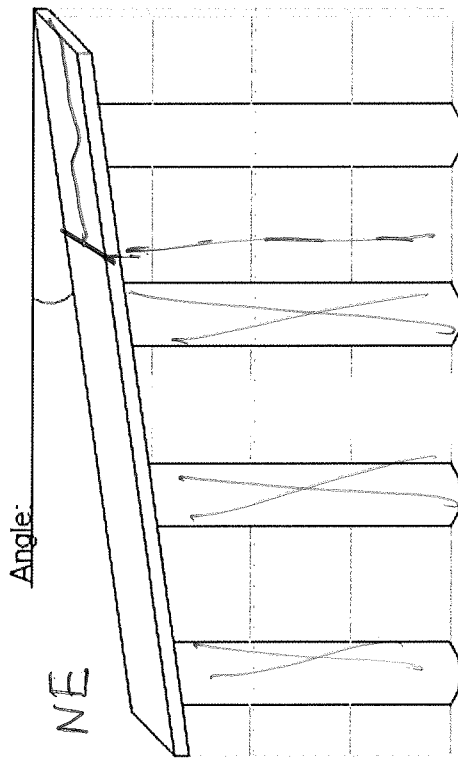
**EOB**

Notes: *50% of cap is decayed due to significant plant growth noted through hammer soundings & probe pick.*

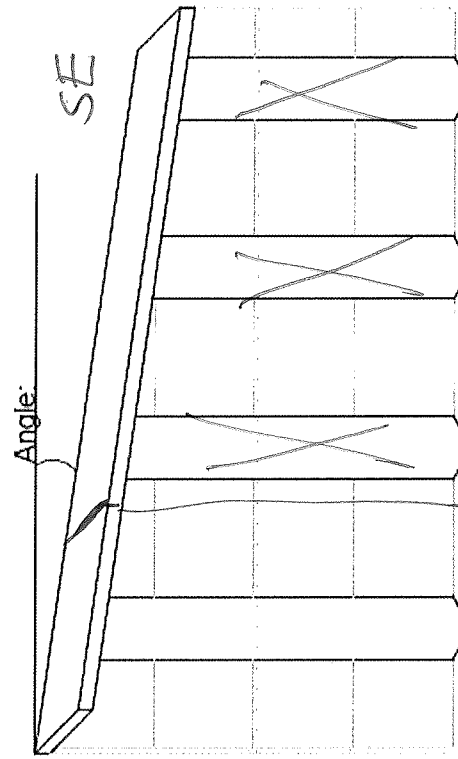
Notes: *Cap fully covered by deterioration potential future decay.*
