Condition and Durability of Segmental
Concrete Block Retaining Walls Along
Roadways in Minnesota

| 4. Title and Subtitle CONDITION AND DURABILITY OF SEGMENTAL CONCRETE BLOCK RETAINING WALLS ALONG ROADWAYS IN MINNESOTA | | 5. Report Date July 2001 | |

Final Report

July 2001

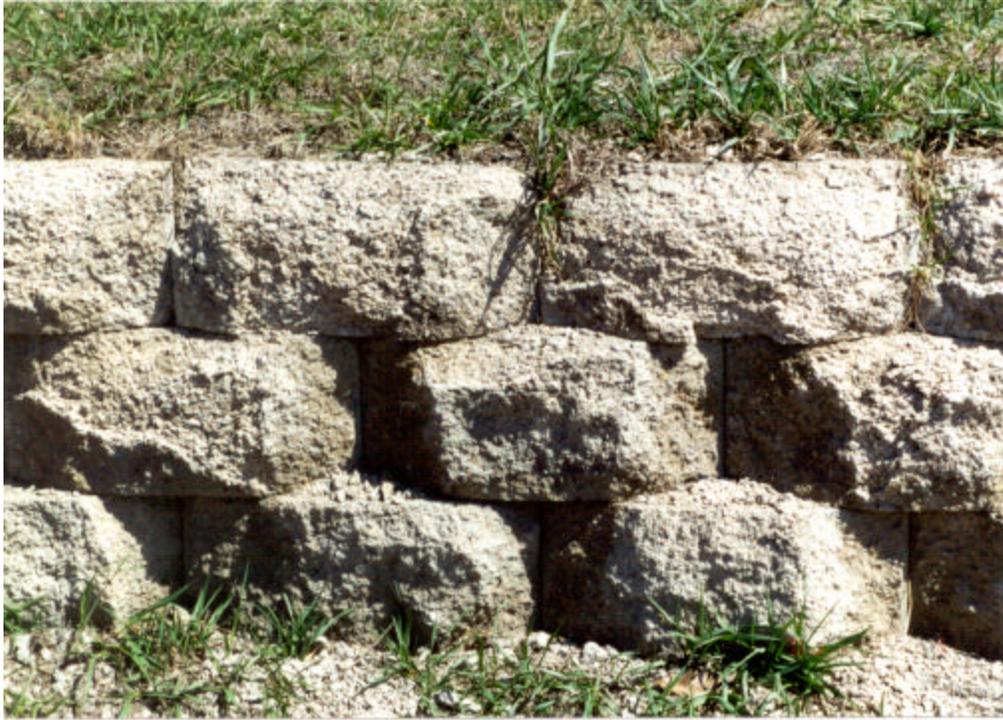
The number of surveys performed at each SCBRW location depended on the number of tiers or separate walls at the given location, and the type and severity of distresses present on each wall/tier. Only one distress condition survey was performed when each wall/tier had similar distress types and severity levels present. However, for cases where this did not hold true, separate surveys were performed on each tier/wall with differing distress type and severity levels. For example, one wall (Hennepin county, CSAH 101 and 130 ft south of 24th Ave.) had to be split into three surveys. At this location, two walls were constructed and three condition surveys had to be completed (one survey for the northern wall and two surveys for the southern wall). The northern portion of the southern wall had a significantly different distress condition than the southern portion (see figures 3.1 – 3.4). The average subjective ratings assessed for the northern and southern portion of this wall were 0.65 (“Very Poor”) and 3.85 (“Good”), respectively. In general, it appears that the southern portion of the wall is at the initial stages of durability problems (e.g., the presence of low-severity freeze-thaw damage, as exhibited in figure 3.4), while the northern portion has reached the later stages of durability failure (e.g., the presence of high-severity scaling as exhibited in figure 3.2).

Figure 3.2. Close-up photo of northern portion of south wall (CSAH 101 and 24th Ave.).

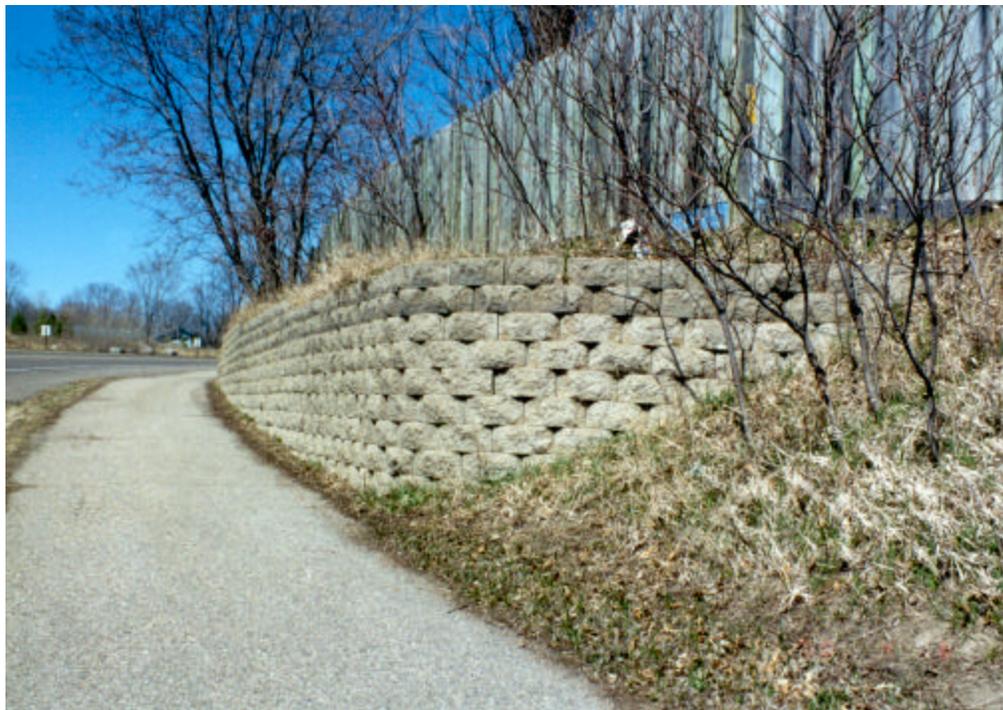
Figure 3.3. Overall photo of southern portion of south wall (CSAH 101 and 24th Ave.).

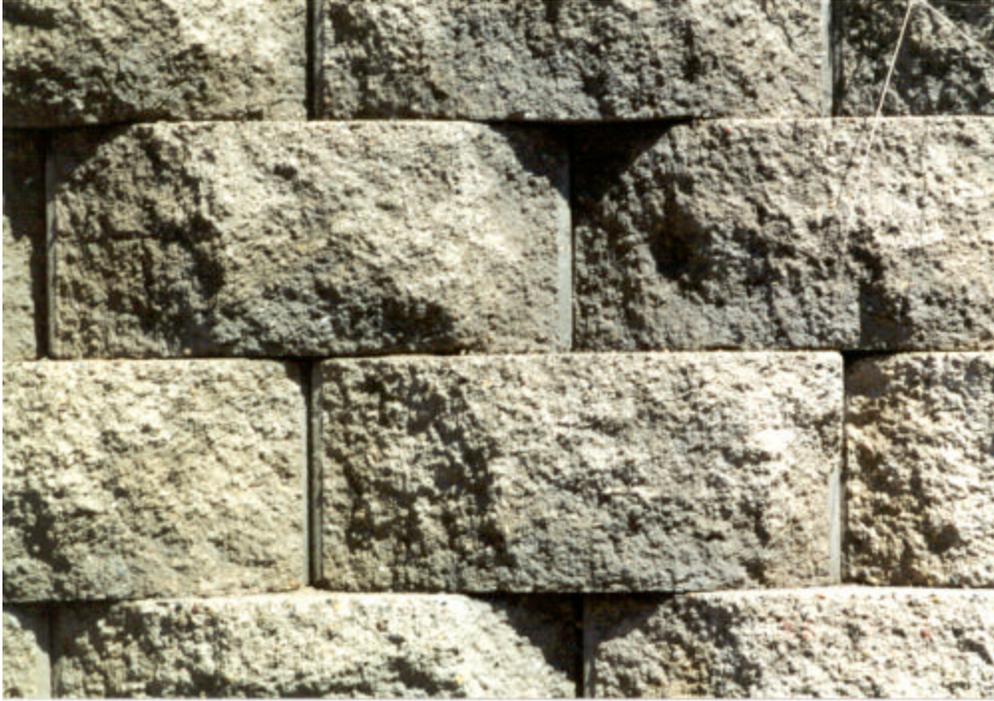
Figure 3.4. Close-up photo of southern portion of south wall (CSAH 101 and 24th Ave.).

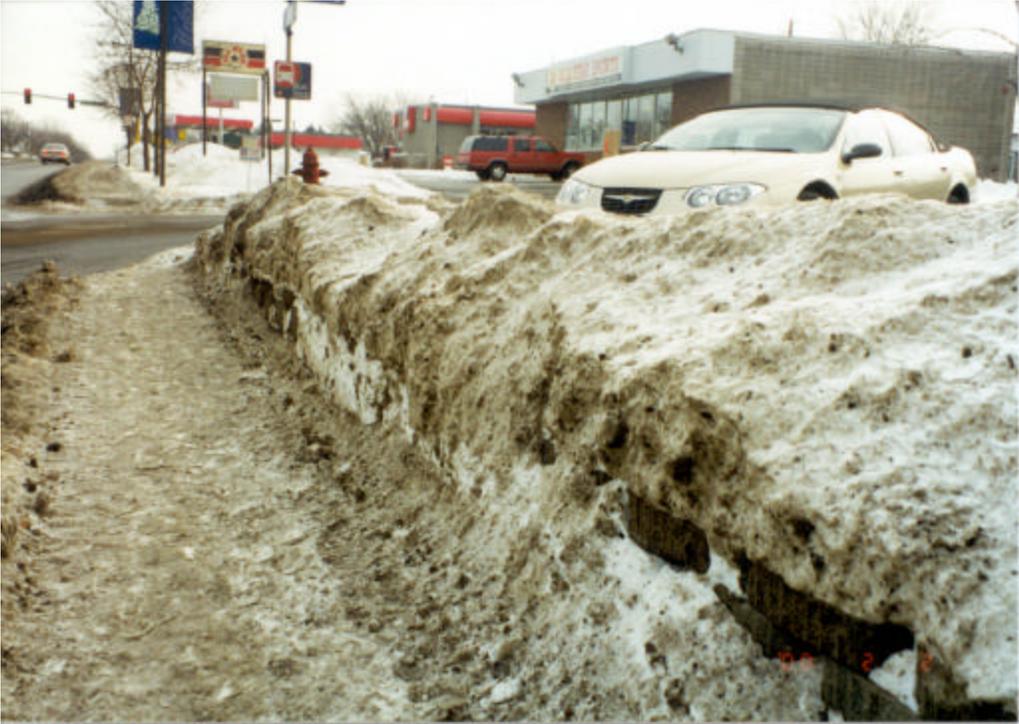
The SCBRW located at the intersection of CSAH 9 and Oregon, in Hennepin County, Minnesota is a good illustration of a wall subjectively rated as “Very Poor”. An average subjective rating of 0.85 was assessed for this SCBRW. Figures 4.7 – 4.9 illustrate photos of the typical snow coverage during the peak winter period. As illustrated, there are three types of snow removal near this wall: main-line, side-walk and parking lot snow removal. Therefore, the snow

accumulation on the top block layer and vertical surfaces for this SCBRW as due to these three types of snow removal, along with “free” falling snow. The quantity of deicing sand/salt present in the snow was visually identified as high.

Figure 4.7. Photo of snow accumulation on SCBRW subjectively rated as “very poor”.

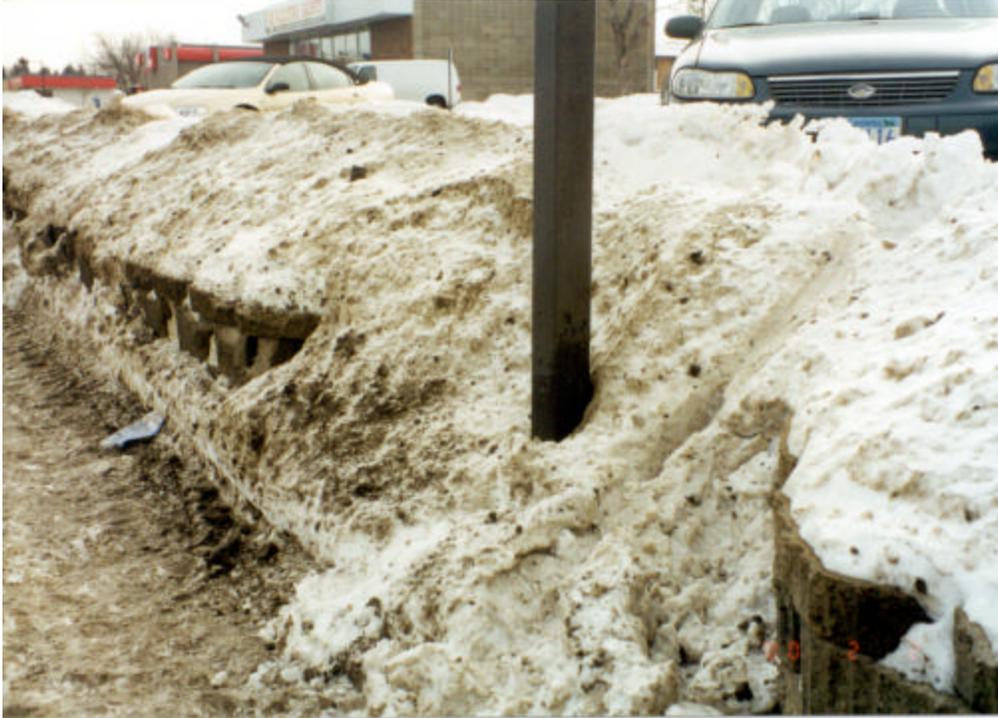
Figure 4.8. Photo of snow accumulation on curved segment of SCBRW subjectively rated as “very poor”.

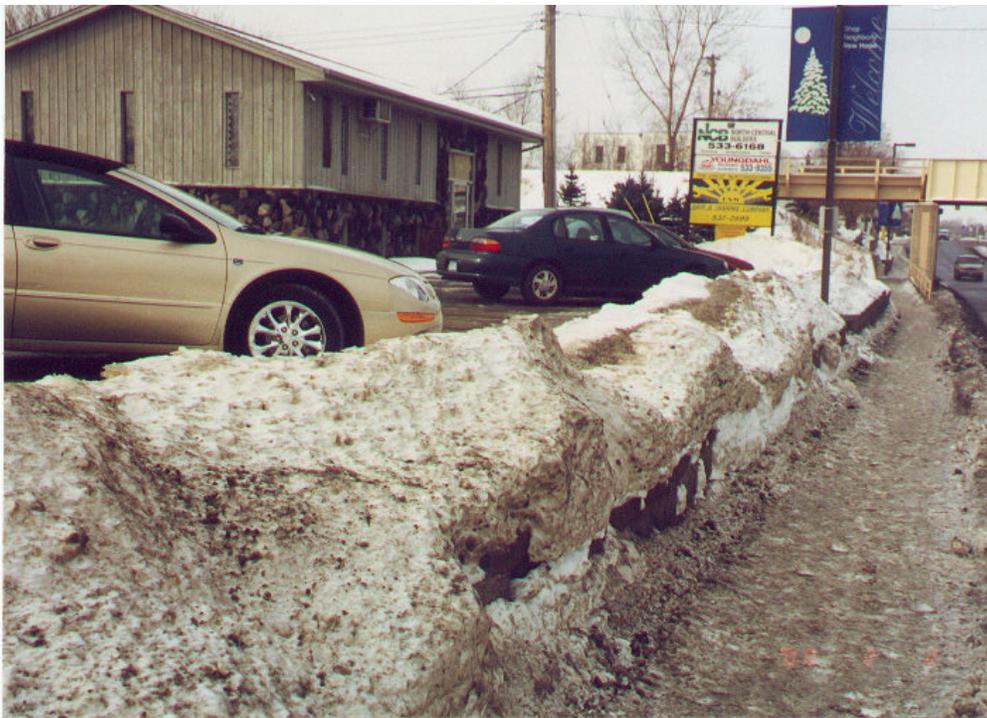
Figure 4.9. Overall photo of snow accumulation on SCBRW subjectively rated as “very poor”.

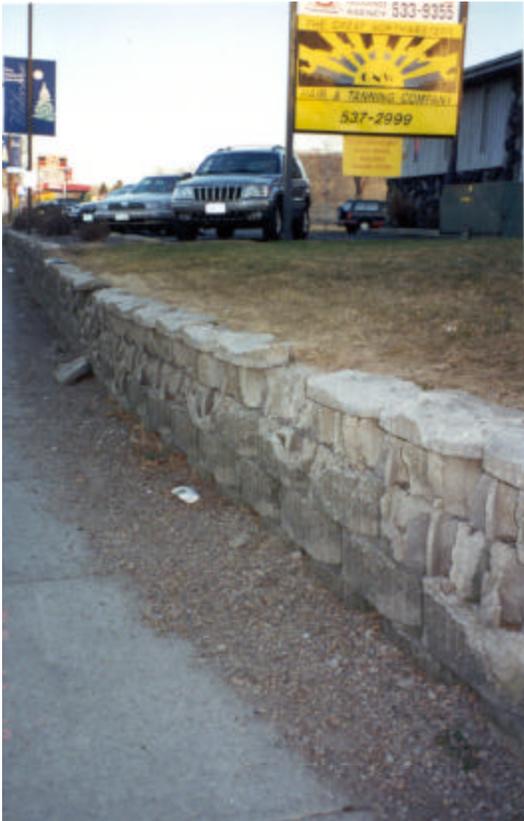
Figure 4.10 is a photo illustrating the overall wall condition during the general distress survey. High-severity scaling is readily apparent in this picture along the wall when looking at both the capstone, vertical surfaces and the debris (i.e., scaled material) resting on the sidewalk adjacent to the SCBRW. Figure 4.11 illustrates a close-up photo of the freeze-thaw deterioration present on the masonry block units used in this SCBRW.

As presented in tables F-15 and F-16 (see appendix F), 0, 1-10 and 75-100 percent of the SCBRW was observed with low-, medium- and high-severity scaling of the capstone and vertical surfaces, respectively. Additionally, less than 1, 75-100 and 25-50 percent of the SCBRW capstone was observed with low-, medium- and high-severity freeze-thaw damage, respectively, while 75-100, 0 and 75-100 percent of the SCBRW vertical surfaces exhibited low-, medium- and high-severity freeze-thaw damage (see table F-13 of appendix F).

Figure 4.10. Overall photo of SCBRW subjectively rated as “very poor”.

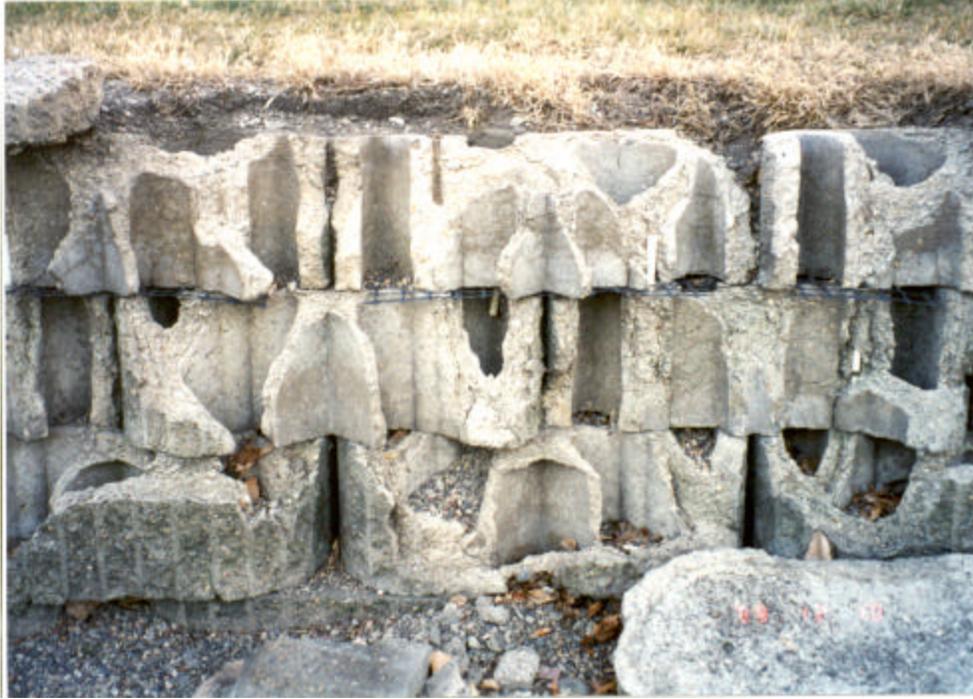
Figure 4.11. Close-up photo of high-severity scaling on SCBRW subjectively rated as “very poor”.

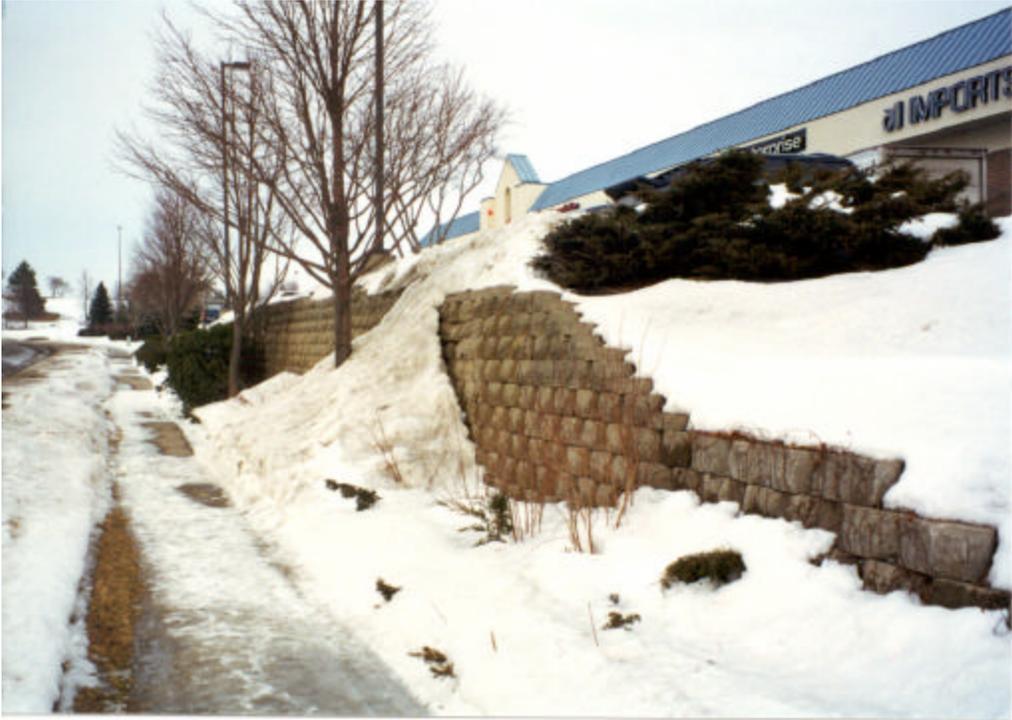
The SCBRW located at the intersection of South Cross and Burnhaven, in Dakota County, Minnesota is a good example of a wall subjectively rated as “Poor”. An average condition rating of 1.95 was assessed for this SCBRW. Figures 4.12 and 4.13 are photos of the typical snow coverage during the peak winter period and show that there are three types of snow removal near this wall: main-line, side-walk and parking lot snow removal. In general, it appears that the majority of the snow accumulation on the top block layer and vertical surfaces for this SCBRW was due to the parking lot snow removal located behind the SCBRW. The quantity of deicing sand/salt present in the snow was visually observed as “medium”.

Figure 4.12. Overall photo of snow accumulation on SCBRW subjectively rated as “poor”.

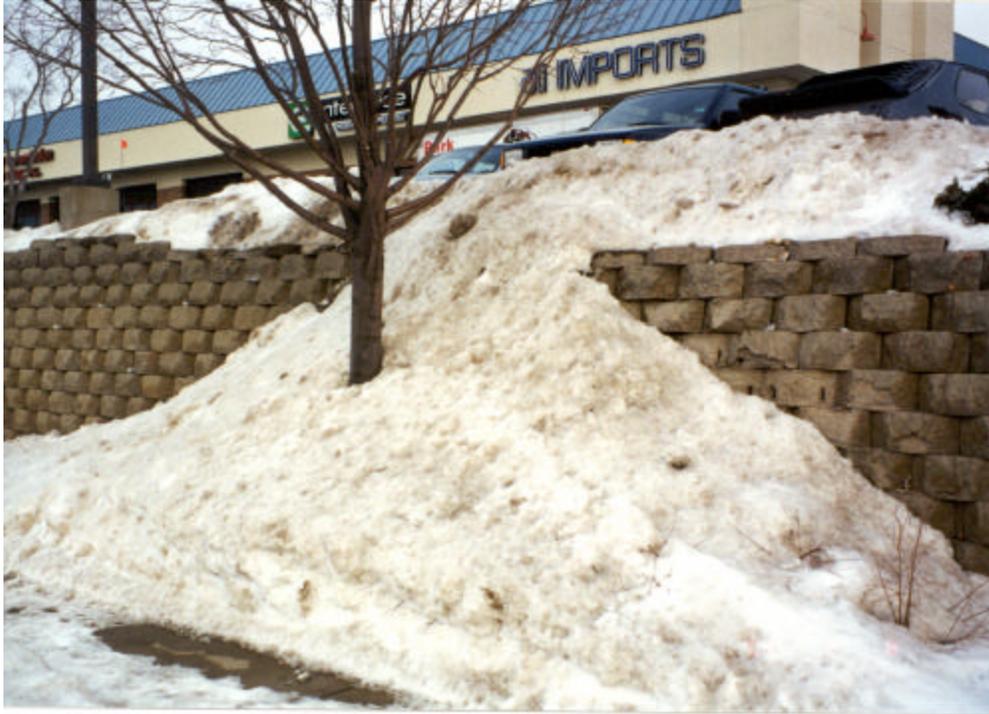
Figure 4.13. Close-up photo of snow accumulation from parking lot snow removal on SCBRW subjectively rated as “poor”.

Figures 4.13 and 4.15 present photos taken at the same location and show snow accumulation due to parking lot snow removal and the resulting high-severity scaling observed on the wall. Another example of this observation is illustrated in figures 4.17 and 4.21, which present photos of snow accumulation containing a high quantity of deicing sand/salt and a close-up photo of the associated high-severity scaling (both photos were taken at the same location).

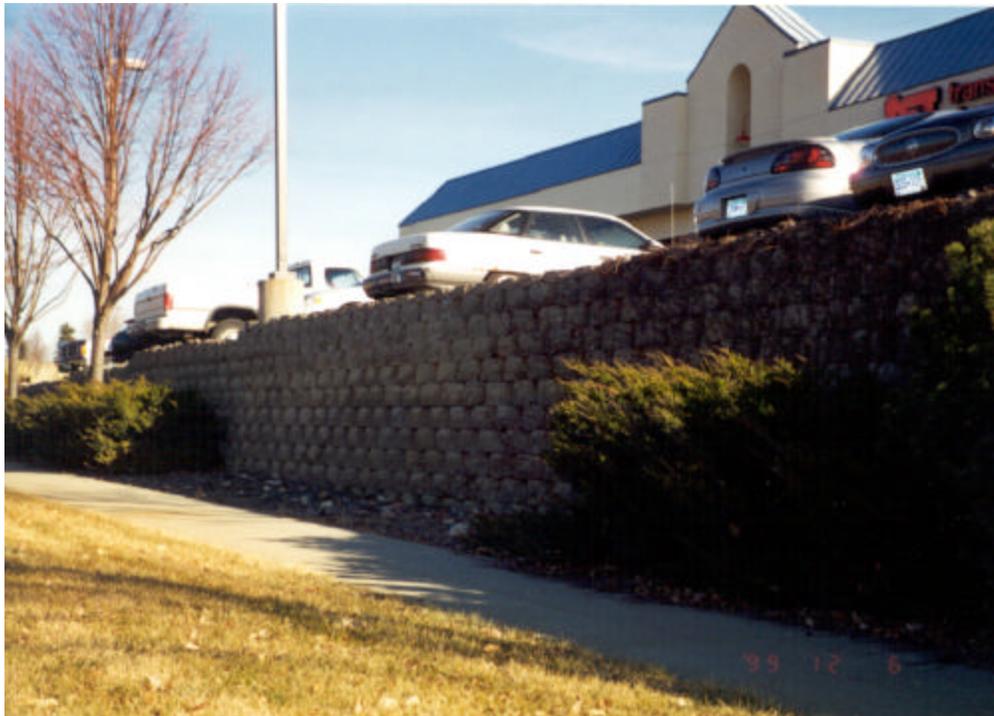
Figures 4.14 – 4.16 are photos showing regions of the wall exhibiting the greatest amount of distress. High-severity scaling is readily apparent in figure 4.15. This location is the same location shown in figure 4.13, where the largest amount of parking lot snow removal accumulation resided. Figure 4.16 shows both high-severity scaling and high-severity freeze-

Figure 4.14. General photo of SCBRW subjectively rated as “poor”.

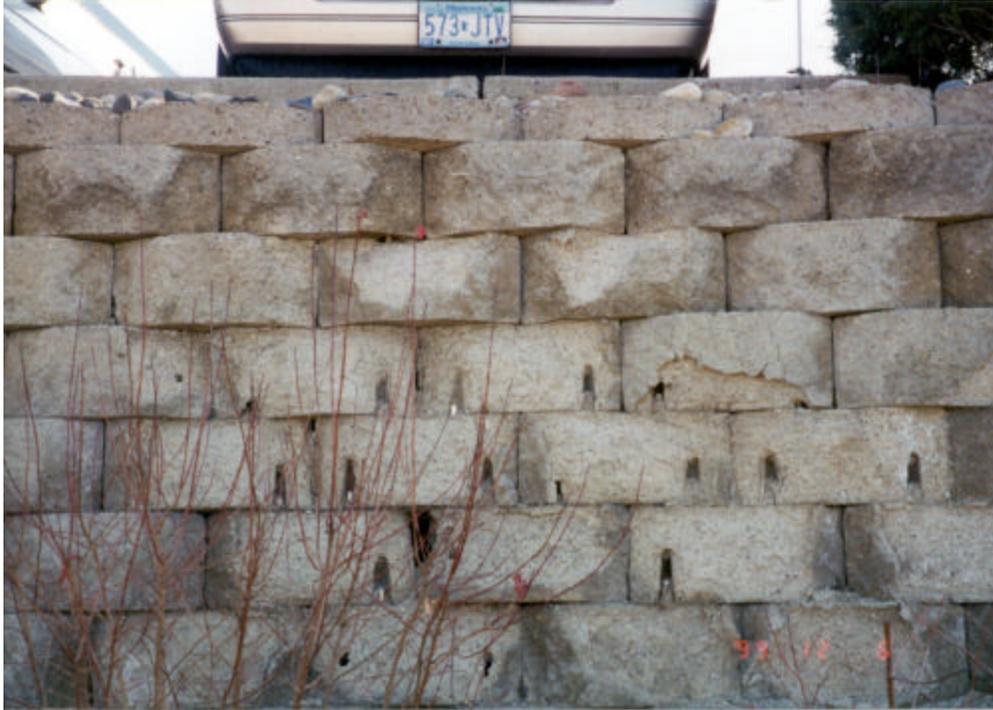
As presented in tables F-33 and F-34 (see appendix F), 75-100, less than 1 and 1-10 percent of the SCBRW was observed with low-, medium- and high-severity scaling of the capstone, respectively. Low-, medium- and high-severity scaling of the vertical surfaces was observed for 75-100, 1-10 and 25-50 percent of the SCBRW. Additionally, 50-75, 0 and 0 percent of the SCBRW capstone was found to exhibit low-, medium- and high-severity freeze-thaw damage, respectively; while 75-100, 10-25 and 1-10 percent of the SCBRW vertical surfaces exhibited low-, medium- and high-severity freeze-thaw damage (see table F-31 of appendix F).

Figure 4.15. Close-up photo of high-severity scaling on SCBRW subjectively rated as “poor”.

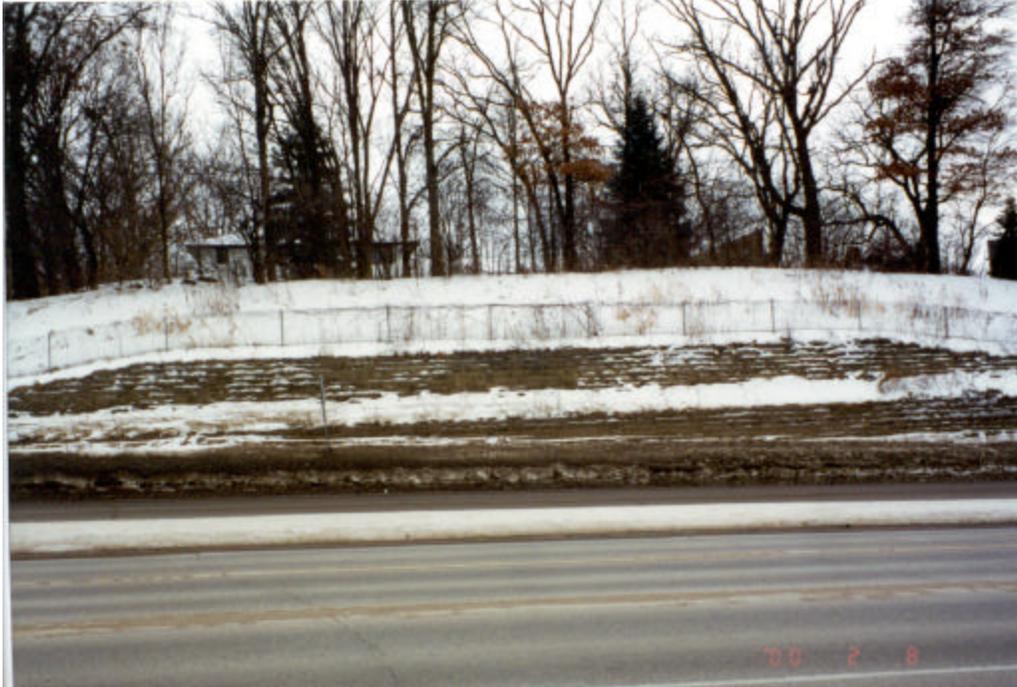
The SCBRW located at the intersection of CSAH 38 and Gardenview (south wall, tier 1), in Dakota County, Minnesota is a good example of a wall subjectively rated as “Fair”. An average condition rating of 2.65 was given to this SCBRW. Figures 4.17 and 4.18 are photos of the typical snow coverage during the peak winter period, and show that there is only one type of snow removal near this wall (i.e., main-line snow removal). The quantity of deicing sand/salt present in the snow was visually identified as “high”.

Figure 4.18. Overall photo of snow accumulation on SCBRW subjectively rated as “fair”.

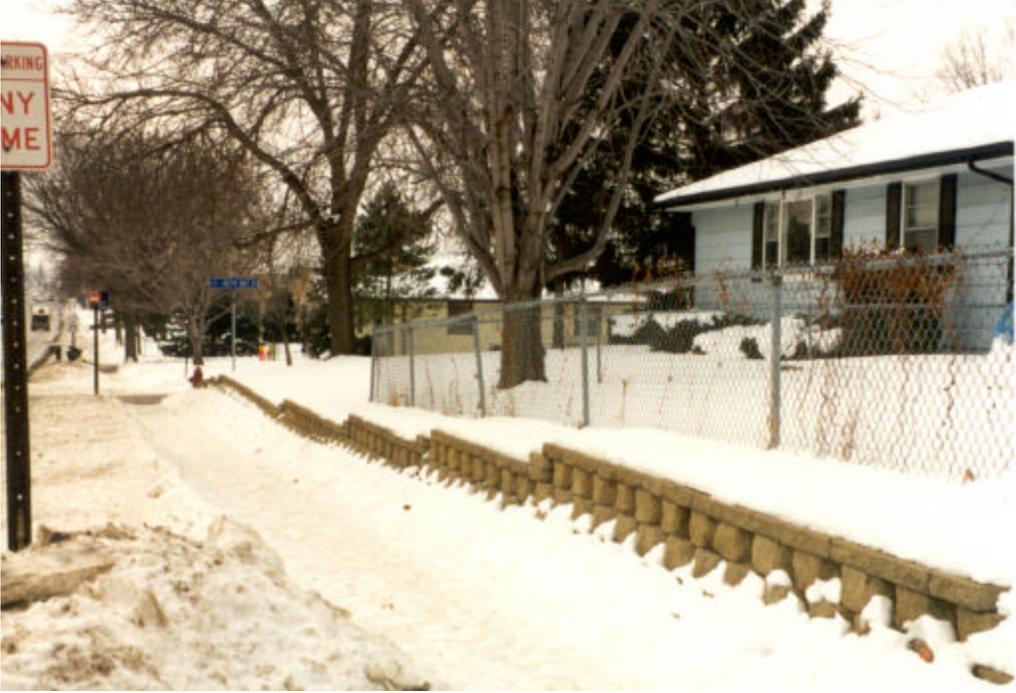
The SCBRW located at the intersection of CSAH 156 and 46th Ave., in Hennepin County, Minnesota is a good example of a wall subjectively rated as “Good”. An average condition rating of 3.5 was given to this SCBRW. Figures 4.22, 4.23 and 4.24 are photos of the typical snow coverage during the peak winter period, and show that there are three types of snow

removal near this wall: main-line, side-walk and driveway snow removal. The quantity of deicing sand/salt present in the snow was visually observed as “medium”.

Figure 4.22. Overall photo of snow accumulation on southern SCBRW subjectively rated as “good”.

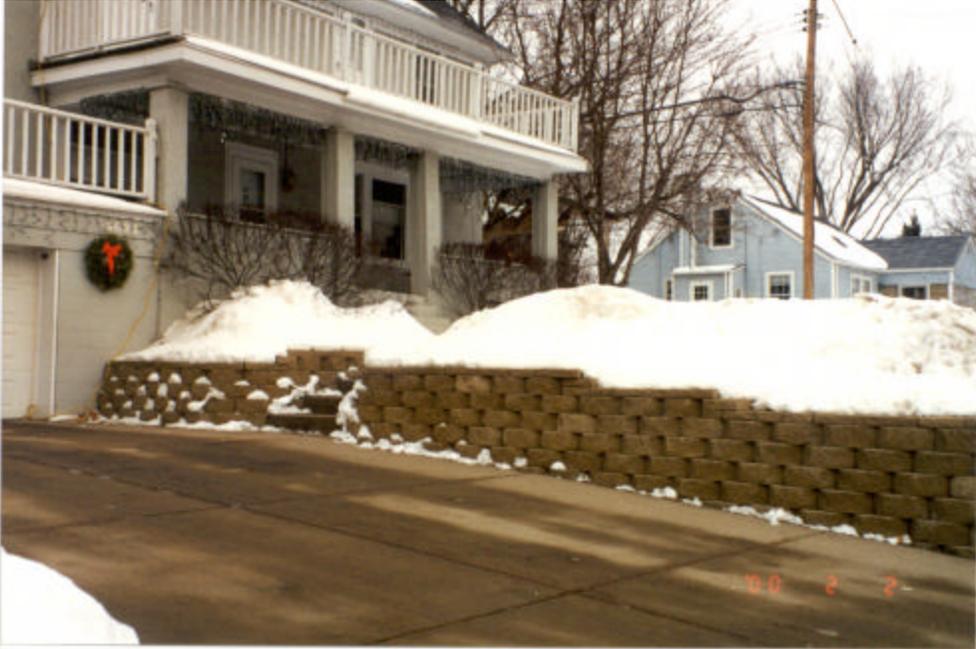
Figure 4.23. Photo of snow accumulation on portion of SCBRW located in driveway subjectively rated as “good”.

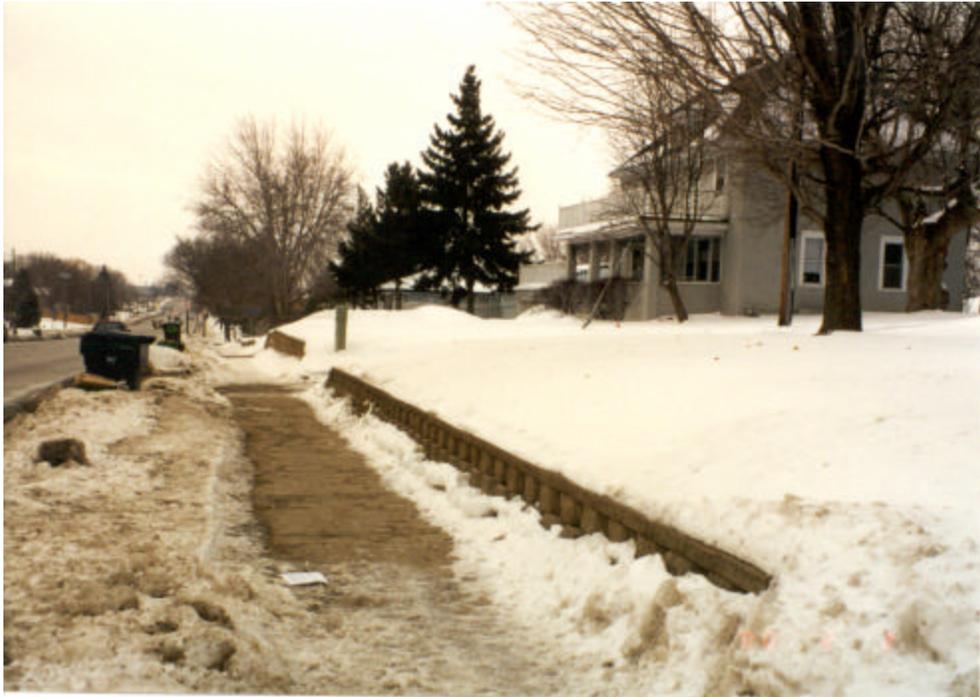
Figure 4.24. Overall photo of snow accumulation of northern SCBRWs subjectively rated as “good”.

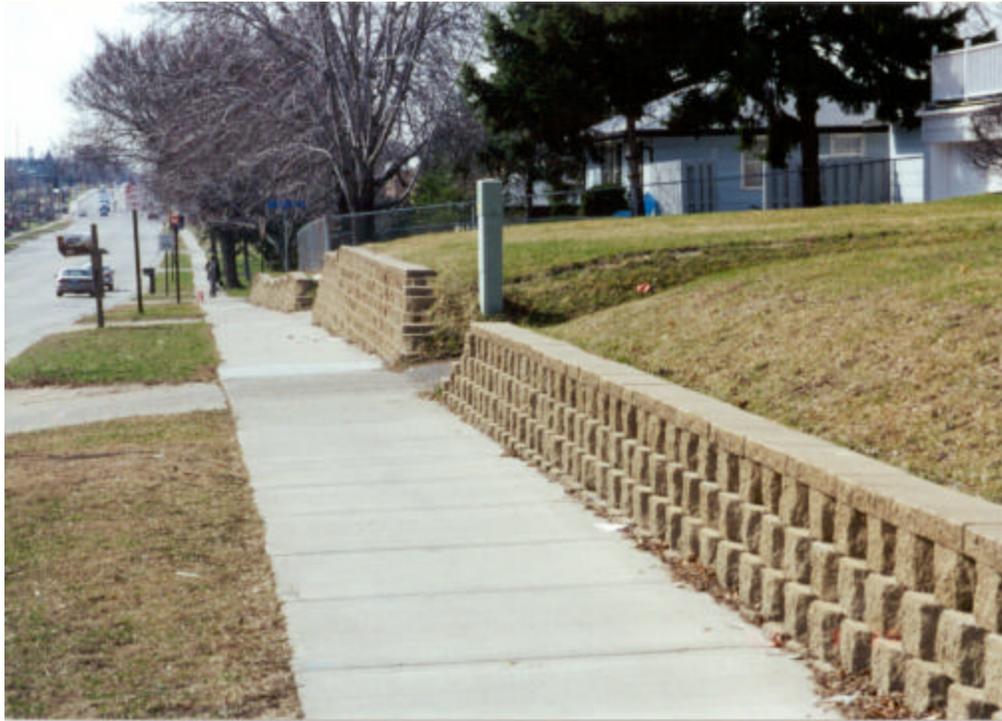
Figures 4.25 and 4.26 are photos presenting an overall view of the SCBRWs at this location. Figures 4.27 and 4.28 are photos that document the general good condition of the masonry block units used in this SCBRW. There is, however, some low-severity freeze-thaw damage present on the lower portions of the masonry block units, as shown in the figures.

Figure 4.25. Overall condition photo of SCBRWs subjectively rated as “good”.

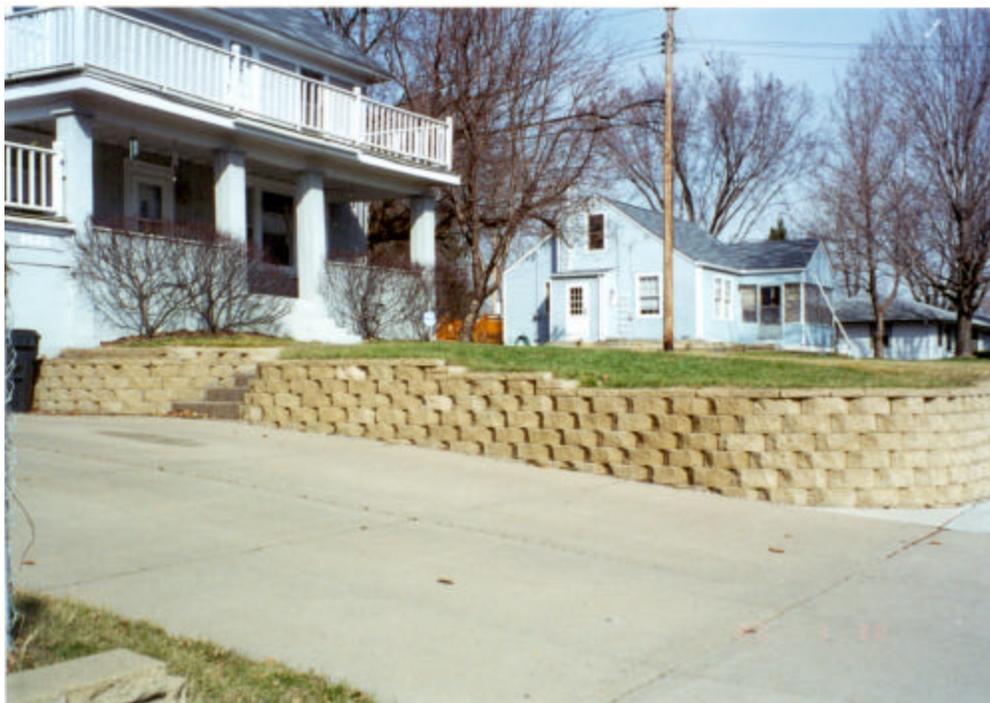
Figure 4.26. Overall condition photo of SCBRW located in driveway subjectively rated as “good”.

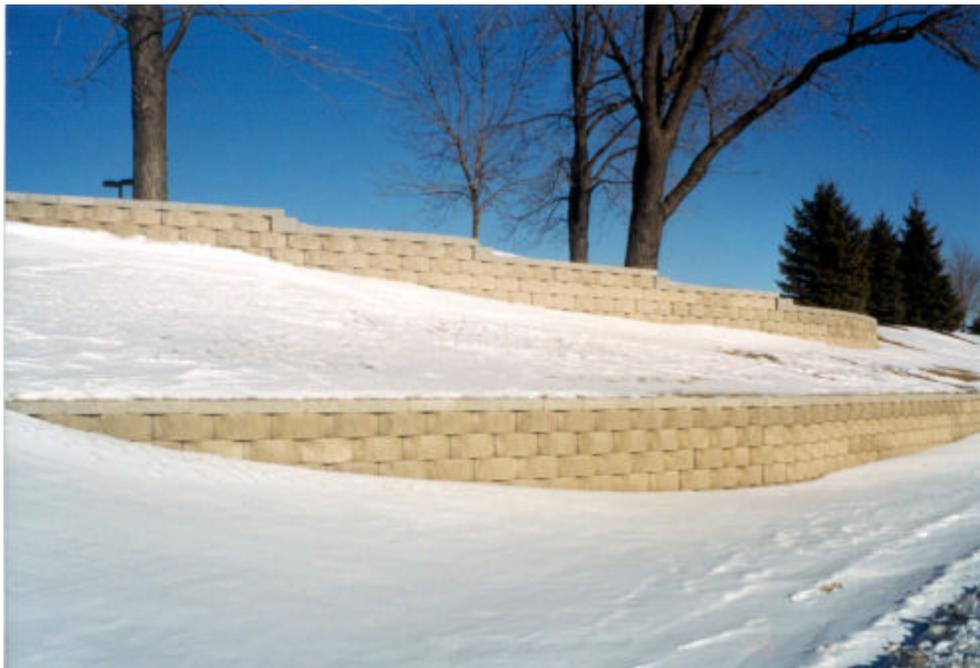
The SCBRW located at the intersection of CSAH 10 and Trenton (tiers 1 and 2), in Hennepin County, Minnesota is a good example of a wall subjectively rated as “Very Good”. An average condition rating of 4.8 was given to this SCBRW. Figure 4.29 presents a photo of the typical snow coverage during the peak winter period, and shows that there is no snow removal that affects snow accumulation on this SCBRW. Therefore, the snow accumulation on the top block layer and vertical surfaces for this SCBRW was solely due to free-falling snow. The figure does show that there is sidewalk snow removal near the SCBRW (as illustrated in the lower-right portion of the photo); however, it appears that there are no deicing chemicals in this snow to affect the saturation rate of the masonry block units.

Figure 4.29. Photo of snow accumulation of SCBRW subjectively rated as “very good”.

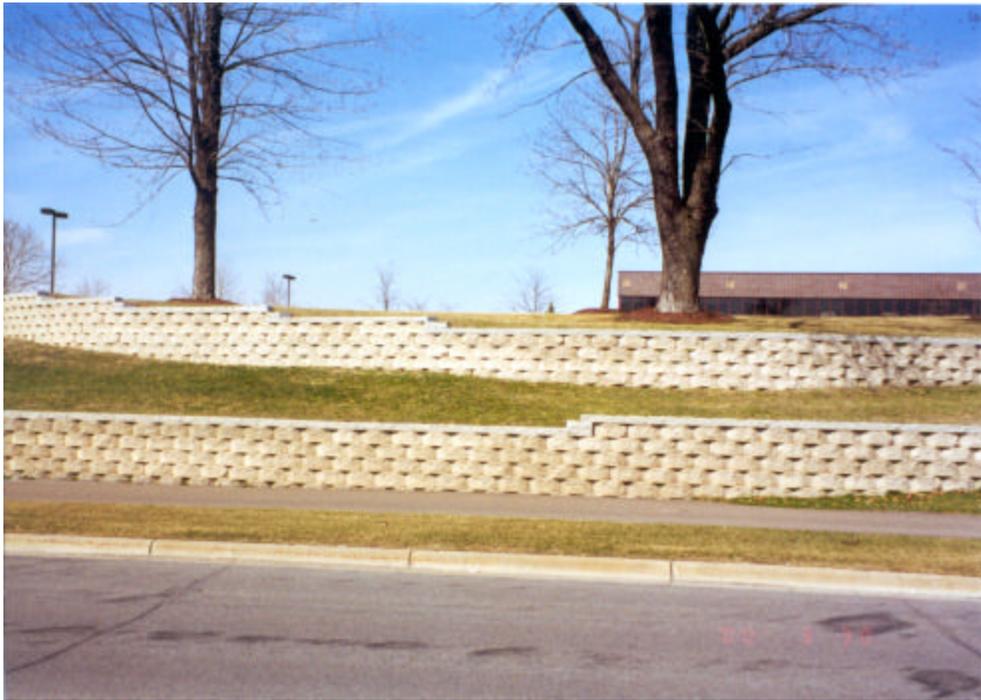
Figures 4.30 and 4.31 are photos illustrating an overall distress condition view of the SCBRW tiers at this location. It is apparent in the photos that the capstone on both tiers has been replaced recently. This replacement was probably necessitated by severe degradation of the original capstone units. Figure 4.32 presents a photo exhibiting the general condition of the masonry block units used in this SCBRW, and shows that these block units are in very good condition and are exhibiting only some minor external staining at the joints.

Figure 4.30. Overall condition photo of SCBRW subjectively rated as “very good”.

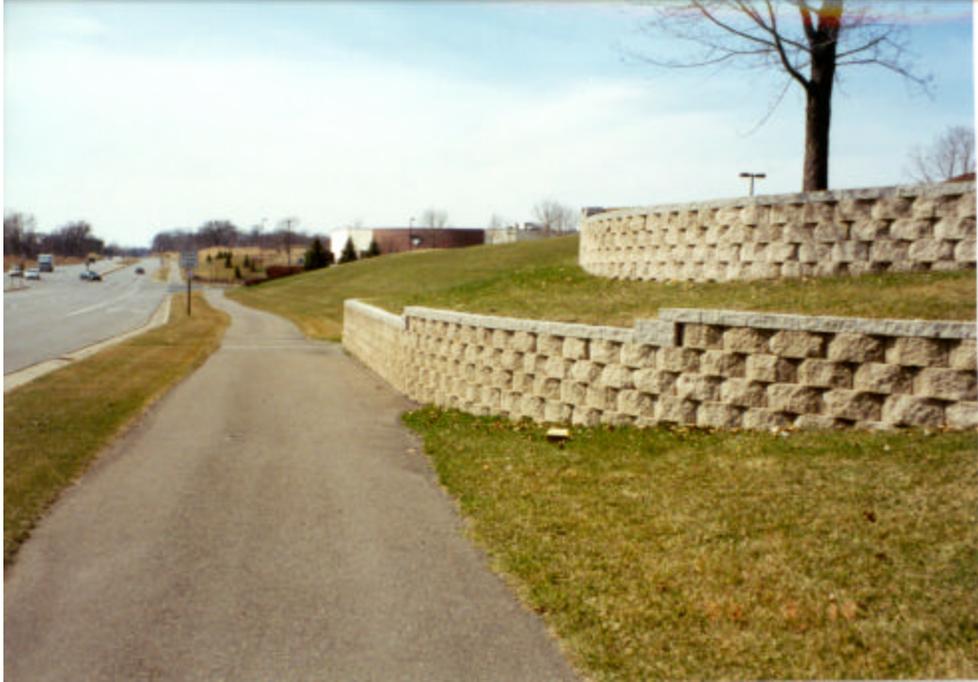
Figure 4.31. Overall condition photo of SCBRW subjectively rated as “very good”.

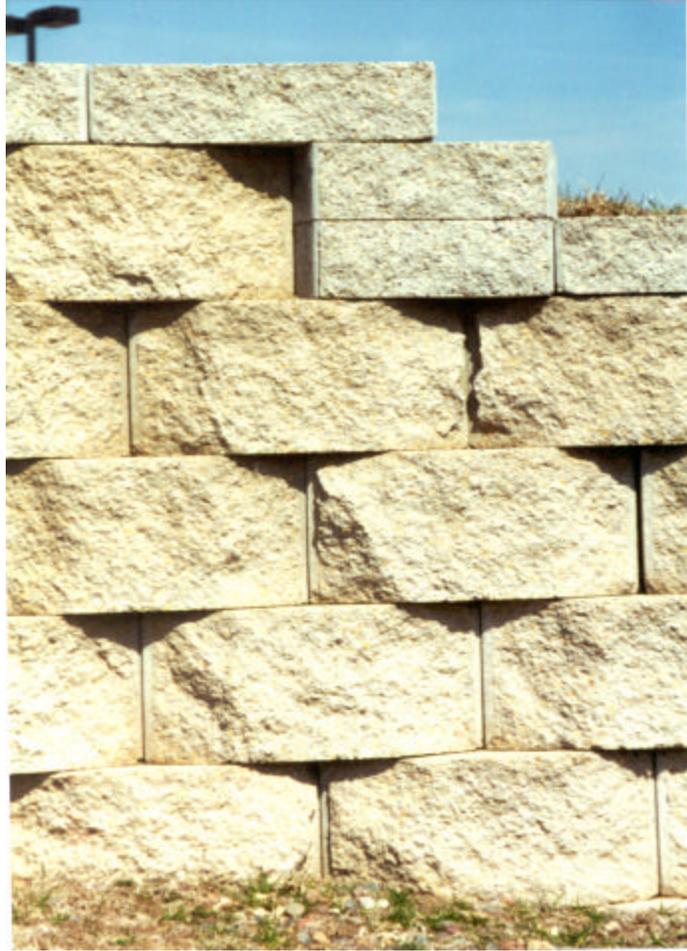
Figure 4.32. Close-up photo of general condition of masonry units used in SCBRW subjectively rated as “very good”.

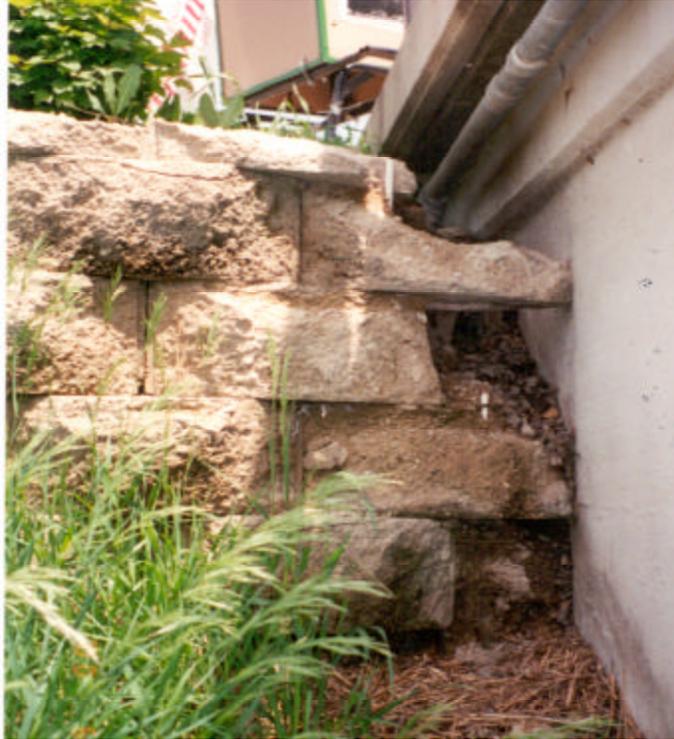
a. SCBRW located on west side of pedestrian bridge.

In addition to the above photos, figure 4.36 does an excellent job of depicting the accelerated freeze-thaw deterioration that can occur from water runoff containing deicing chemicals. This water runoff originates from a pedestrian bridge, which is heavily salted in the winter, located above the wall. As previously stated, salt-saturated water is more readily absorbed into concrete resulting in higher levels of saturation which can accelerate freeze-thaw deterioration (the crystallization of salts in the concrete pores may also produce damaging stresses/deterioration).

Figure 4.36. Photos (a and b) illustrating high-severity scaling in a location subjected to a large amount of water runoff containing deicing chemicals.

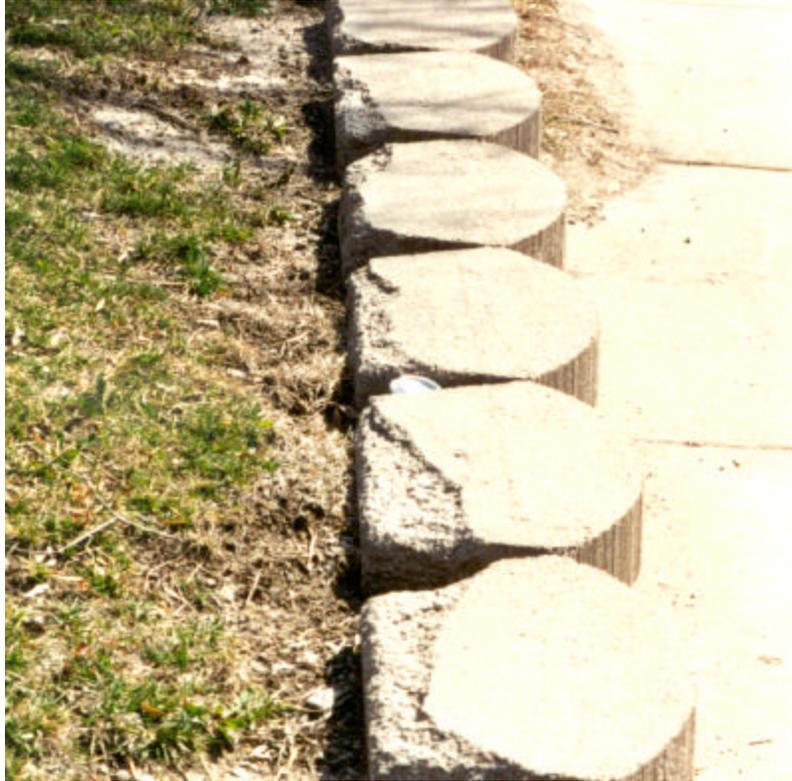
In general, there was a greater amount of scaling present where large amounts of fertilizers were used. The phosphates in the fertilizers behave in a manner similar to that of deicing salts, such that freeze-thaw deterioration is accelerated due to increased water saturation in the concrete pores resulting from the water-phosphate solution. This deterioration was generally manifested in the capstone units (which are heavily exposed to the water-phosphate solution), as illustrated in figure 4.37.

a. SCBRW capstones after exposure to fertilizer.

Figure 4.37. Freeze-thaw deterioration exacerbated by the presence of fertilizers.

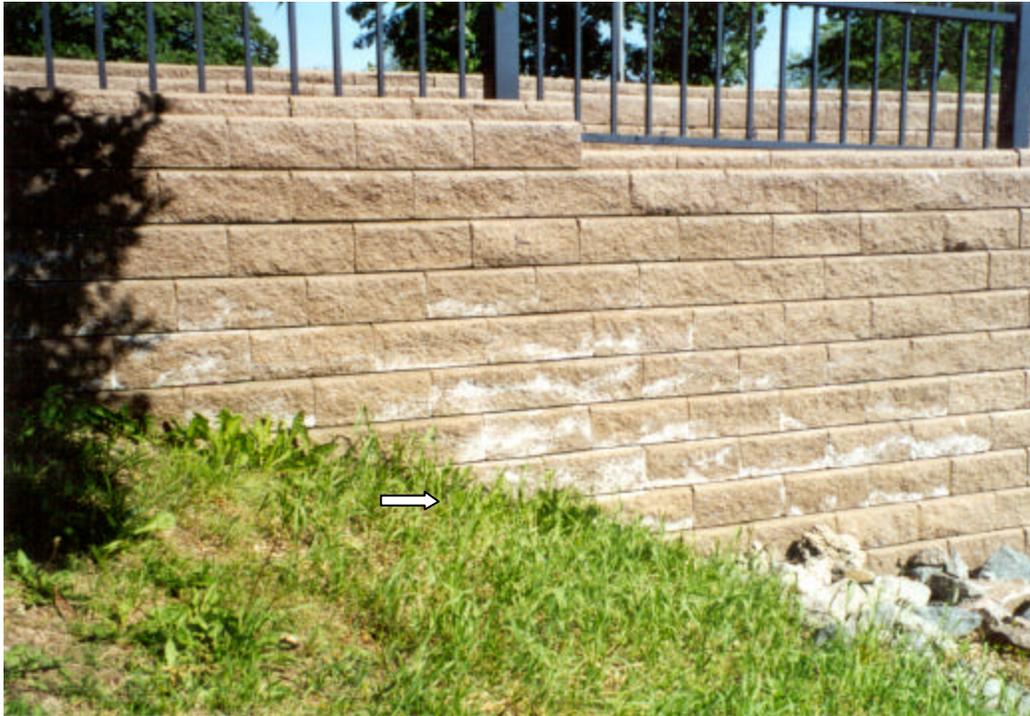
There was an increased incidence of efflorescence on block units subjected to a high quantity of water runoff (e.g., behind/below obstructions, bottom vertical surface of block unit, blocks adjacent ground water runoff). Figures 4.38a and b illustrates the presence of efflorescence on block units subjected to increased water runoff from physical obstructions. In addition, figures 4.39 and 4.40 present photos demonstrating the increased efflorescence in locations near water runoff from sloped land and adjacent to a water supply (e.g., river or drainage pipe), respectively.

Figure 4.39. Photo demonstrating increased efflorescence in location near water runoff from sloped land.

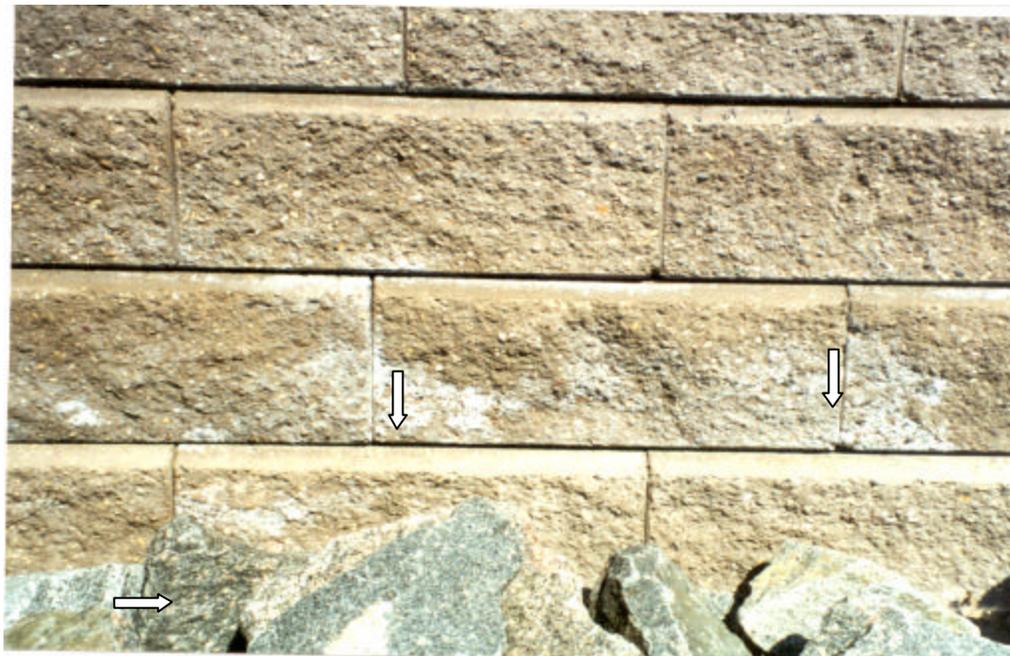
a. Efflorescence on blocks adjacent to water level of river.

Figure 4.40. Photos (a and b) presenting increased efflorescence on blocks adjacent to a water supply.

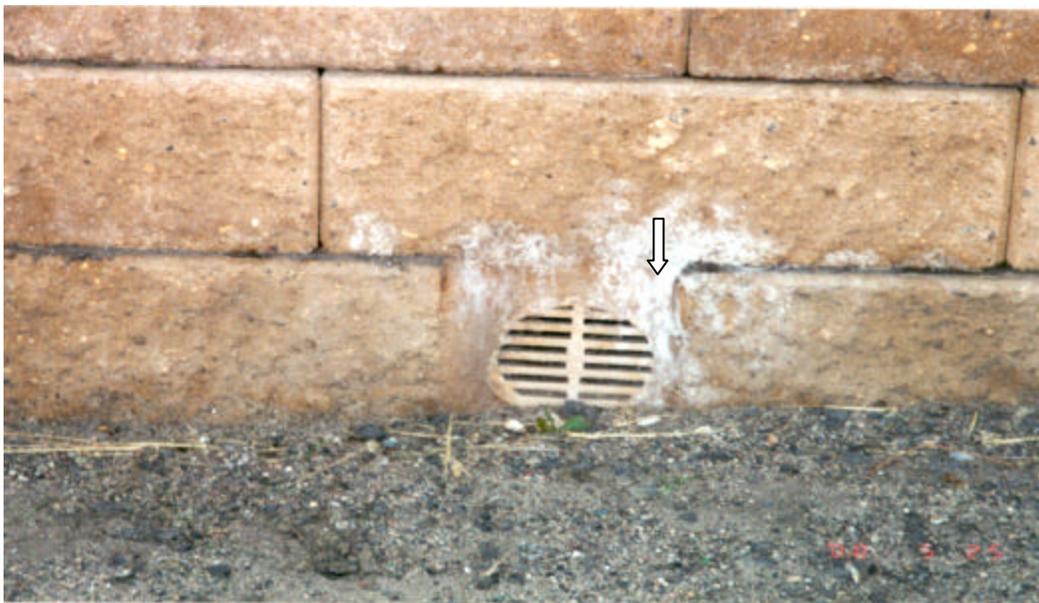
b. Efflorescence around drainage pipe.

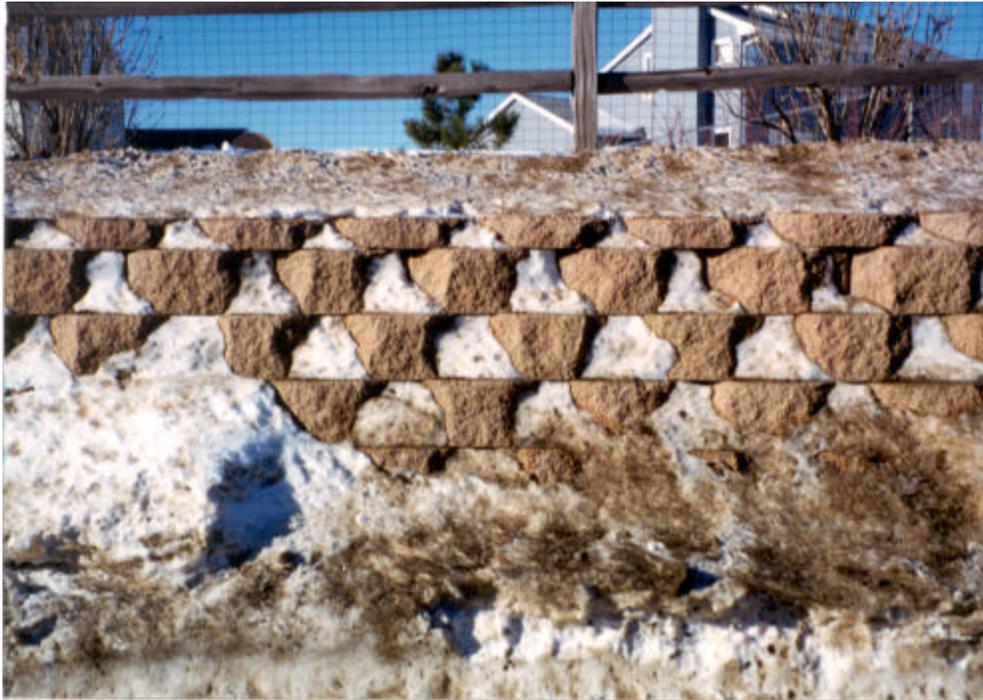
Fifty percent of the SCBRWs surveyed have a fence constructed behind the top block layer. The type and location of fencing often affects the amount of snow accumulation on the top block layer, which in turn, affects the degree of saturation to which the masonry block units are exposed. Figures 4.66 – 4.67 illustrate the increased snow accumulation due to fencing (or a guardrail, as illustrated in figure 4.66) constructed immediately behind the SCBRW. In addition, the effect of the type of snow removal on snow accumulation can be seen in figure 4.67. For this case, there was both mainline and sidewalk snow removal near the wall. The snow on the sidewalk was removed using a plow, which resulted in the packing of snow against the vertical surfaces, as illustrated in the photo for the bottom 3 ft of the SCBRW.

Figure 4.67. Photo illustrating the effect of fencing on snow accumulation (CSAH 101 and 87th Place [west SCBRW]).
