Condition and Durability of Segmental
Concrete Block Retaining Walls Along
Roadways in Minnesota

| 4. Title and Subtitle CONDITION AND DURABILITY OF SEGMENTAL CONCRETE BLOCK RETAINING WALLS ALONG ROADWAYS IN MINNESOTA | | 5. Report Date July 2001 | |

Final Report

July 2001

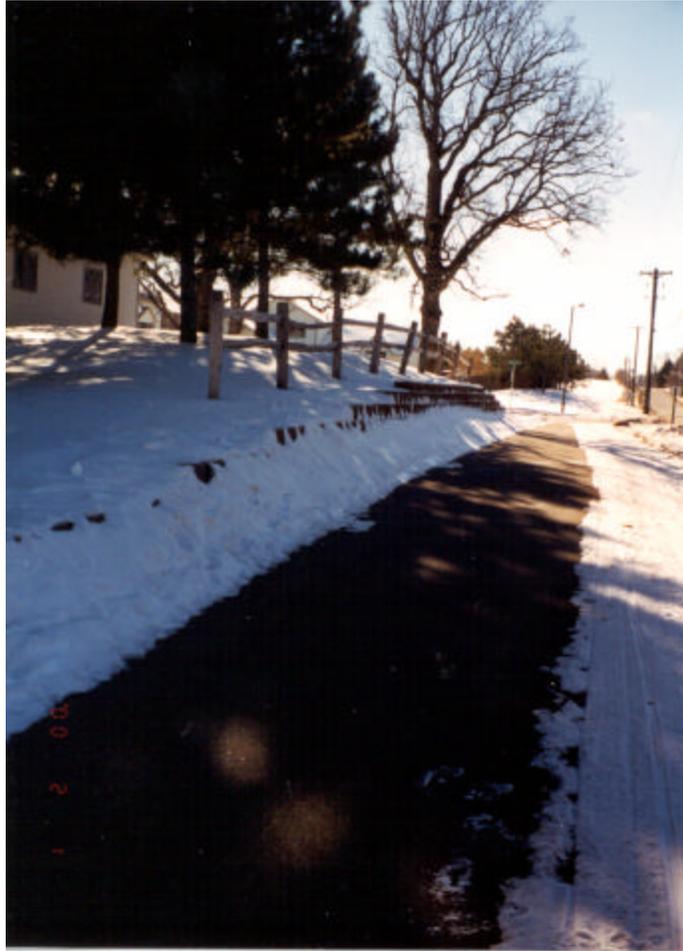
As previously described in section 3.2.3 “Stage 3 (Peak Winter Survey), the quantity of deicing sand/salt in the snow accumulation on the top block layer and adjacent to the vertical surfaces was visually rated as low, medium or high. Figures 4.68, 4.69 and 4.70 present photos illustrating typical concentrations classified as low, medium and high, respectively. It appears that 18, 12 and 70 percent of the SCBRWs are exposed to snow accumulation containing low, medium and high concentrations of deicing agent, respectively, on the top block layer; 9, 14 and 77 percent of the SCBRWs surveyed are exposed to low, medium and high concentrations, respectively, of deicing agent on the vertical surfaces (see figure 4.71).

Figure 4.68. Photo illustrating low quantity of deicing sand/salt in snow accumulation (CSAH 101 and 82nd Ave. N).

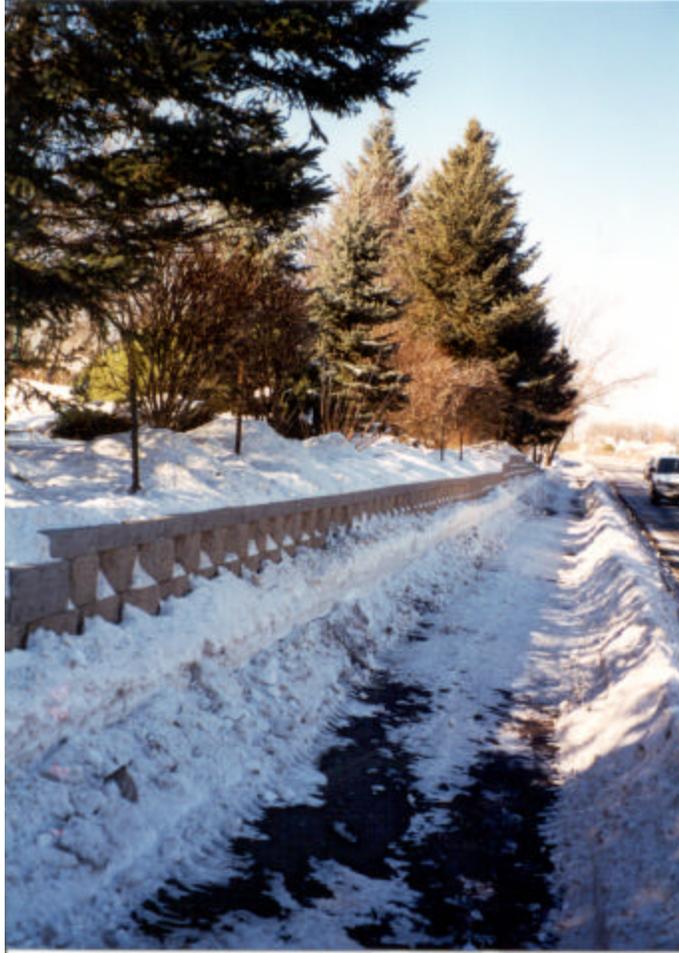
Figure 4.69. Photo illustrating medium quantity of deicing sand/salt in snow accumulation (CSAH 10 and Jonquil).

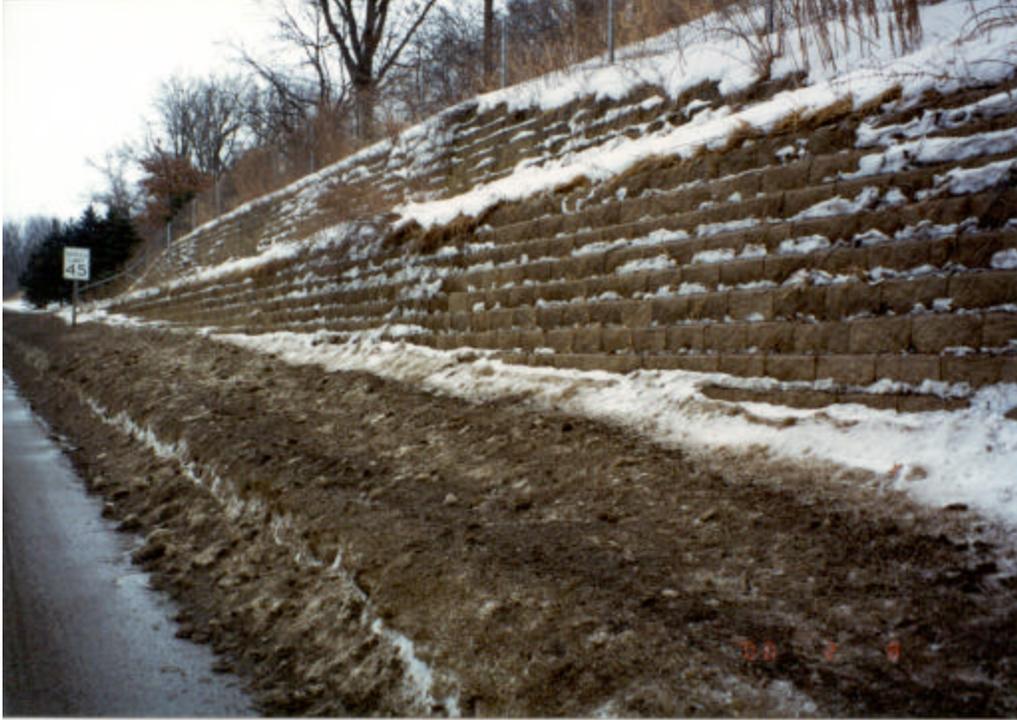
Figure 4.70. Photo illustrating high quantity of deicing sand/salt in snow accumulation (CSAH 38 and Gardenview).

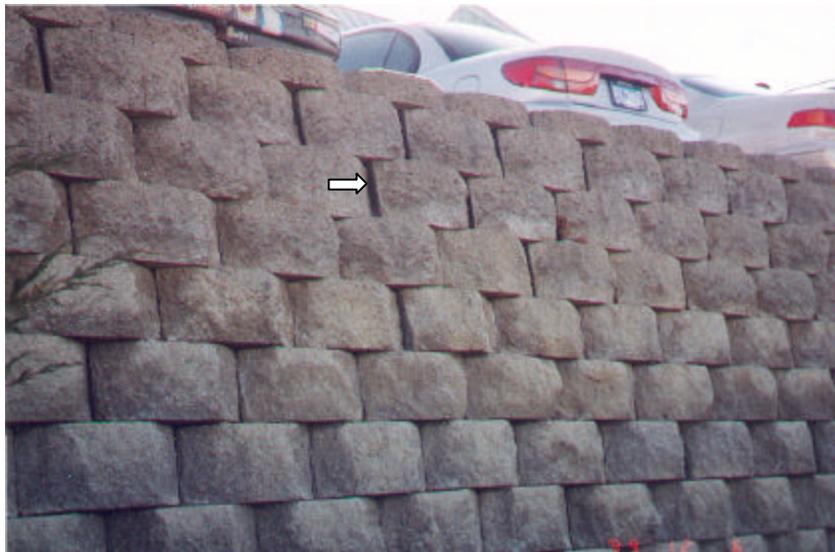
Medium-Severity Construction Flaw (Twisted Blocks)

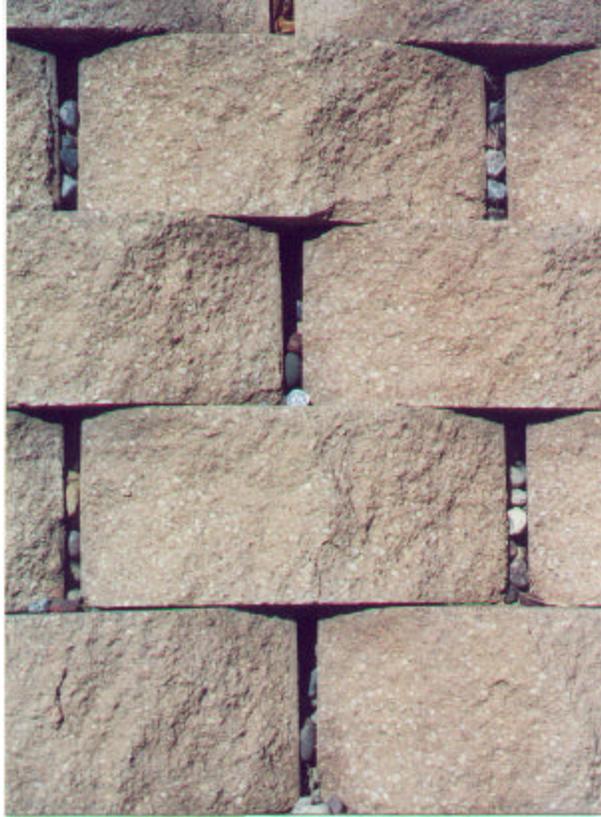
Medium-Severity Construction Flaw (Open Joints)

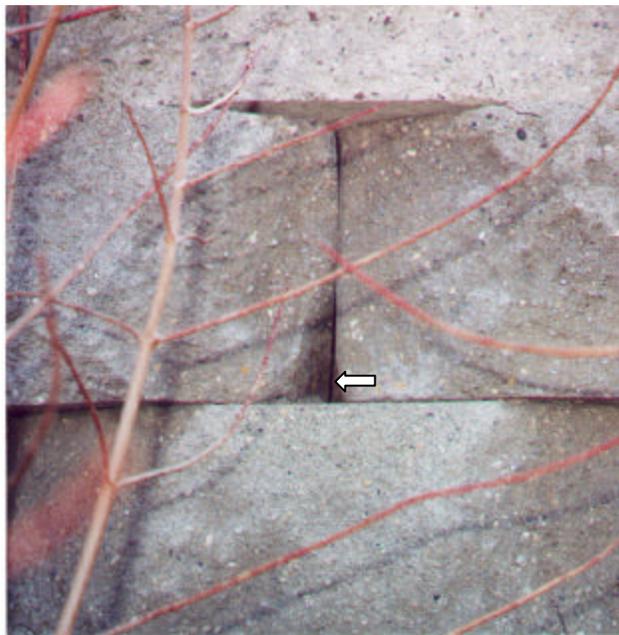
Low-Severity Corner Break

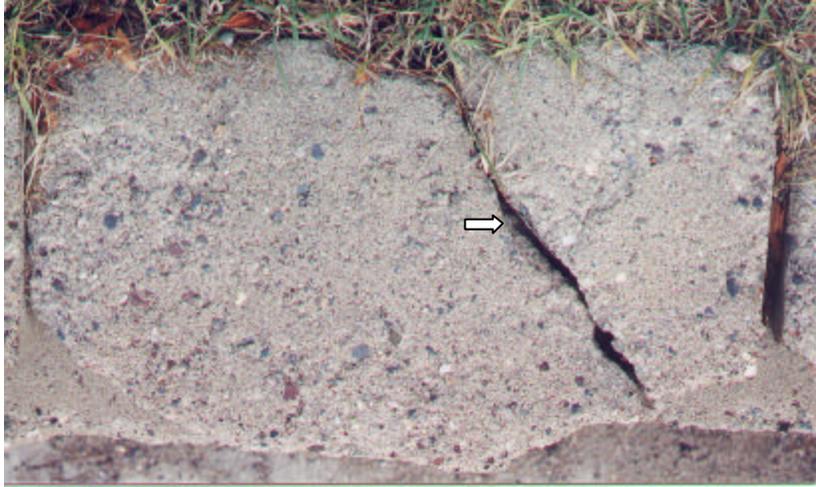
High-Severity Cracked Block

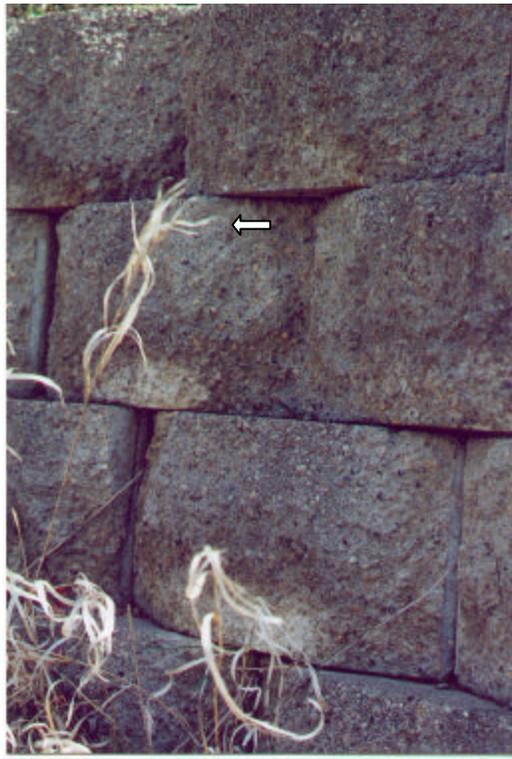
Low-Severity Efflorescence

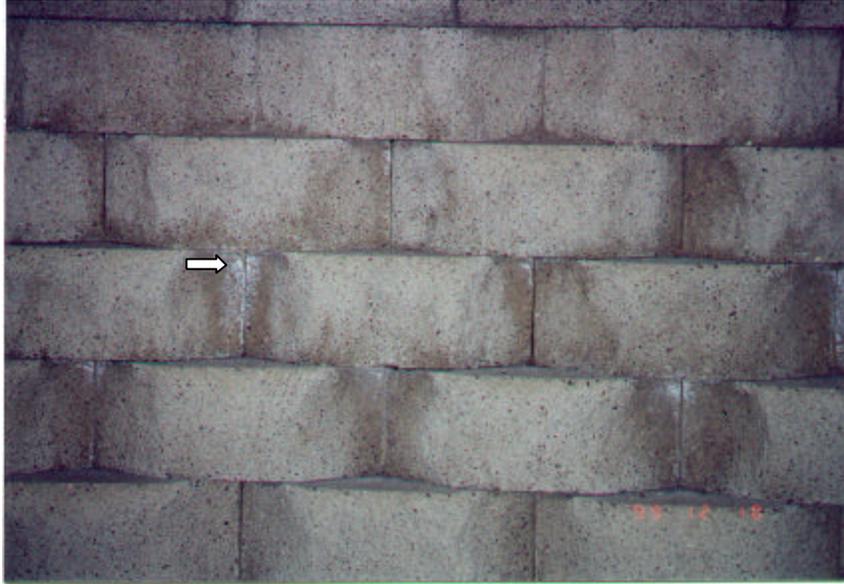
Medium-Severity Efflorescence

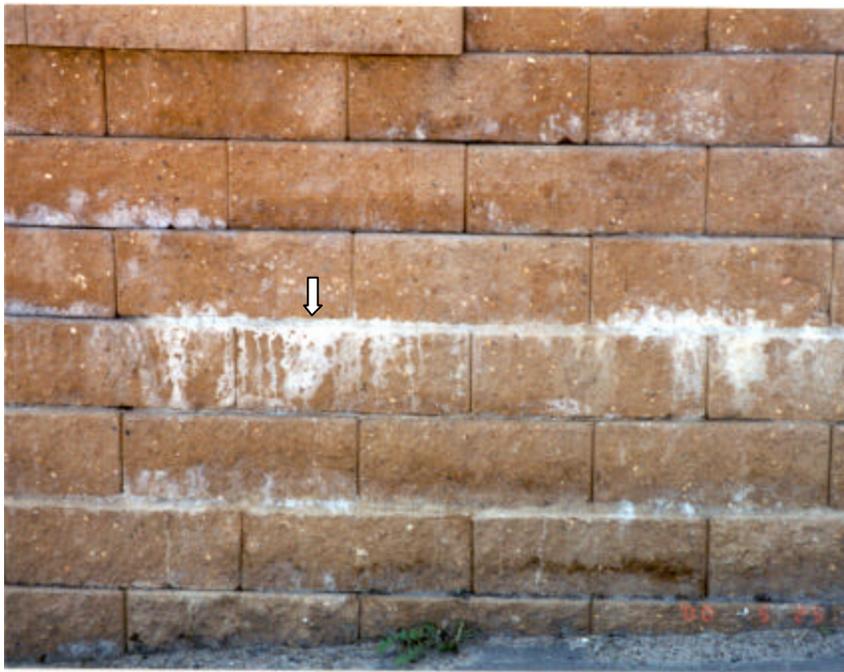
High-Severity Efflorescence

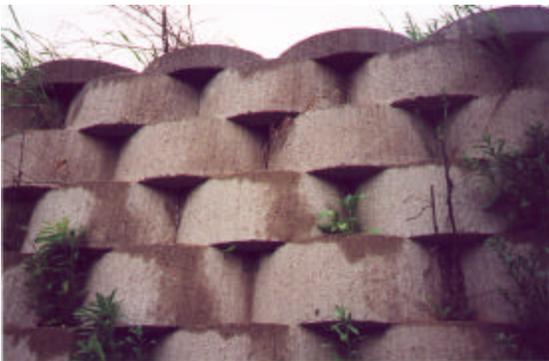
Low-Severity Embedded Vegetative Growth

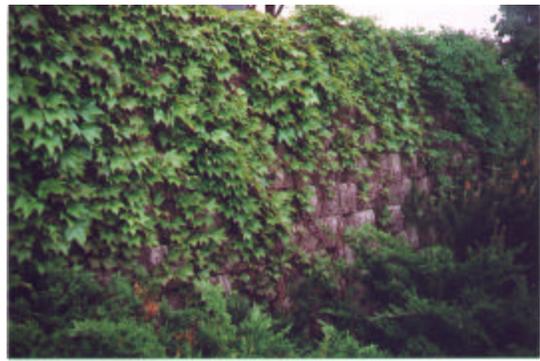
Medium-Severity Embedded Vegetative Growth

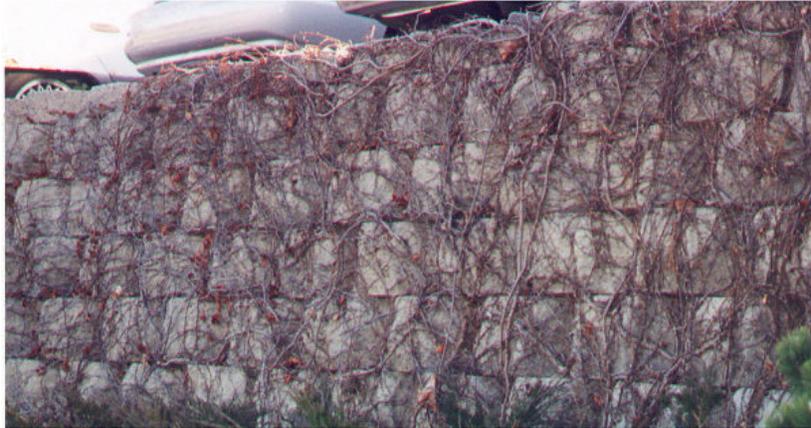
Medium-Severity Embedded Vegetative Growth

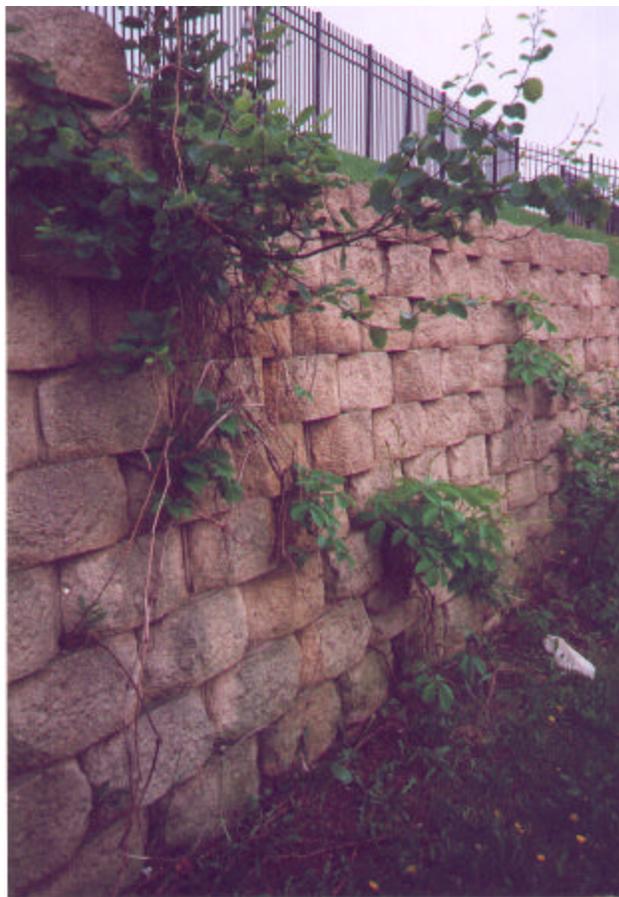
High-Severity Embedded Vegetative Growth

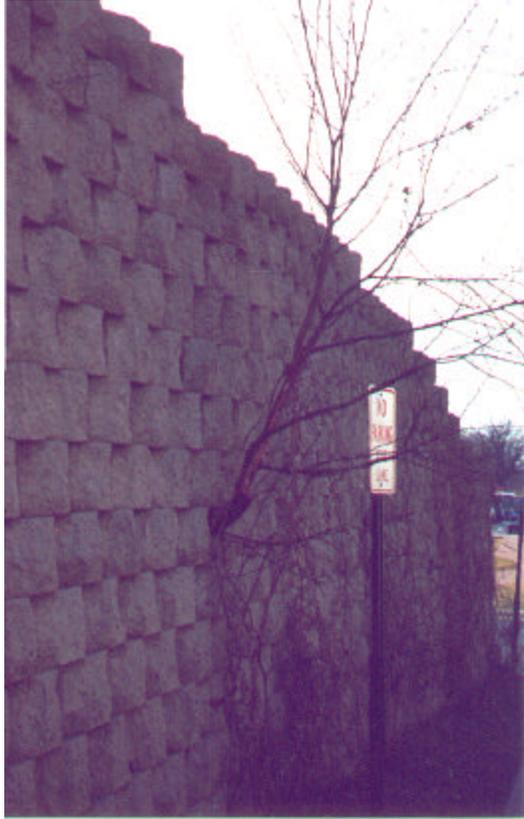
High-Severity Embedded Vegetative Growth

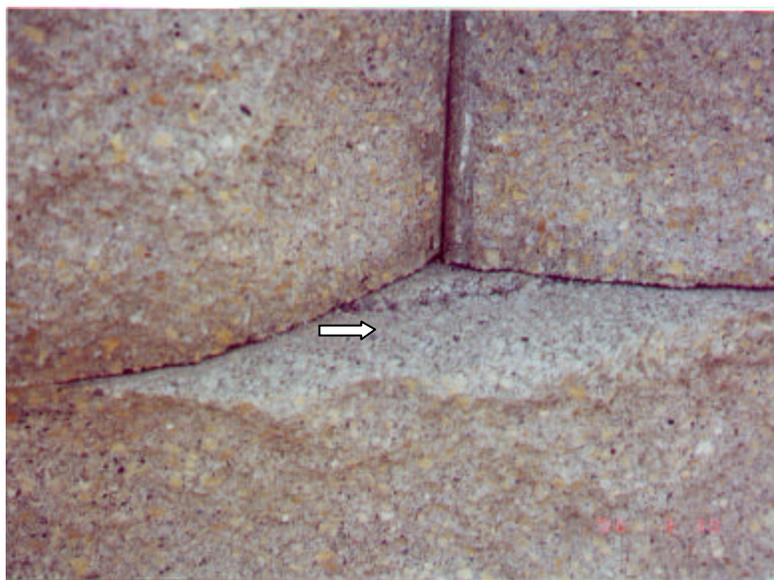
Erosion is the loss of SCBRW surface material due to the action of water or wind-blown abrasives (e.g., sand and salt). This distress may be easily confused with surface scaling and freeze-thaw damage because the latter distresses are generally more severe in areas of water flow and saturation. Erosion is typically evidenced by relatively uniform loss of surface mortar along the paths of water flow; scaling and freeze-thaw damage often involve loss of embedded aggregate and damage to greater depths, particularly near the bottom of the block where critical levels of saturation may exist more frequently.

Low-Severity Erosion

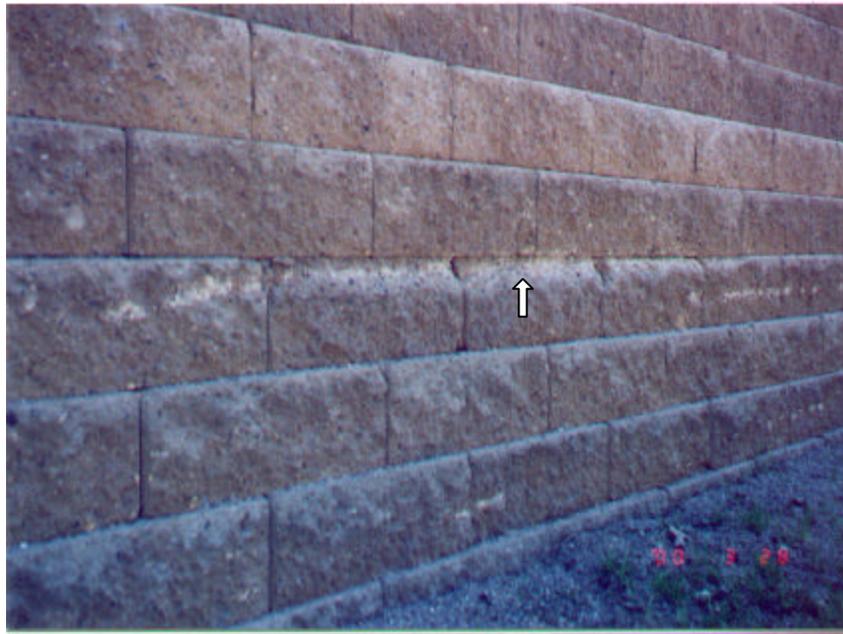
Scrapes in Vertical Surface Block

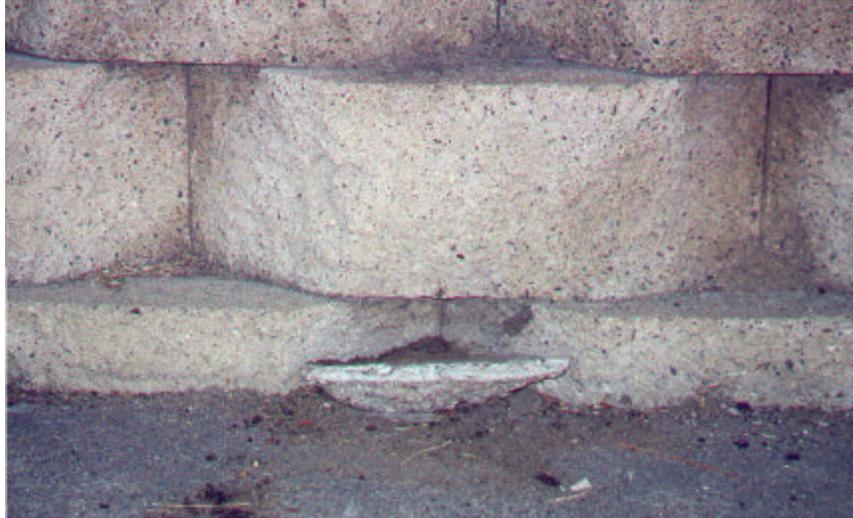
Bottom Block Popped out of Ground.

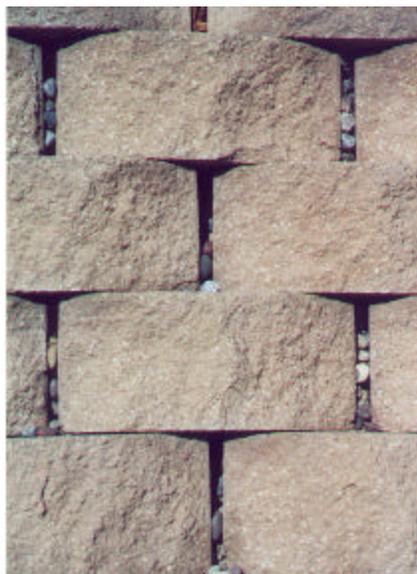
Medium-Severity Open Joints

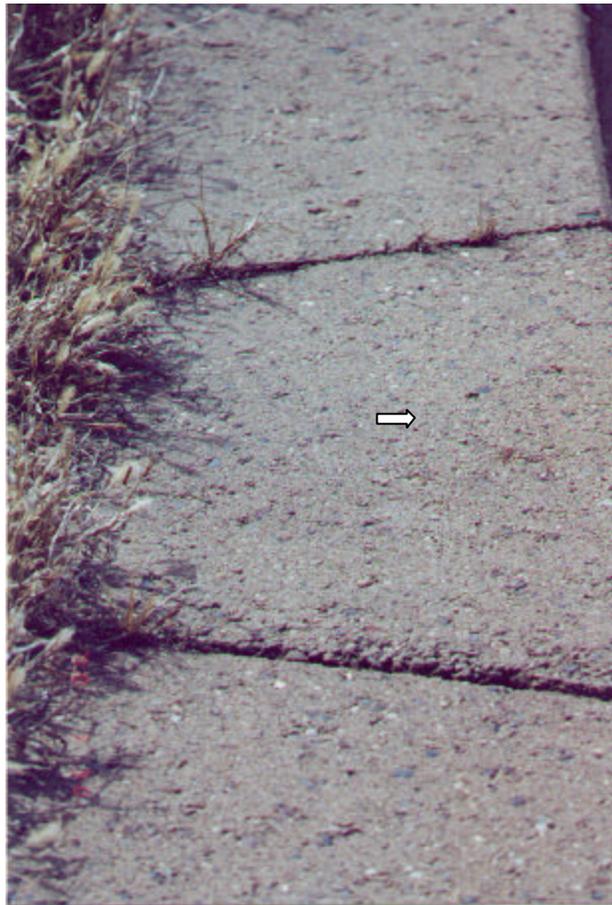
Low-Severity Top Block Layer Scaling

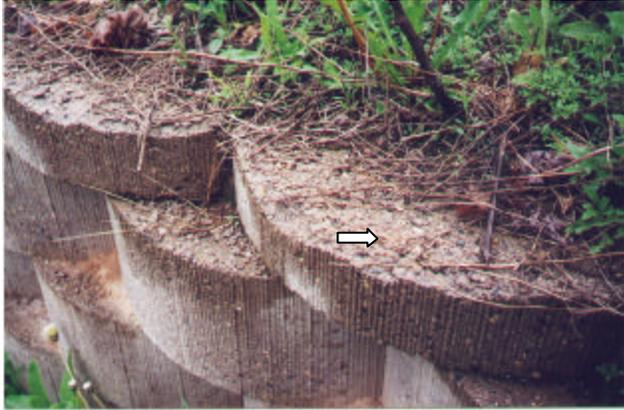
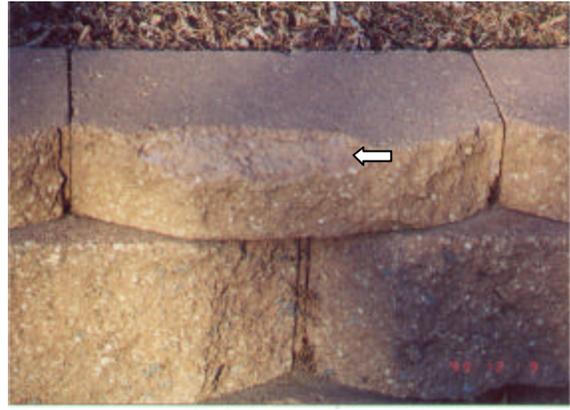
Medium-Severity Top Block Layer Scaling

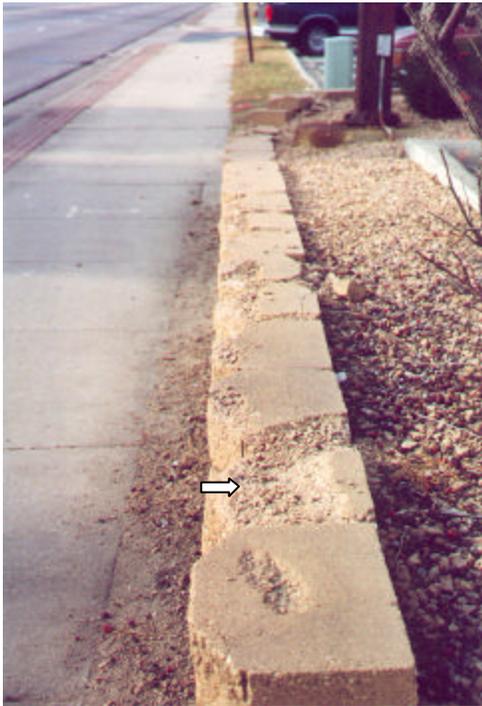
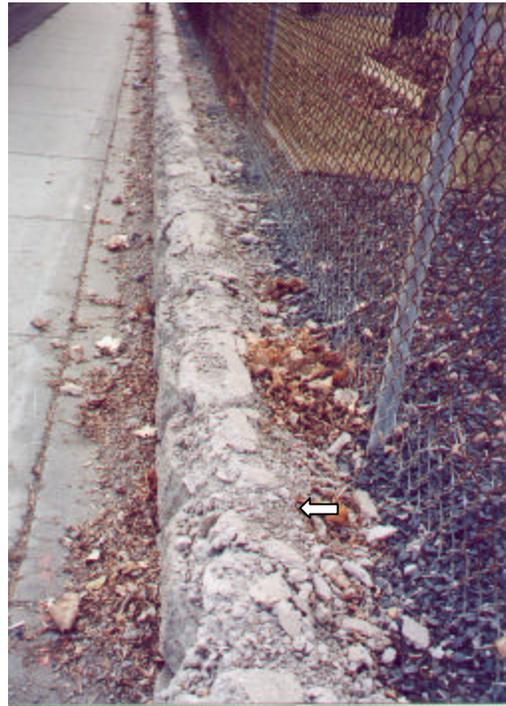
High-Severity Capstone Surface Scaling

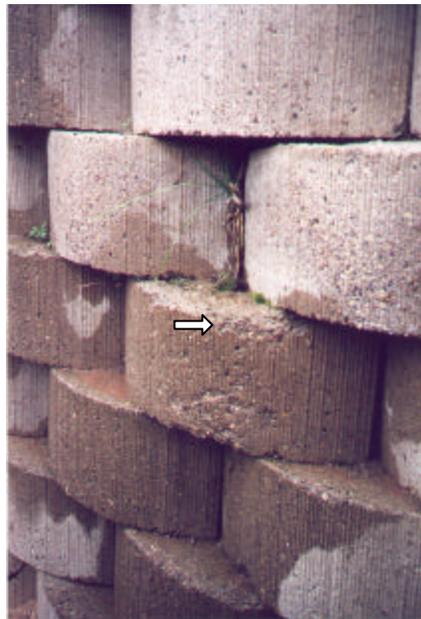
Medium-Severity Vertical Surface Scaling

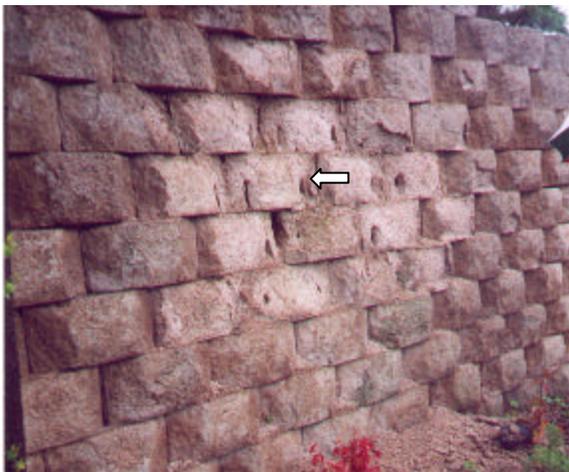
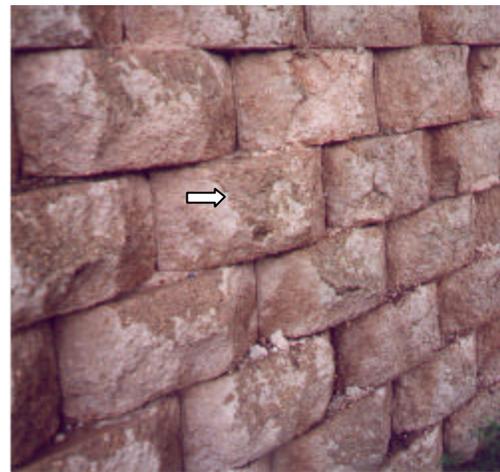
High-Severity Vertical Surface Scaling

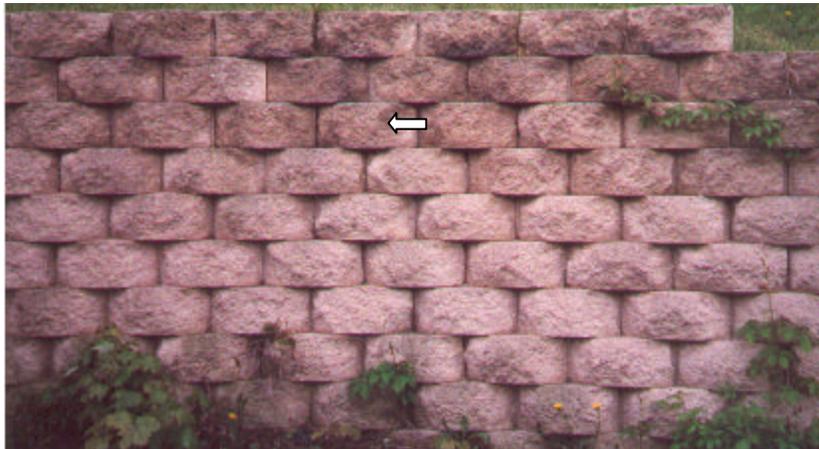
Medium-Severity Staining (External Source)

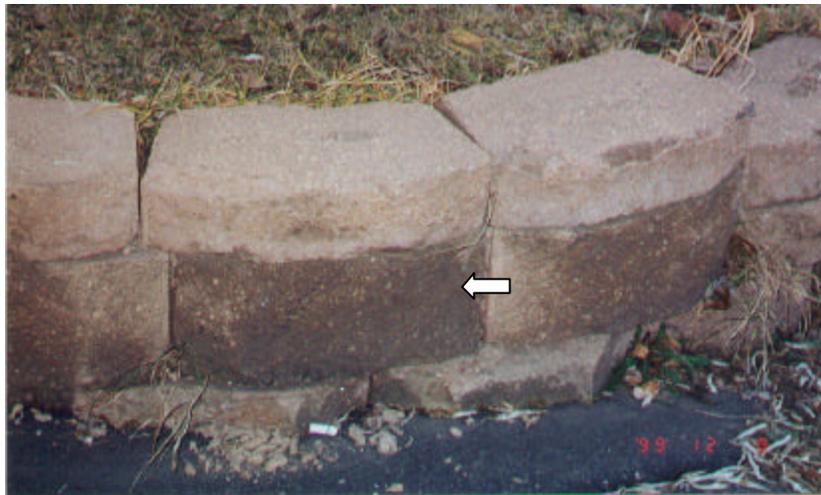
High-Severity Staining (External Source)

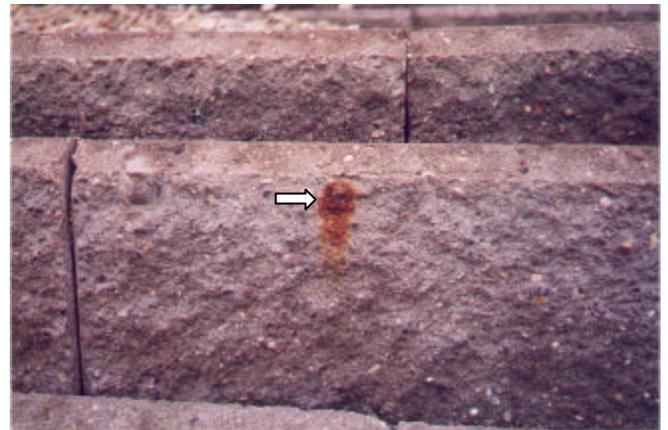
Staining (Internal Source)

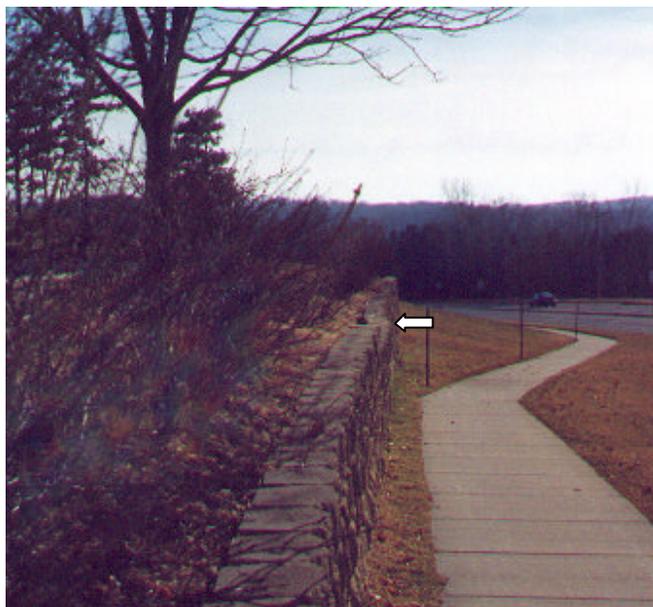
Low-Severity Structural Distress

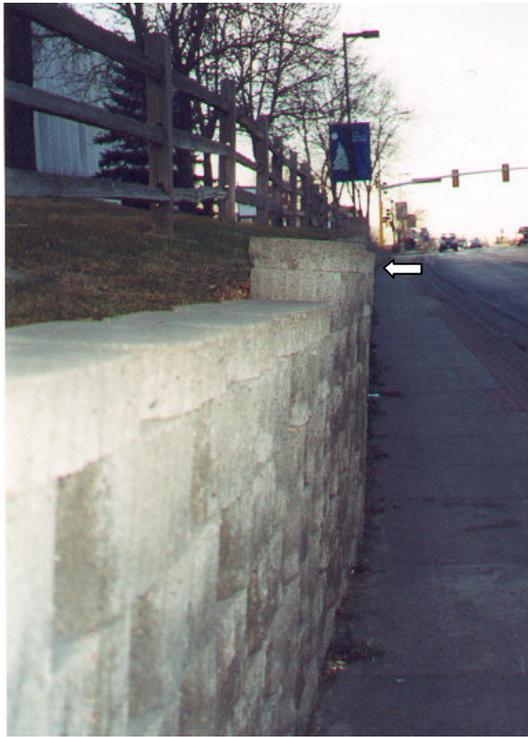
Medium-Severity Structural Distress

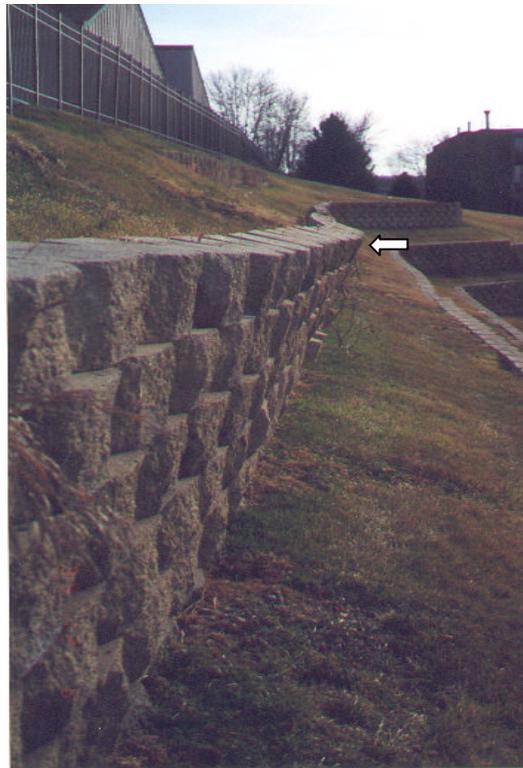
High-Severity Structural Distress

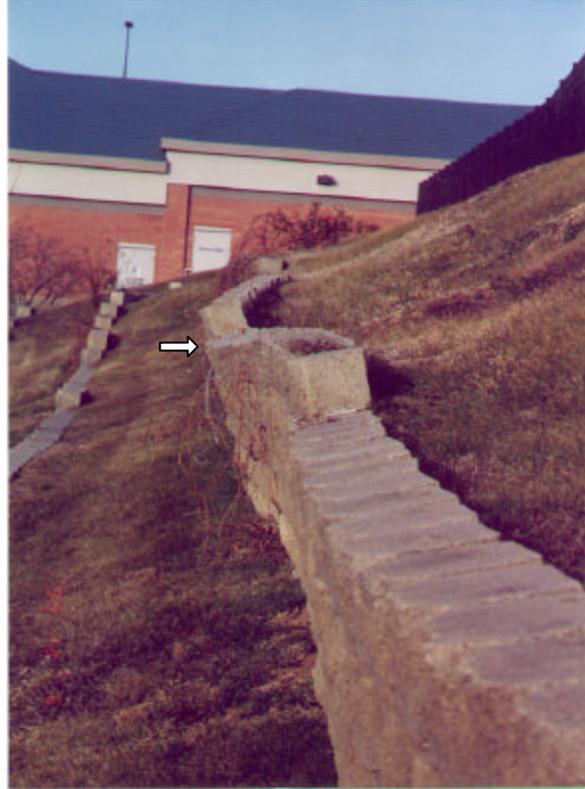
High-Severity Structural Distress
